BUILDING PERFORMANCE ASSESSMENT REPORT

**OKLAHOMA AND
KANSAS**

Midwest Tornadoes of May 3, 1999

**OBSERVATIONS, RECOMMENDATIONS,
AND TECHNICAL GUIDANCE**

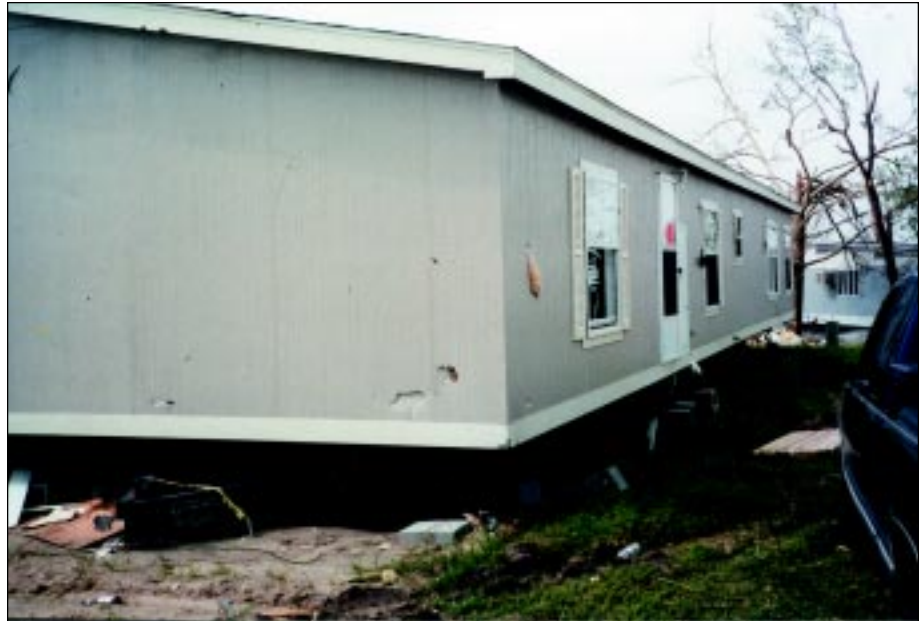
Several double-wide manufactured housing units in Haysville and Wichita, Kansas, partially survived high wind forces. However, ground anchors were pulled out of the soil, or they were bent over, loosening tie-down straps. Homes shifted laterally from wind forces and fell off un-reinforced and ungrouted CMU block piers. In some cases, tie-down straps with metal clips for attachment to chassis beams were loose and lying on the ground (Figures 4-57 through 4-60).

FIGURE 4-60: *Manufactured home laterally shifted off its dry-stacked masonry block foundation from wind force generated along the periphery of a violent tornado, Wichita, Kansas.*

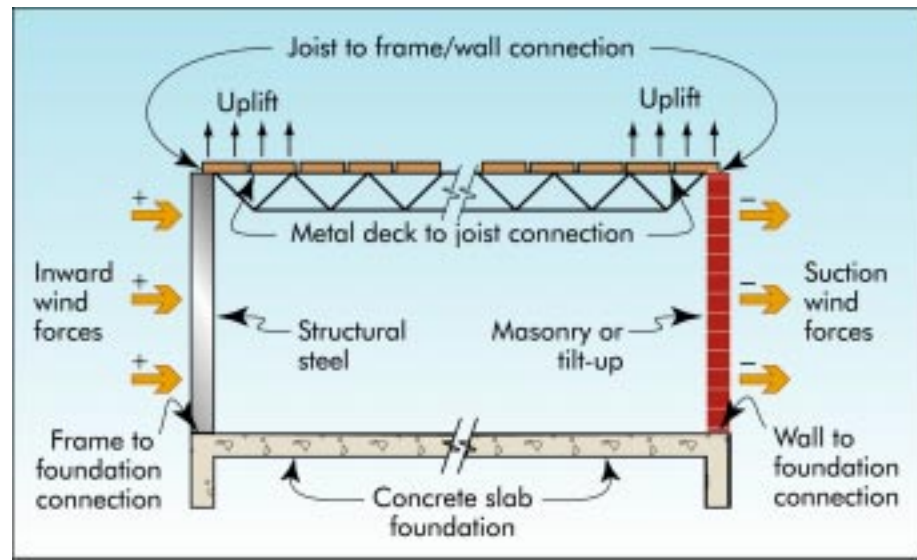
A continuous load path from the roof structure to a building foundation is essential for a building to resist not only gravity loads, but lateral and uplift loads generated by high winds as well. Figure 5-1 shows critical connections in the continuous load paths for representative types of non-residential buildings that sustained structural damage. To resist these loads, adequate connections must be provided between the roof sheathing and roof structural support, steel joists or other structural roofing members and walls, and foundation and walls or structural columns. Each of these connections must be capable of resisting uplift and lateral loads as well as gravity loads.

FIGURE 5-1: Critical connections that failed in the load path, resulting in structural damage or collapse.

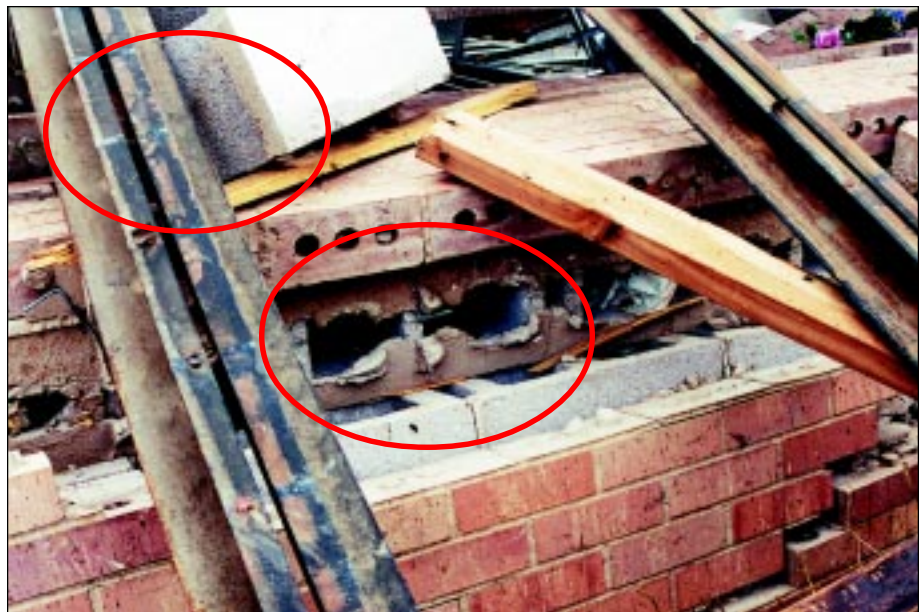
Figure 5-4 shows a close-up of a joist end over the cafeteria. The circle shows a location where the roof deck was supported for gravity load, but not sufficiently welded for uplift. Below the circle, broken welds can be seen. Some of the welds appeared to provide adequate diaphragm action based on deck material that remained at the welds; the deck appeared to fail at the welds only due to uplift. Spacing of the welds appeared to be consistent with standard weld spacing for deck welds.

Also visible in Figure 5-4 is the lower portion of the exterior wall. As illustrated in the photograph, no effective vertical reinforcement was found in the wall. Consequently, the wall had low resistance to uplift in combination with high lateral wind loads.

FIGURE 5-4: Failed structure showing broken deck welds (top circle), and no effective vertical reinforcement (bottom circle). Kelly Elementary School, Moore, Oklahoma, hit by vortex of violent tornado.

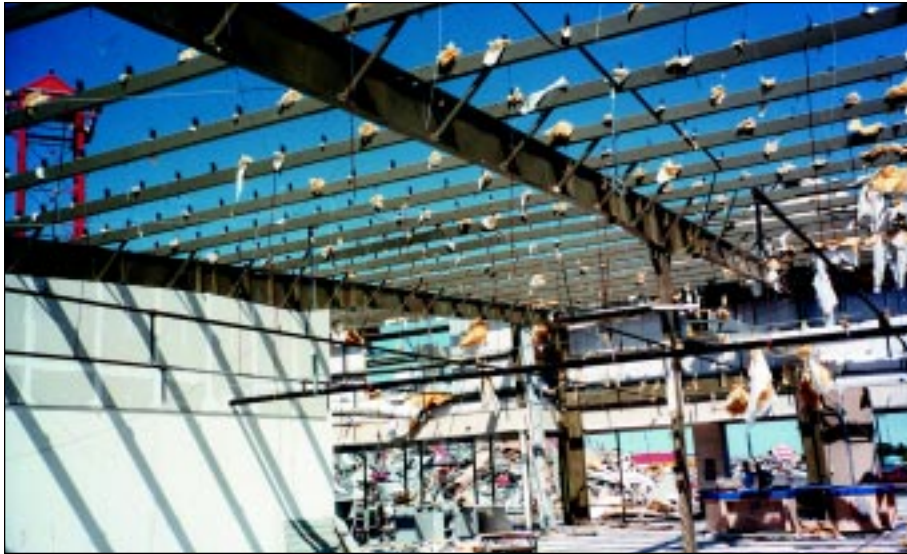
FIGURE 5-5: Metal roof deck (missing in photo) of regional outlet mall, Stroud, Oklahoma, was blown off when hit by a strong tornado vortex.

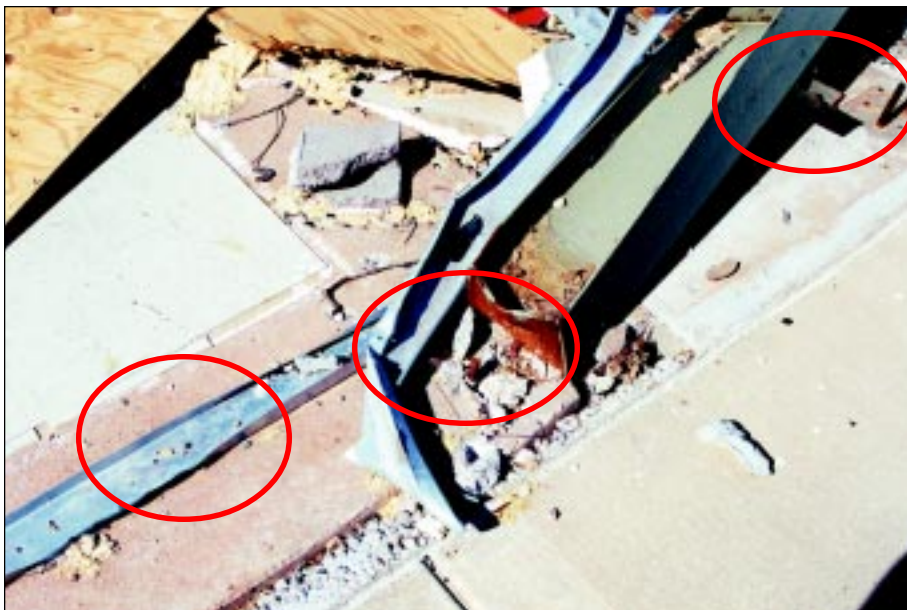
Figure 5-6 shows the attachment of columns to the foundation and attachment of the wall bottom plates to slab concrete. At the circle on the right in Figure 5-6, anchor bolts were provided, but the apparent lack of nuts on the anchor

FIGURE 5-6: Attachment of columns to foundation and attachment of wall bottom plates to concrete slab. Regional outlet mall, Stroud, Oklahoma, hit by a strong tornado vortex.

bolts permitted the column to lift off of the foundation. At the center circle, anchor bolts with properly attached nuts provided a high level of restraint to column uplift. The circle at the left shows a wall bottom plate that was attached to the concrete slab by powder-driven fasteners. Although the plate held at this location, lack of penetration by the nails into the concrete permitted the plate to pull out at many other locations. Additional fastener penetration would be needed to ensure consistent attachment of wall bottom plates to the slab.

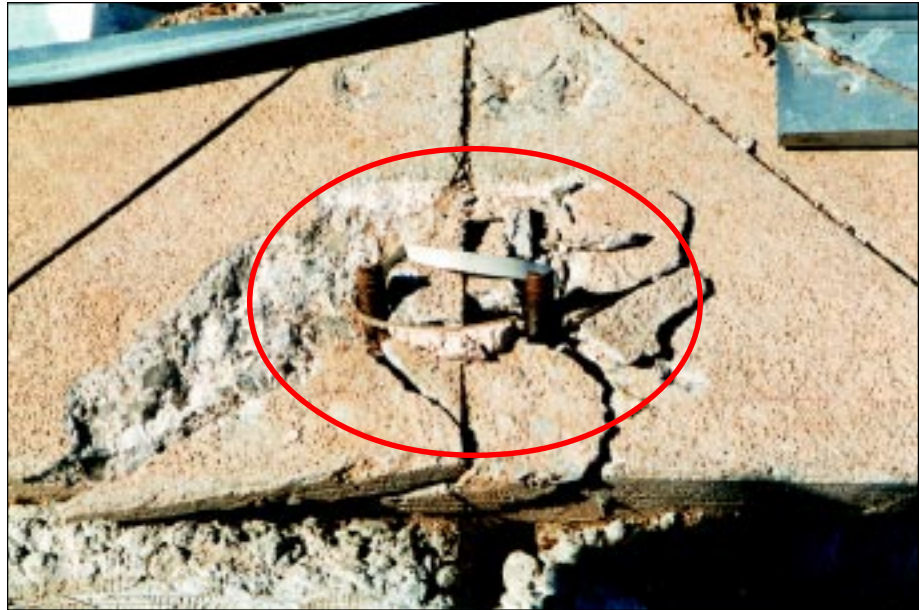
Most bolts with nuts exhibited a ductile steel failure as shown in Figure 5-7. This was the failure mode observed in most cases. This was also the failure mode for the anchorages at the steel water tower in Mulhall, Oklahoma. However, some of the bolts observed at the mall did pull out of the concrete foundation, indicating a failure either in the concrete bond or inadequate embedment of the anchor bolts (see Figure 5-8).

FIGURE 5-7: Column anchors that exhibited ductile failure at the regional outlet mall in Stroud, Oklahoma, hit by a strong tornado vortex.

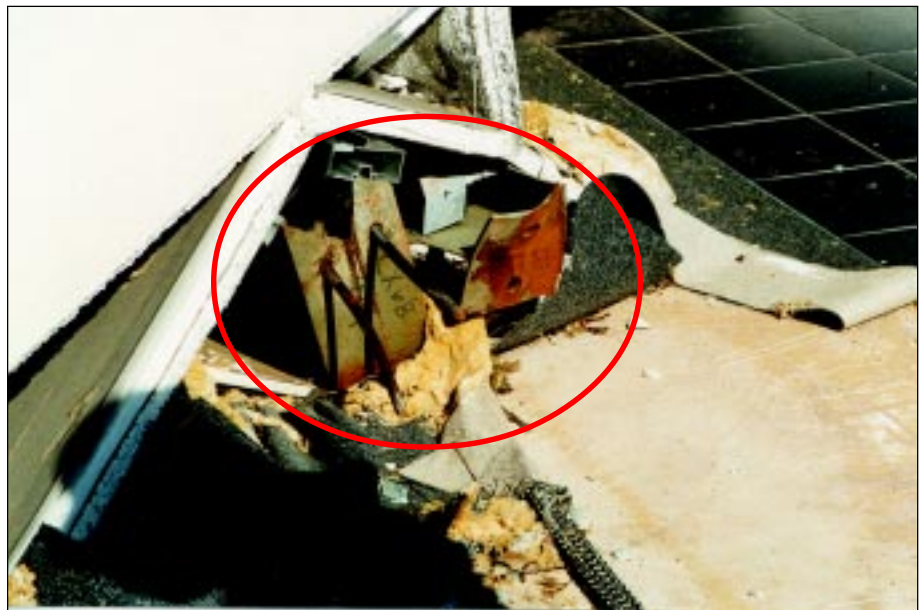
FIGURE 5-8: Column anchors that withdrew from concrete foundation at the regional outlet mall in Stroud, Oklahoma, hit by a strong tornado vortex.

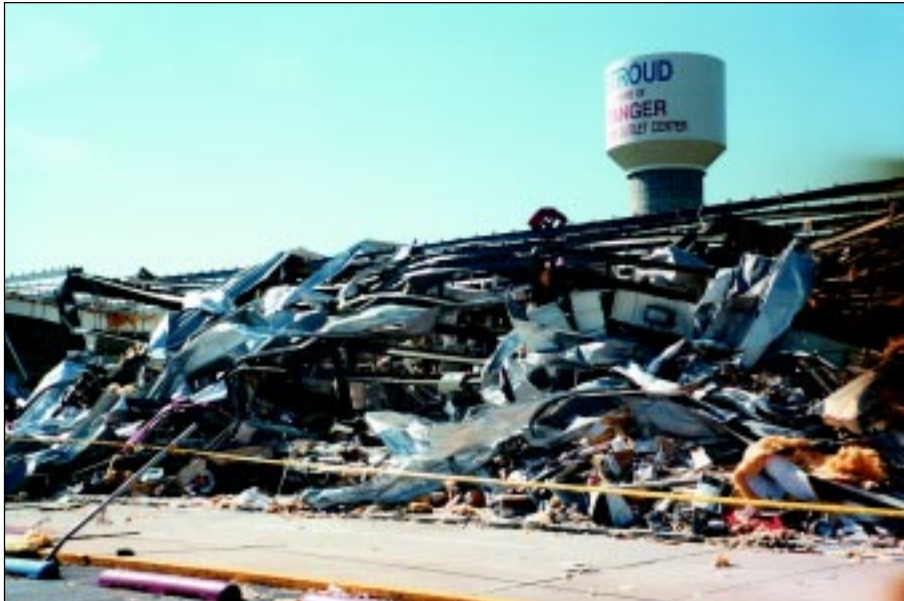
The BPAT investigated the regional outlet mall that was destroyed in Stroud, Oklahoma. Figure 5-9 shows damage to the outlet mall. In this structure, most of the metal roof panels were blown off by the tornado. In addition, most of the glass curtainwalls at the storefronts experienced failures.

FIGURE 5-9: *Stroud Regional Outlet Mall, Stroud, Oklahoma, was struck by the vortex of a weak tornado.*

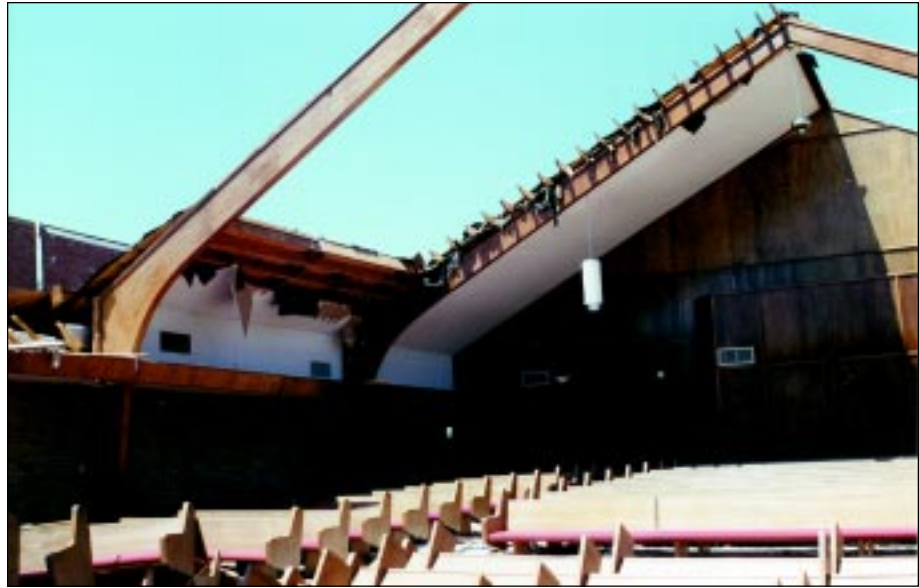
Lack of load path resulted in severe damage to the Regency Park Baptist Church in Moore, Oklahoma. This building was approximately one block north and across the street from Kelly Elementary School. The vortex of a violent tornado passed approximately a few hundred yards to the south. Figure 5-10 shows the rigid frames remaining after the roof had been removed by the tornado. Loss of load path between the rigid frames and the roof purlins resulted in severe damage to the facility.

FIGURE 5-10: *This church suffered loss of roof due to lack of load path between the rigid laminated wood arches and the roof purlins (missing in photo) that supported roof sheathing. Inflow area of a violent tornado, Moore, Oklahoma.*

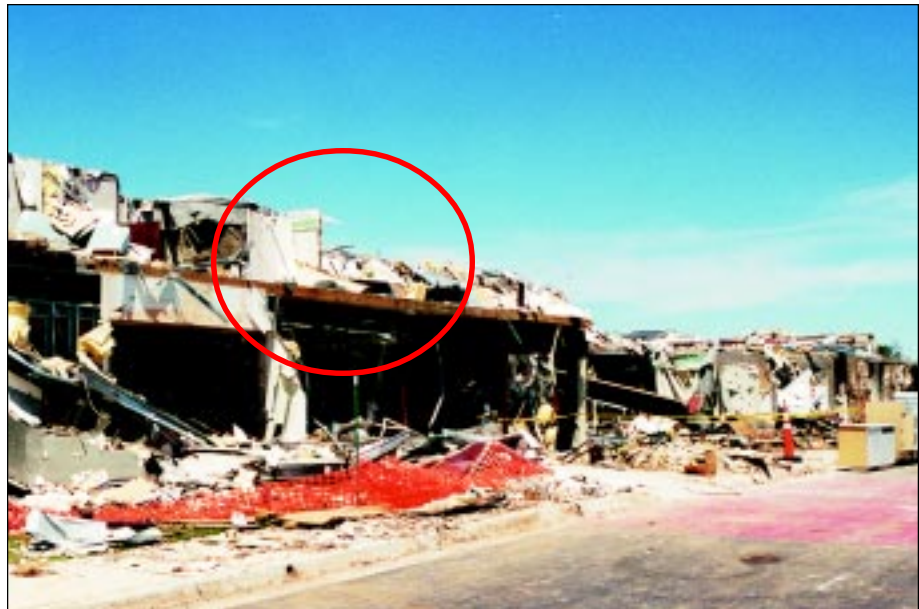
In several locations, combined effects of wind uplift and horizontal wind loads caused damage to structures. A continuous load path is often observed in this type of construction at the connection of the floor slabs to the walls. However, at many of the buildings of this type of construction, a continuous load path for uplift and lateral loads did not exist and roof failures and upper level floor failures were observed. Figure 5-11 shows the remains of a motel in Midwest City, Oklahoma, hit by a violent tornado vortex. The circle shows a steel beam

FIGURE 5-11: *Motel in Midwest City, Oklahoma that experienced major damage when struck by the vortex of a violent tornado.*

that had been deflected inward significantly when the floor slab was lifted during the tornado. There was no positive connection between the steel beam and the floor above.

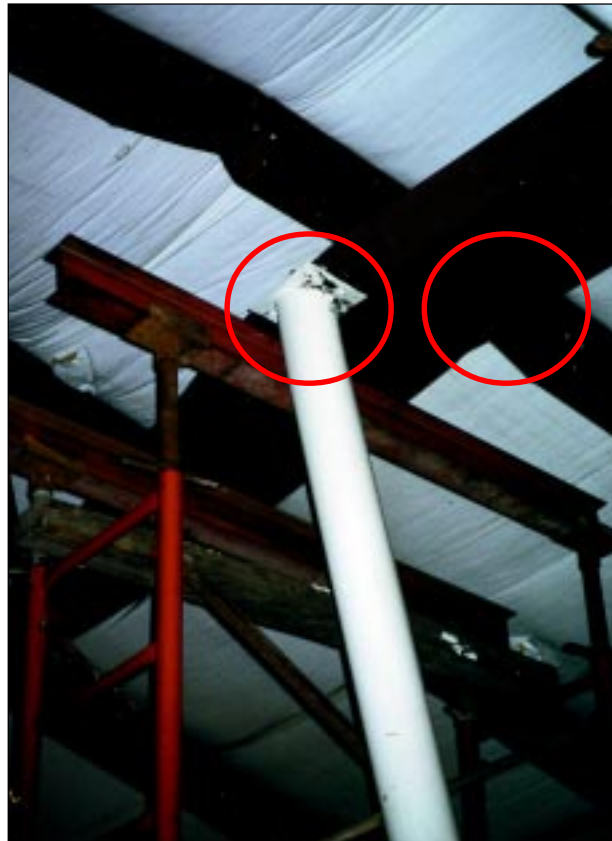
At a plastics manufacturing plant in Haysville, Kansas, a combination of uplift and horizontal wind caused out-of-plane buckling of the bottom flange of a main girder supporting the roof (Figure 5-12) when the plant site was struck by a strong tornado. One circle shows the column that supports the girder, while the other circle shows the bottom flange of the girder. It can be seen that the bottom flange has displaced significantly sideways in relation to the top flange of the girder. Inspection along the length of the girder indicated that the bottom flange was braced along its length at every purlin except at the location of the supporting column. This lack of bracing permitted buckling and out-of-plane displacement of the bottom flange. However, due to the light gravity loads left on the roof after the wind forces diminished, collapse did not occur.

FIGURE 5-12: Out-of-plane buckling of the main girder supporting the roof created by a combination of uplift and horizontal wind loads. Plastics plant, Haysville, Kansas, hit by violent tornado. This building was in the inflow area of a strong tornado.

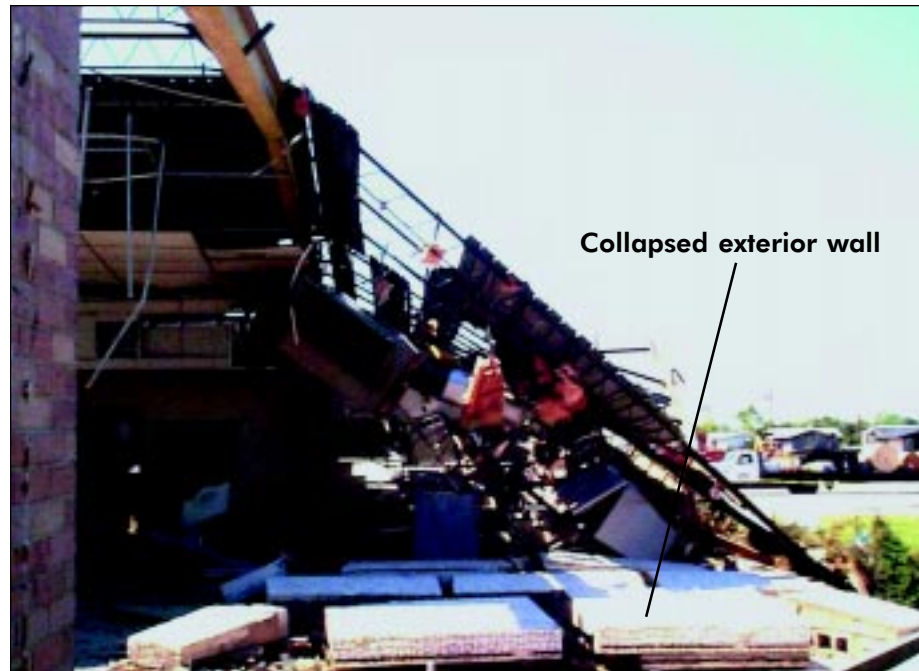
Another example of the effects of uplift and horizontal wind forces is seen in Figure 5-13 at Kelly Elementary School in Moore, Oklahoma. The exterior wall collapsed inward, indicating that the roof had lifted up as the wind loads acted inward on the wall. Failure to have a continuous load path from the joists supports into the masonry wall to resist uplift forces contributed to collapse of the wall. The exterior masonry wall is seen lying on the floor beneath the collapsed roof structure.

FIGURE 5-13: Collapsed roof structure and exterior wall at Kelly Elementary School in Moore, Oklahoma, struck by the vortex of a violent tornado.

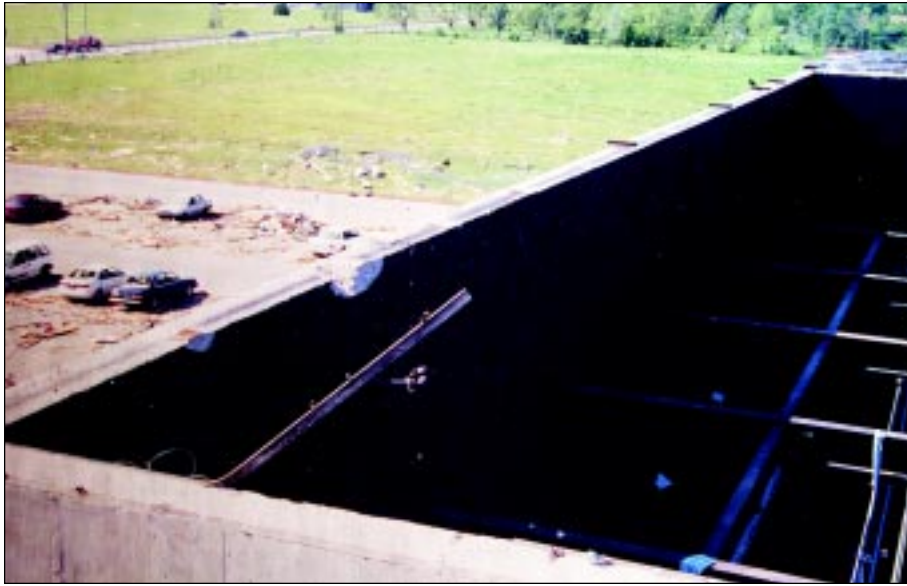
The Westmoore High School in Moore, Oklahoma, was a relatively new structure that was within 100 yards of the vortex of a violent tornado. A portion of the roof deck and supporting steel joists over the auditorium stage was blown off. Figure 5-14 shows the walls where the steel joists had been attached prior to the tornado. In all cases, welds failed between joist ends and embedments in the walls. This loss of continuous load path permitted the roof to be lifted up off of the reinforced concrete walls.

FIGURE 5-14: Roof blown off over top of auditorium at Westmoore High School, Moore, Oklahoma, hit by inflow winds of violent tornado.

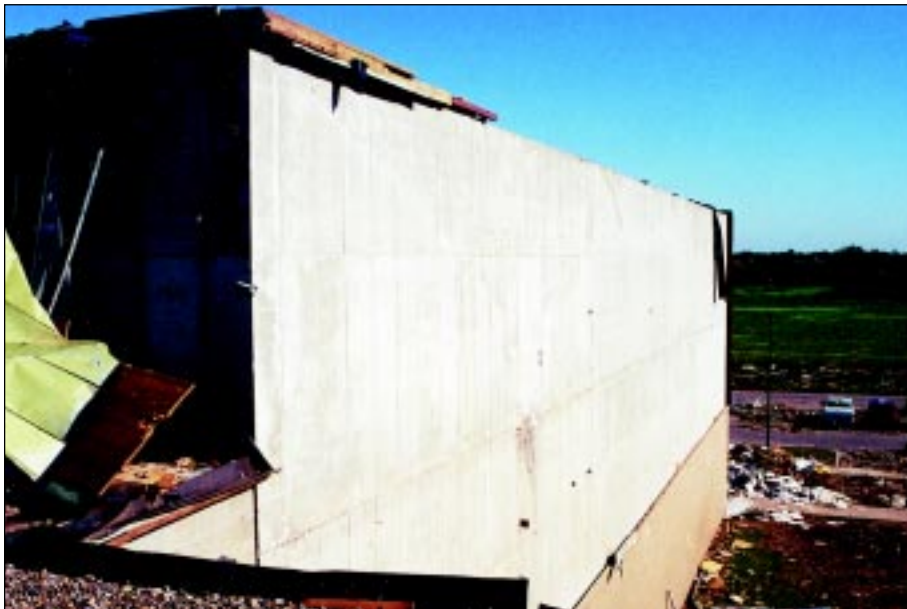
Figure 5-15 shows the exterior of the reinforced concrete wall at Westmoore High School following the tornado. This 12-in thick by approximately 35-ft-tall wall remained essentially undamaged, except for loss of the metal wall covering, even though the diaphragm action of the roof was lost. The construction of the stage area integrated an I-beam horizontal frame, shown in Figure 5-14, with the reinforced concrete walls. This frame helped to stabilize the walls. Prior to the tornado, the bare concrete had been covered with a decorative metal curtainwall. The entire curtainwall blew off during the tornado, while brick masonry veneer on the lower wall remained, with virtually no damage.

FIGURE 5-15: Exterior view of an undamaged reinforced concrete wall, Westmoore High School, Moore, Oklahoma, hit by inflow winds of a violent tornado. Note: decorative metal wall covering was peeled from this wall.

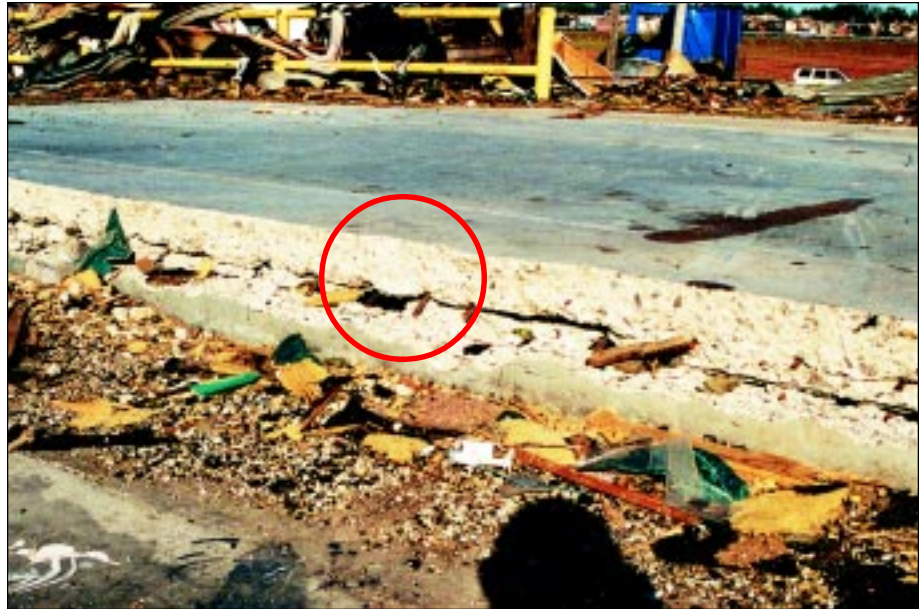
Figure 5-16 shows a tilt-up concrete wall that failed after loss of a roof diaphragm made up of steel joists and metal deck. This building was located

FIGURE 5-16: Failure of tilt-up concrete wall in Del City, Oklahoma, hit by inflow winds of a violent tornado.

approximately 200 yards from a violent tornado vortex near Del City, Oklahoma. As can be seen in Figure 5-16, the wall was heavily reinforced at the foundation level. However, lack of support at the top of the wall permitted the wall to blow outward and collapse.

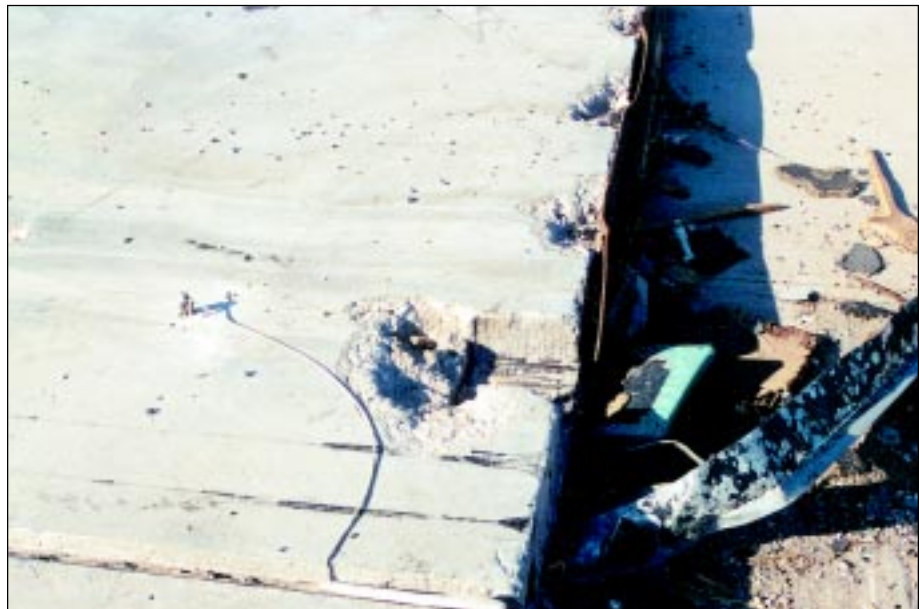
Figures 5-17 and 5-18 show the top of the tilt-up precast concrete wall that failed. Figure 5-17 shows that lateral resistance provided by a beam supported by the wall was lost when the beam pulled out of the wall pocket. Failed welds

FIGURE 5-17: Top of failed tilt-up end wall.

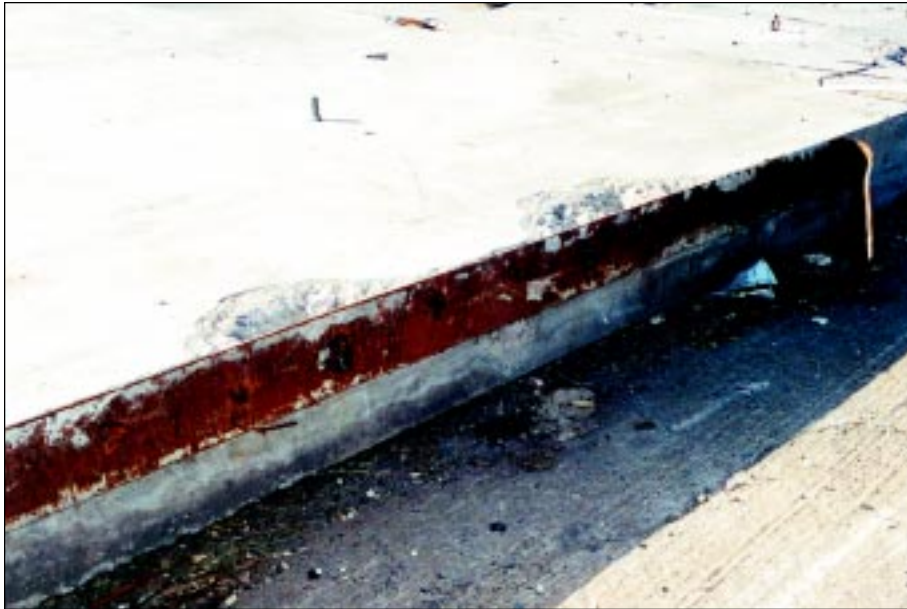
FIGURE 5-18: Top of failed tilt-up wall.

tying the roof joist into plates embedded in the top of the tilt-up wall can also be seen in Figure 5-18. Visual inspection showed that only one of the four walls of the building collapsed. The other walls continued to provide lateral resistance because portions of the roof remained.

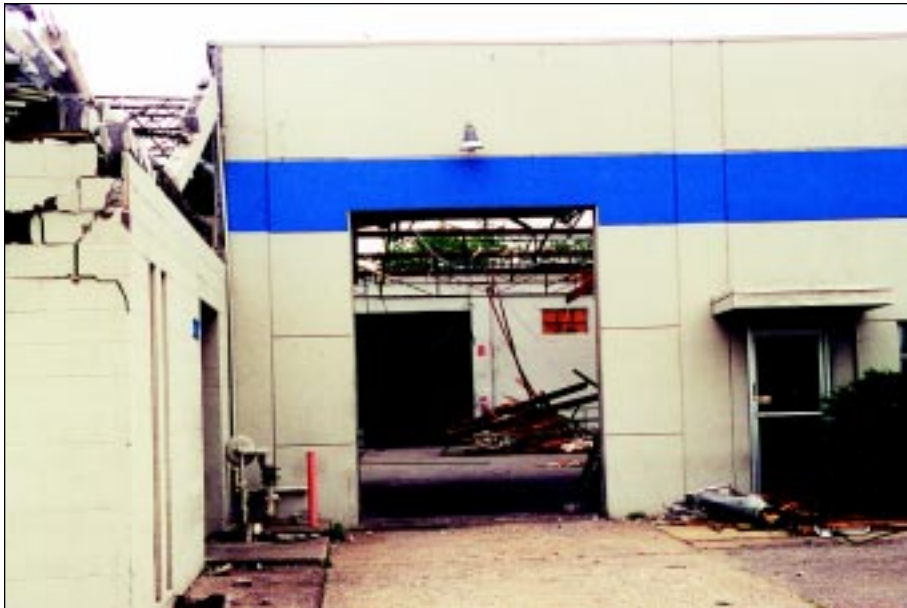
Tilt-up walls at a facility that was located under the vortex of a weak tornado in Wichita, Kansas, survived virtually undamaged, despite loss of metal roof decking. As can be seen in Figure 5-19, trusses spanning the open area maintained enough lateral support for the walls that failure did not occur.

FIGURE 5-19: The tilt-up precast concrete walls in this building did not fail when the roof system failed. The masonry walls shown at the left of the photo were damaged. Note: many roof joists are still in place. Building was located in Wichita, Kansas, and was hit by weak tornado vortex.

In Figure 5-19, damage to a portion of the building having steel roof joists supported on masonry walls can be seen at the left. Walls in this portion of the building collapsed when subjected to the vortex winds of a weak tornado. Even though some diaphragm action was maintained, the masonry walls did not have enough lateral load resistance under the combined uplift and horizontal load of the tornado.

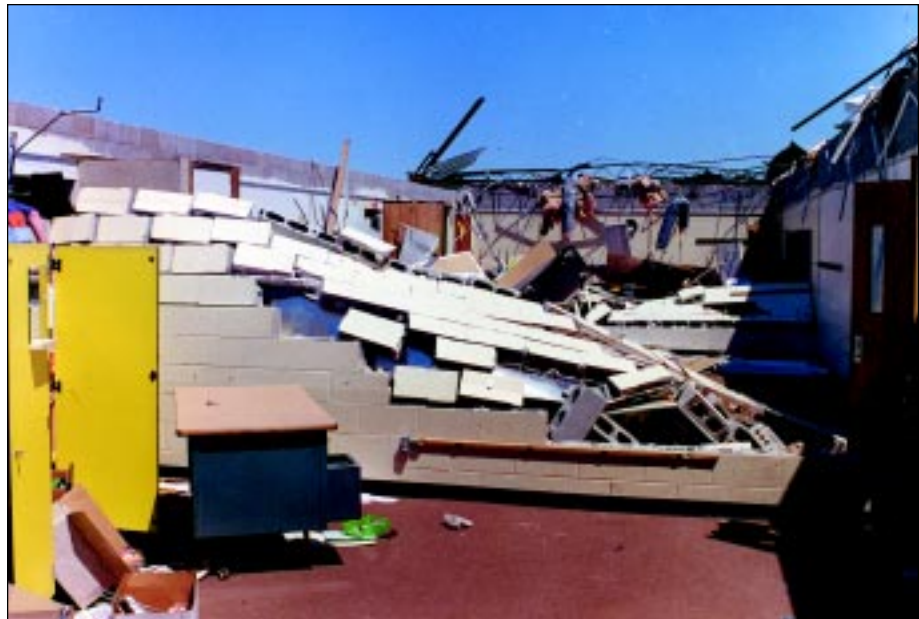
Figure 5-20 shows damage to both interior and exterior unreinforced masonry walls (URM) at Kelly Elementary in Moore, Oklahoma. Wind loads due to the vortex of a violent tornado lifted the roof system until the bond beam atop the URM wall failed. When this bond beam failed, the roof separated from the building and some interior walls failed.

Figure 5-20: Damage to interior and exterior unreinforced masonry walls when bond beams failed at Kelly Elementary School in Moore, Oklahoma. The school was struck by the vortex of a violent tornado.

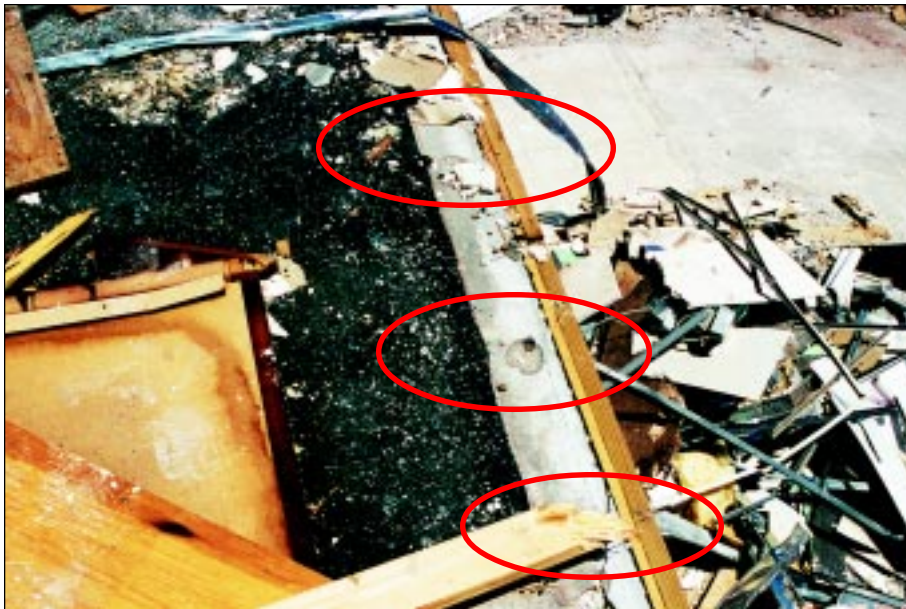
Elsewhere along the edge of the second floor of the motel, failure occurred between the hollow core planks and exterior walls of the building. As shown in Figure 5-22, lower plates for the walls had been attached to the hollow core planks using powder-driven anchors. As indicated by the circles, the powder-driven anchors pulled out during the tornado.

FIGURE 5-22: Attachments of lower plates for wall to hollow core plank using powder driven anchors failed when required to carry loads generated by the winds of a strong tornado vortex. This motel was located in Midwest City, Oklahoma.

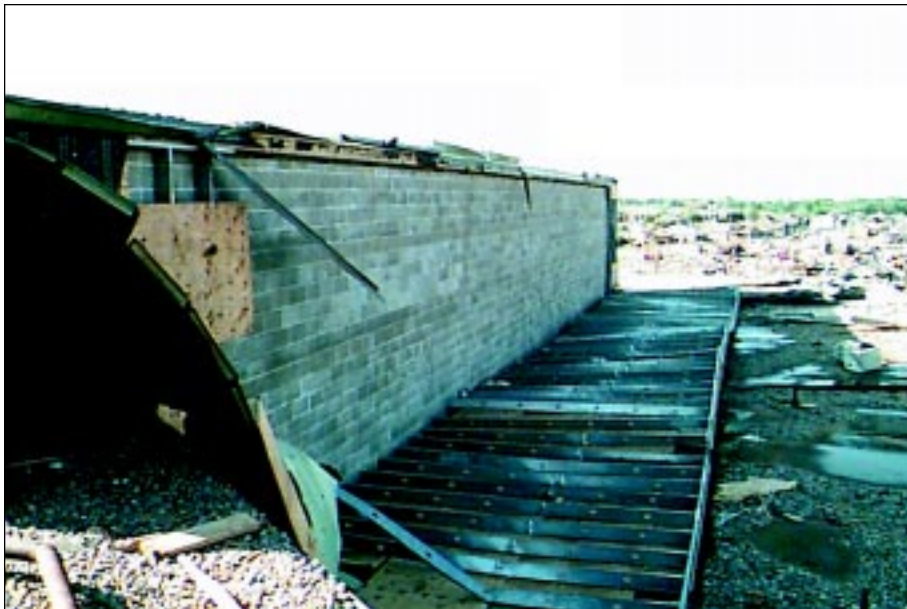
Brick veneer is discussed in Section 4.1.9. Some metal wall coverings over steel studs collapsed (Figure 5-28). All the metal wall systems at this building that experienced suction wind forces failed at this site. Although it did result in structural failures it exposed some internal areas to tornado winds. Some exterior insulating finishing system (EIFS) failures were observed (Figure 3-10). EIFS wall failures observed were the result of impact of windborne missiles and suction wind forces.

FIGURE 5-28: *This metal-clad wall covering collapsed and in other areas it was blown completely away.*

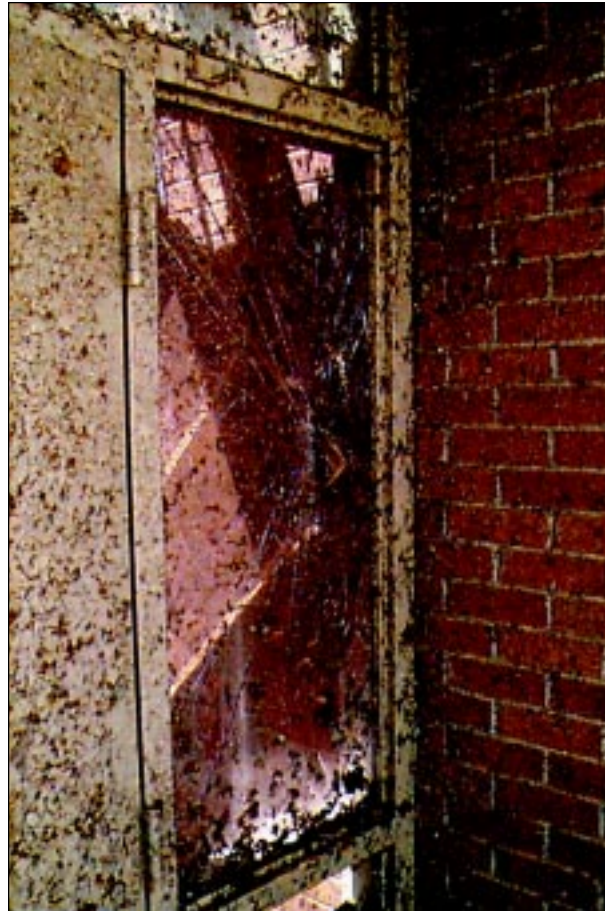
In a few instances, examples of laminated glass performance were observed. In some cases, the glass remained in the frame after missile impact (Figure 5-29). In another case, the glass was punched out of its frame. The school in Figure 5-29 is located adjacent to the Regency Park Baptist Church in Moore, Oklahoma, shown in Figure 5-10. The vortex of a violent tornado passed a few hundred yards south of this building.

FIGURE 5-29: *The corner of a table penetrated this laminated glass, but the glass remained in its frame. This school suffered major damage from inflow winds of a violent tornado in Moore, Oklahoma.*

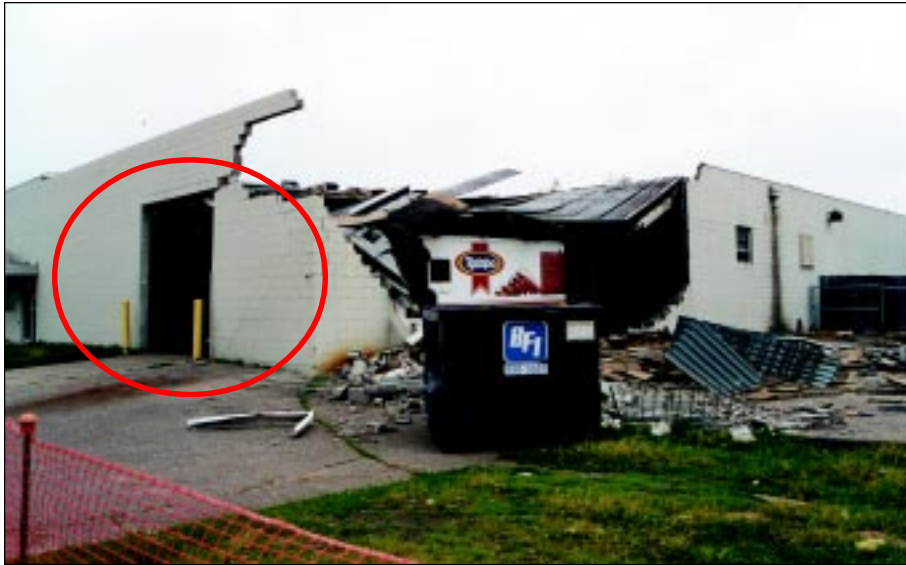
The breach of overhead rollup commercial doors resulted in internal pressurization of several structures leading to significant load increases. Not unlike the residential case, where a breach in the building envelope was observed at a roll-up door, this breach initiated a partial or total failure of primary structural systems. This was particularly true for pre-engineered buildings, which typically had little redundancy in load transfer of their structural systems. Figure 5-30 shows a breached commercial rollup door at a bread manufactur-

FIGURE 5-30: Failure of roof and walls on structure due to increased loads caused by initial failure of a rollup door, Wichita, Kansas.

ing and distribution center in Wichita, Kansas. The building exterior walls were constructed using both CMU and tilt-up concrete panels. The standing seam metal roof panels were on a Z purlin system. The rollup door failure appears to be a result of positive (inward) pressure. The breach may have caused a sufficient enough rapid increase in load to produce failure of the URM wall. Note the location of the failed door near a corner where high suction (outward) pressure is likely to occur on the adjacent wall. As a result of the exterior wall collapse, severe damage to the roof system occurred due to the loss of the load bearing exterior support wall. However, notice that the roof collapsed to the interior of the building, which may indicate that uplift loads acting on the roof were insufficient to cause progressive peeling failure of the roof decking.

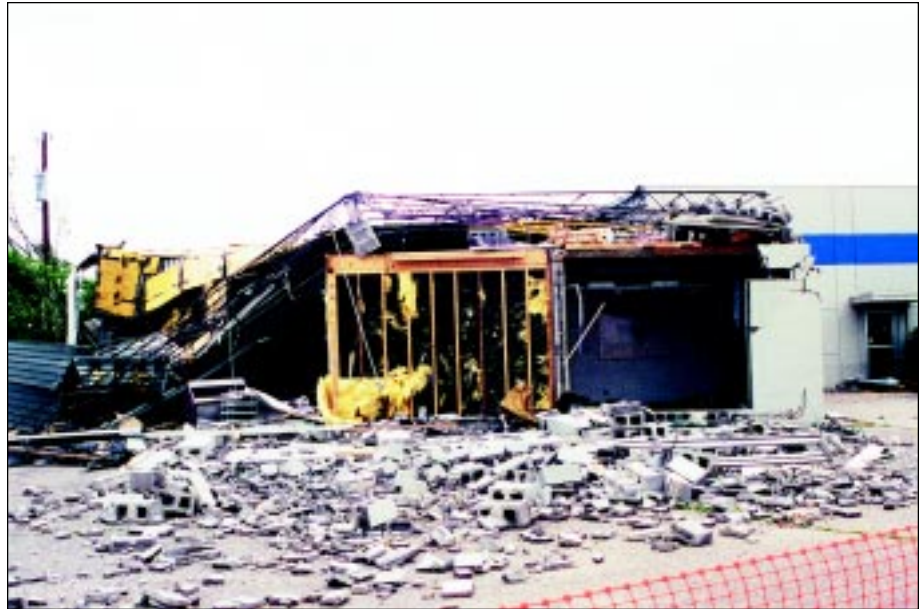
Figure 5-31 illustrates another condition in Wichita, Kansas, where breach of the building envelope contributed to additional structural damage. In this case, loss of showroom windows and a rollup door greatly increased loads in the showroom and on the wall at the left of the photograph. These increased loads caused the walls to fail and the roof to partially collapse, thereby greatly increasing structural damage.

FIGURE 5-31: *Additional structural damage caused by breach of envelope in Wichita, Kansas.*

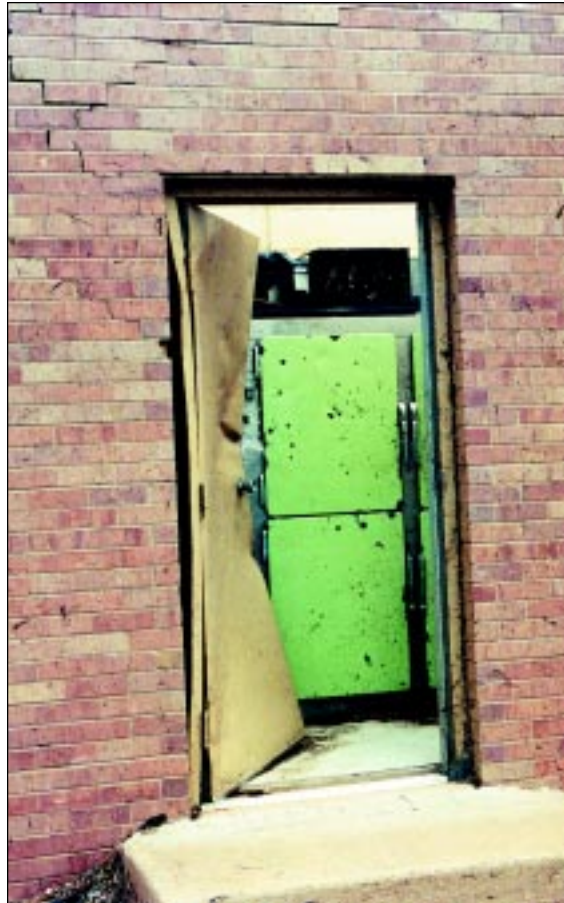
Figure 5-32 shows a steel door that appears to have been opened by impact of a heavy object. This door at Kelly Elementary School in Moore, Oklahoma, led into an area where the roof was completely missing. The breached door may have caused an increase in load that propagated damage to that part of the building envelope. A nearby door, which was also heavily impacted, but did not open, was located in an area of the school that saw less damage to the wall and roof of the building.

FIGURE 5-32: *Damaged door most likely opened by impact with heavy object. Kelly Elementary School, Moore, Oklahoma.*

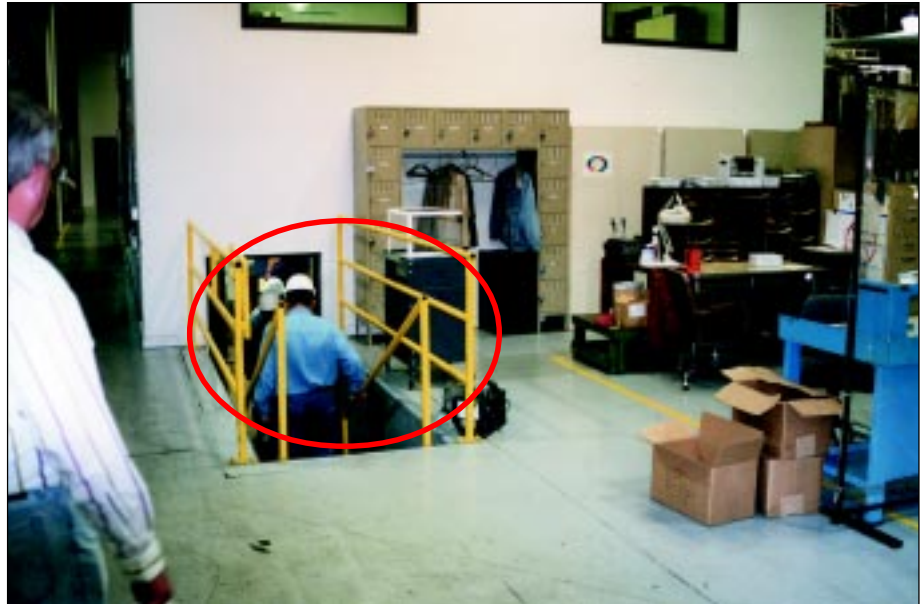
Deficiencies and vulnerabilities were observed in the group shelter presented in Figures 6-7 and 6-8. The shelters in both figures are only accessible by stairs and, depending upon the emergency plan, are possibly non-compliant by ADA requirements. The interior of the shelter in Figure 6-7 was also very damp, signifying a moisture problem that may be a problem for long duration stays within the shelter. The group shelter in Figure 6-8 has a vent on the top that is

FIGURE 6-7: Entrance to the plastics manufacturing plant group shelter in Haysville, Kansas.

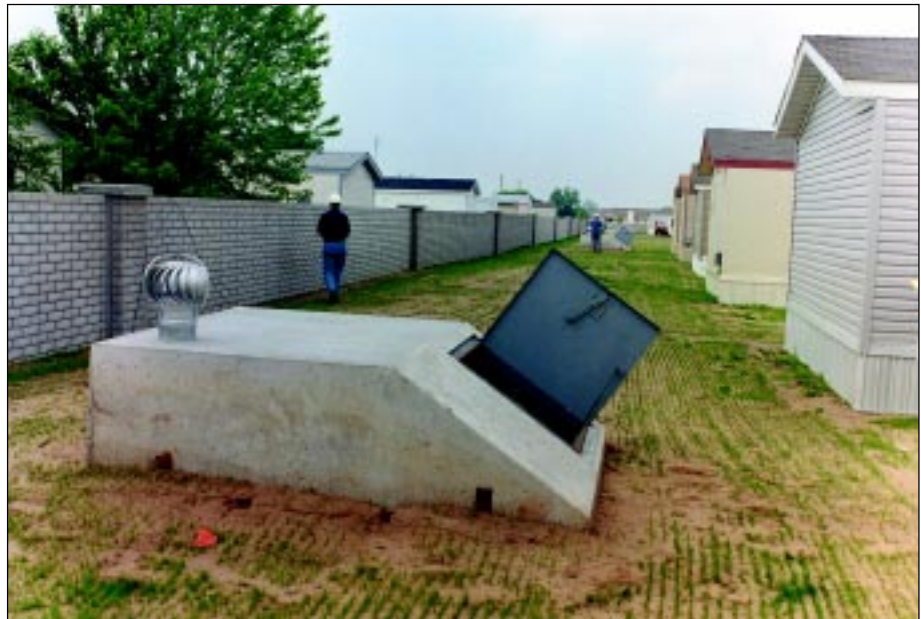
FIGURE 6-8: Group shelters at a manufactured home rental community in Wichita, Kansas.

very susceptible to damage and removal by wind and windborne debris. The door, specifically the latch mechanism, is vulnerable to windborne debris. Damage to either of these two elements would result in experiencing wind, windborne debris, and hail and rain from a storm event within the shelter.

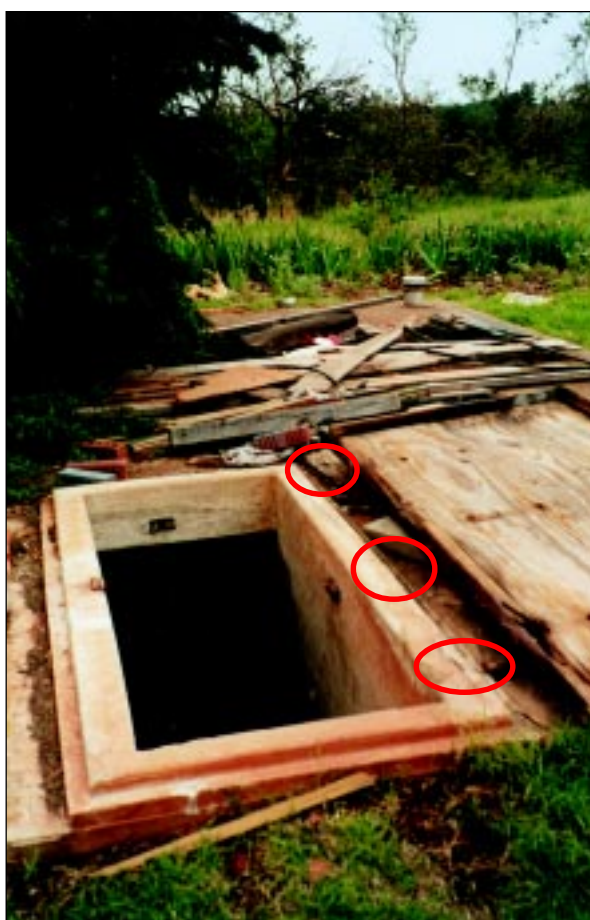
In numerous cases, the BPAT observed that construction practices, the selection of materials, and maintenance can impact the effectiveness of shelters (Figure 6-11). Storm cellar doors observed by the BPAT were often covered with thin gauge sheet-metal and exhibited corrosion. The sheet-metal storm cellar doors were often backed with untreated plywood that was usually found to be rotted, delaminated, or otherwise deteriorated to the point where it was no longer useful in providing protection to the shelter opening.

FIGURE 6-11: Door to underground shelter with rotting wood and corroded hinges.

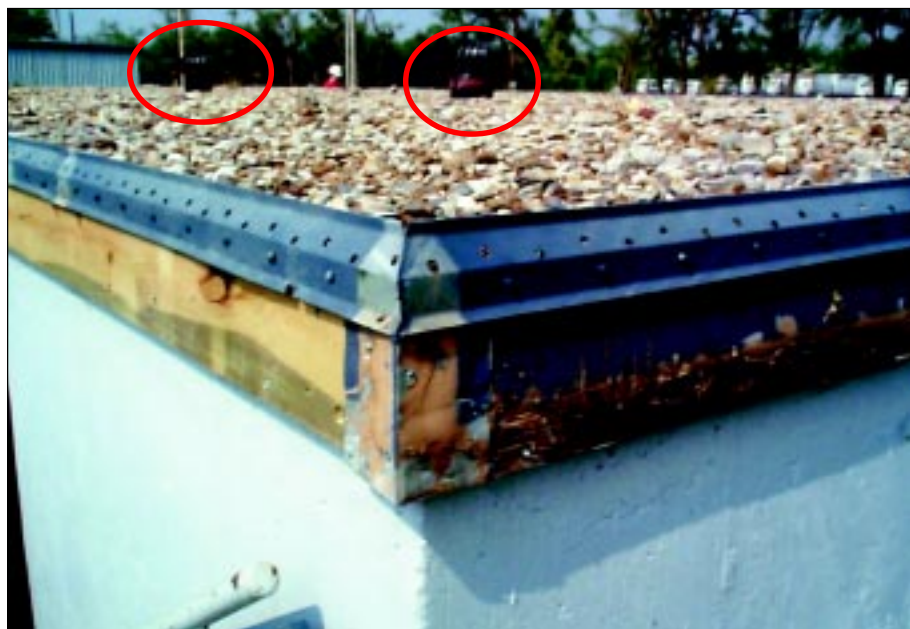
Other shortcomings of shelters were observed by the BPAT. The community shelter in Figure 6-14 produced a potential safety hazard to nearby buildings resulting from windborne missile generation from a fence and roof ballast. A security fence that surrounded this roof area was damaged and removed by the winds of the violent tornado that impacted the opposite side of this community. Aggregate ballast shown in the photo may become airborne during high wind events and cause damage to other properties and injure individuals attempting to access the shelter. In addition, the ventilation covers are inadequate to stop free-falling debris via the penetrations that are in the roof for ventilation.

FIGURE 6-14: Ballast roof covering on a community shelter in Wichita, Kansas was a potential source of deadly windborne missiles to those seeking to access the shelter. Circles identify covers protecting roof penetrations intended for ventilation, but unable to provide adequate resistance to windborne debris.

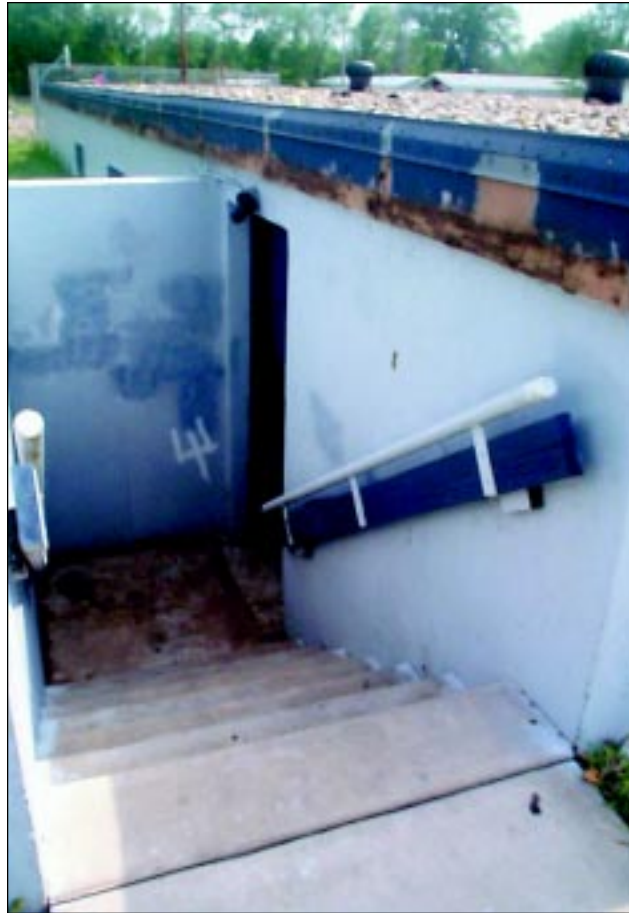
FIGURE 6-15: Stairway leading to entrance of manufactured home community shelter, Wichita, Kansas. The only means of accessing this structure were this stairway and an identical one at the other side of the shelter.

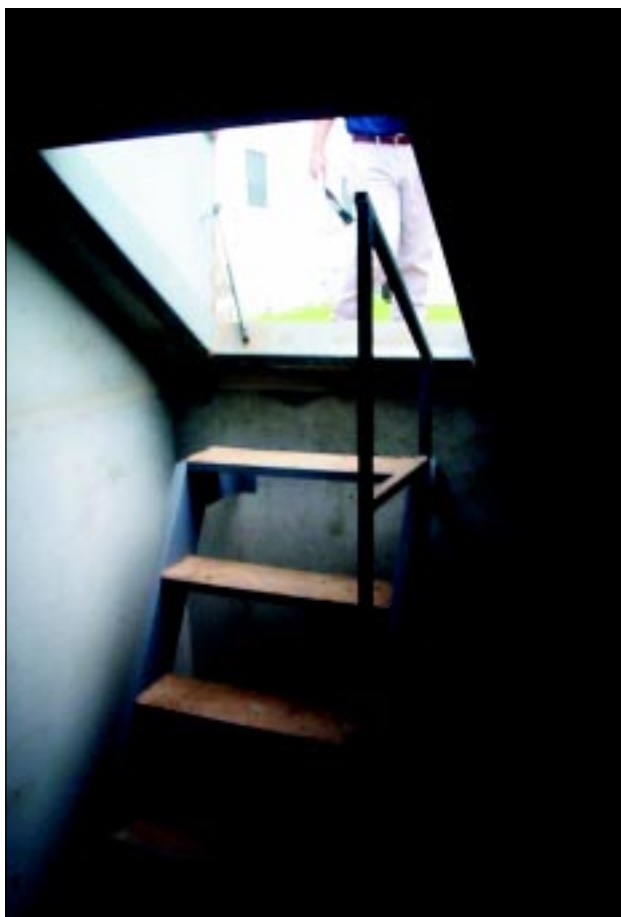
FIGURE 6-16: Stairway access to group shelter at manufactured home rental development, Wichita, Kansas, shown in Figure 6-9. This development was not affected by any of the tornadoes that struck on May 3, 1999.
