BUILDING PERFORMANCE ASSESSMENT REPORT

**OKLAHOMA AND
KANSAS**

Midwest Tornadoes of May 3, 1999

**OBSERVATIONS, RECOMMENDATIONS,
AND TECHNICAL GUIDANCE**

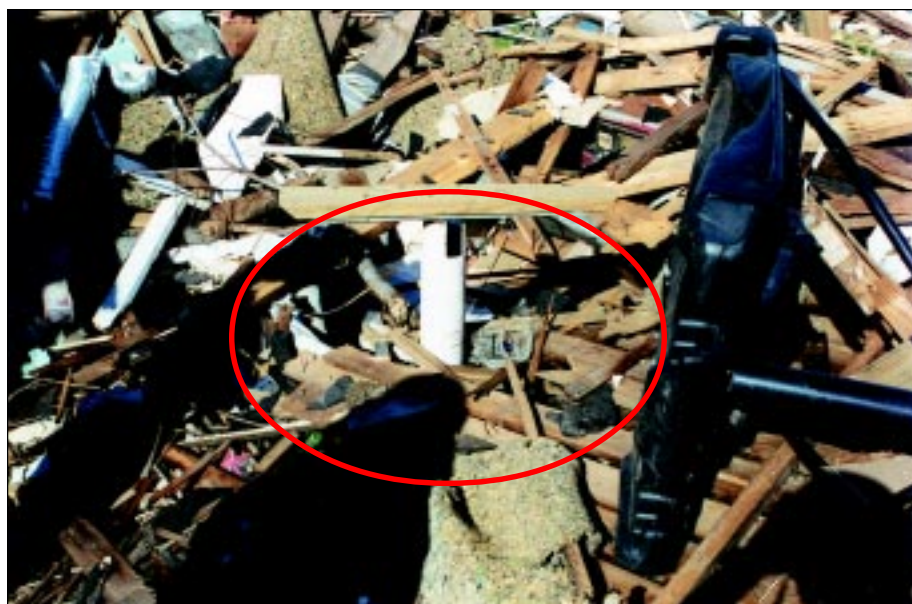
FIGURE 6-17: Heavy gauge ventilation pipe for a belowground shelter in Oklahoma withstood considerable debris impact.

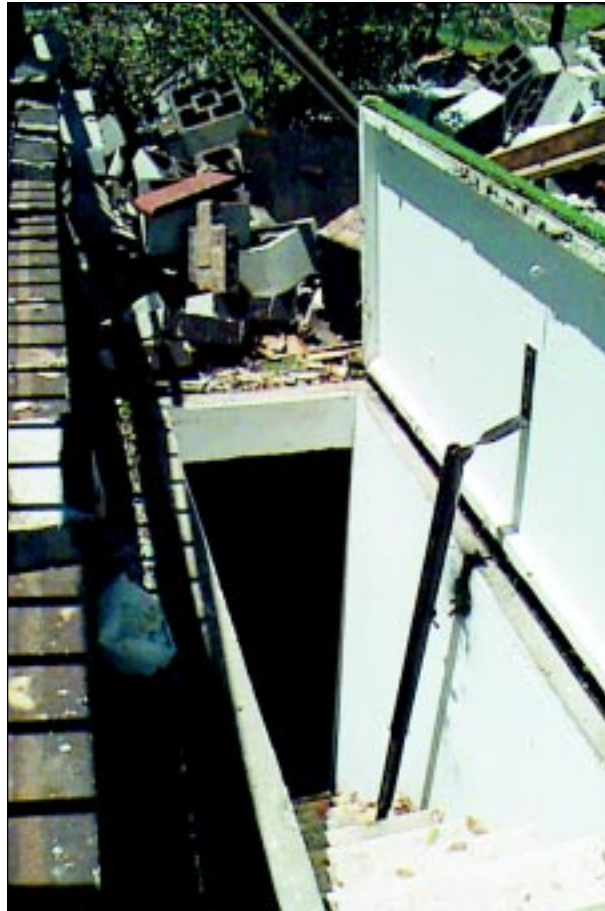
Storm cellars (belowground shelters) were located either in the front, side, or rear yards of the homes. Front yard locations were vulnerable to vehicular traffic and water runoff. The side and rear yard cellars were also vulnerable to water runoff (Figure 6-18). In many cases, the cellar entrance was insufficiently raised above grade and would have allowed for easy entrance of surface water.

FIGURE 6-18: *This belowground shelter is susceptible to water runoff.*

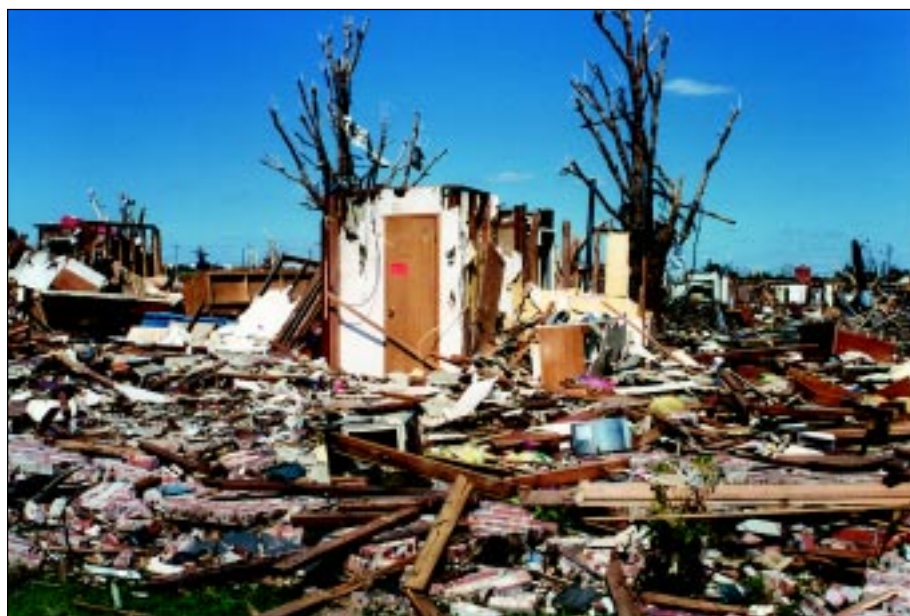
FIGURE 6-19: *Remains of an interior room (or core) of a home in a Moore, Oklahoma, subdivision that was hit by a violent tornado.*

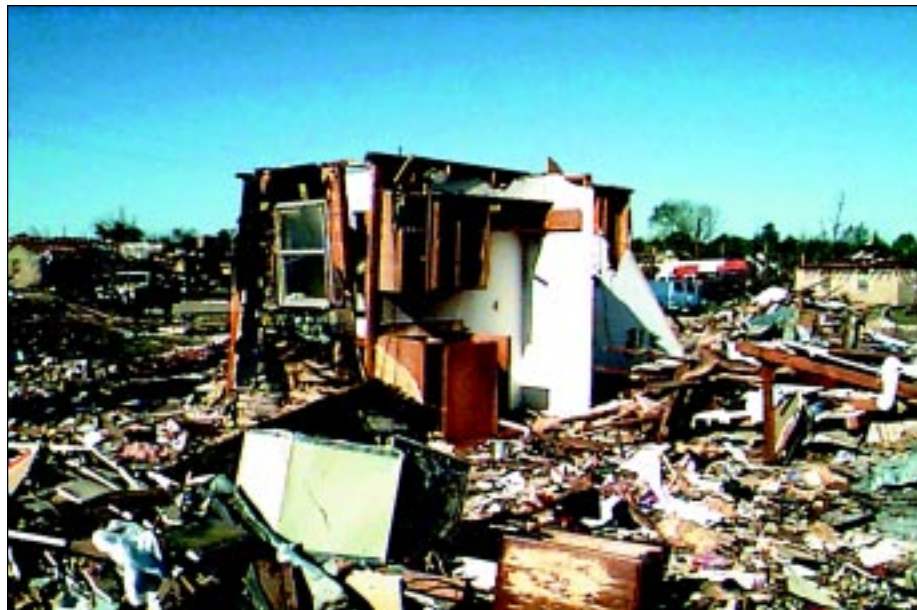
FIGURE 6-20: Interior core of house remains, consisting of a bathroom, closets, and a wall with kitchen cabinets after being struck by a strong tornado.

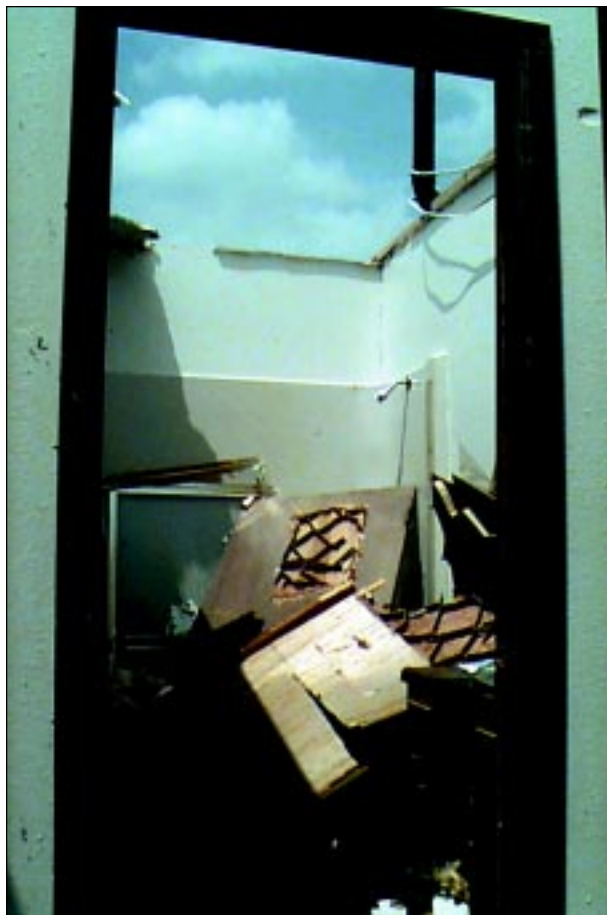
FIGURE 6-21: This apartment complex in Kansas was affected by inflow winds associated with a strong tornado. The roof and ceiling were blown off of the interior bathroom of this house, the door was blown into the bathroom, and the tub was full of debris. This bathroom would not have provided a safe place of refuge.

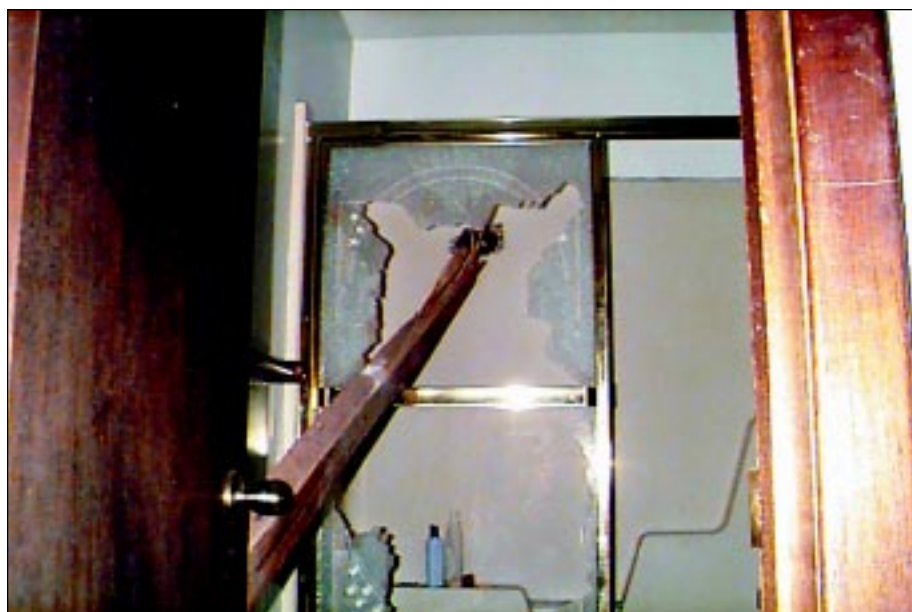
FIGURE 6-22: A 10-ft long 2-in by 6-in missile penetrated the exterior wall of an apartment in this multi-family house, which was sheathed with hardboard panels. The missile, which was generated from the vortex of a strong tornado, then penetrated the gypsum board and plastic tile tub enclosure, the tempered glass shower door, and the interior partition near the door frame. At the interior partition, it pierced through a stud and projected a few inches into the hallway (Figure 6-23).

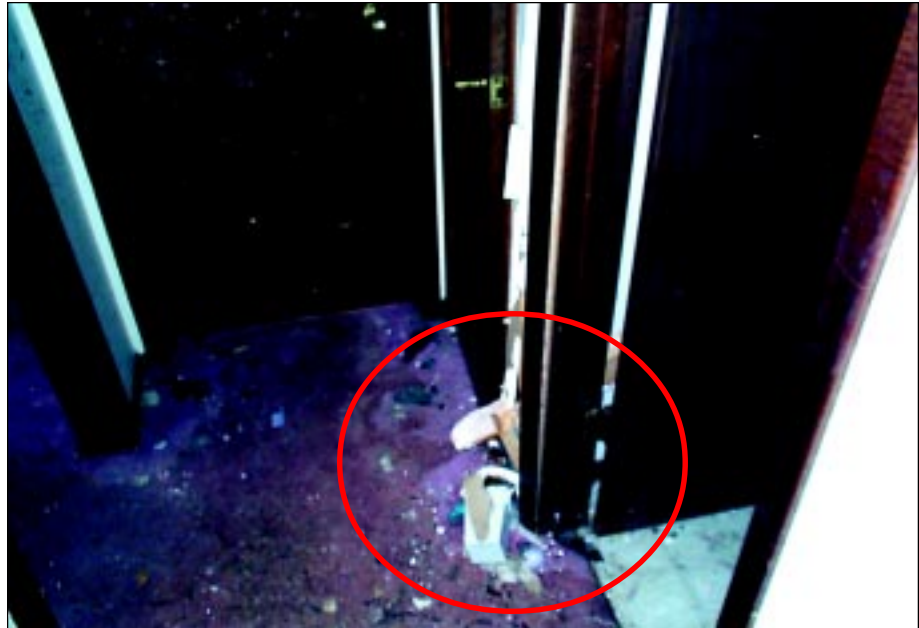
FIGURE 6-23: The missile in Figure 6-22 impacted and broke a 2-in by 4-in stud after traveling through the bathroom.

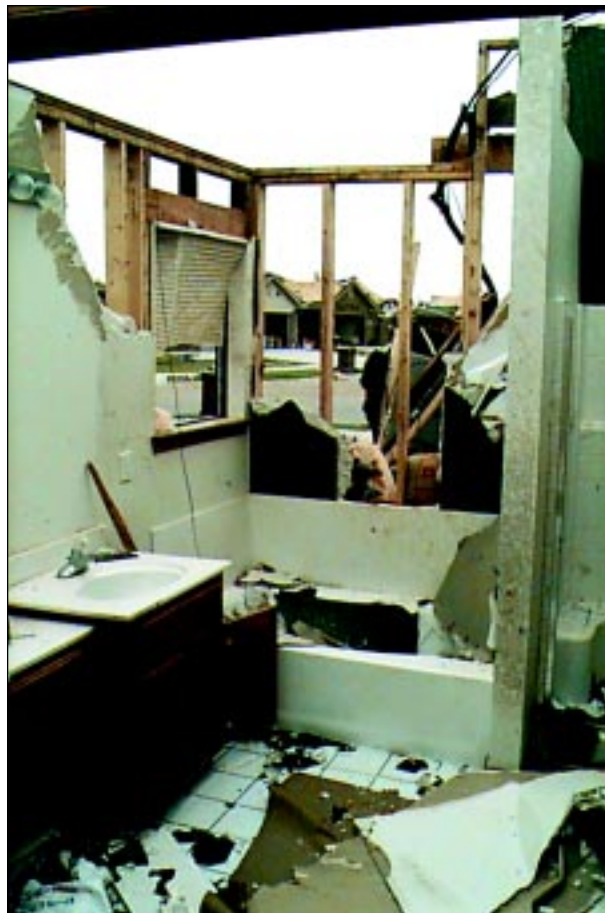
FIGURE 6-24: This bathroom was on an exterior wall and had a window. It did not provide a safe place of refuge.

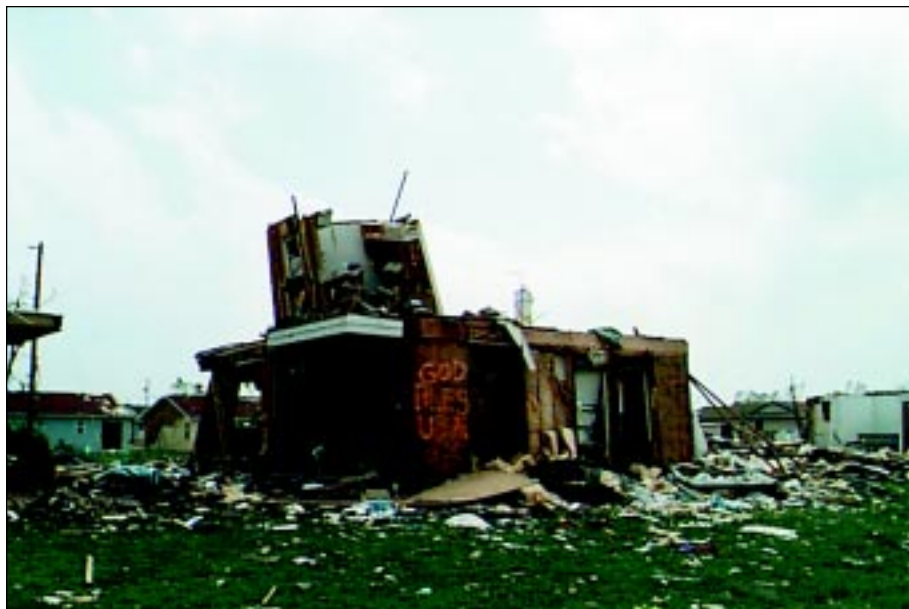
If the residence was more than one floor above grade, the first floor consistently was found to suffer less structural damage than the second floor (Figure 6-25). Therefore, greater protection was afforded when refuge was taken in interior bathrooms or closets on the first floor rather than the second.

FIGURE 6-25: *The second story of single-and multi-family houses typically experienced far greater damage than the first story. This multi-family home in Wichita, Kansas, was affected by inflow winds of a strong tornado.*

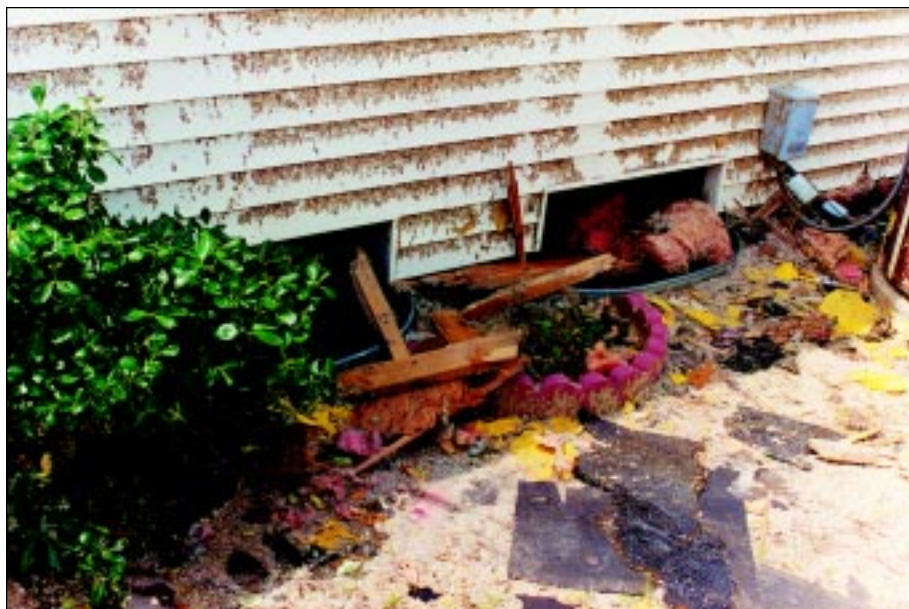
down the stairway to the basement and flew into rooms at the bottom of the stairway. Basements, that were partially above grade and had windows, were observed to be susceptible to missile penetration (Figure 6-26).

FIGURE 6-26: *Basement windows of a single-family residence, showing vulnerability to debris.*

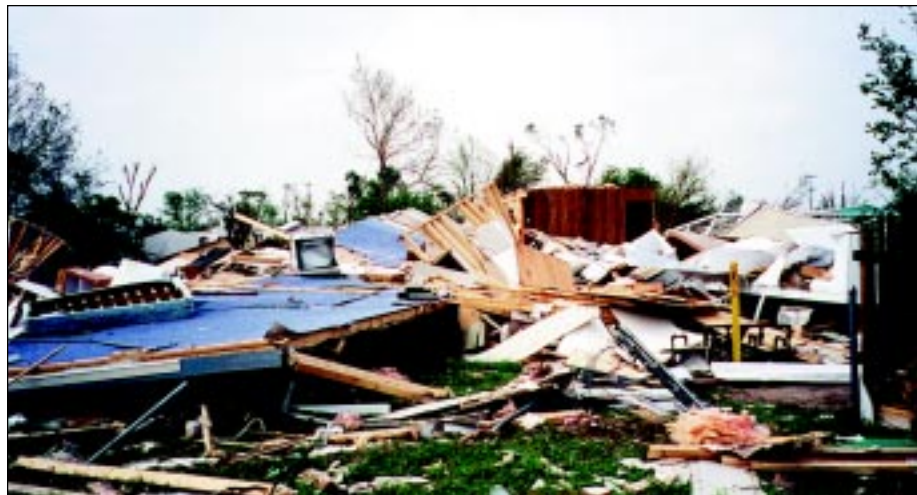
Based on the BPAT observations, persons taking refuge in bathrooms or closets in manufactured houses on non-permanent foundations appear to be at significantly greater risk of injury or death than persons taking similar refuge in conventionally constructed housing (Figure 6-27). The bathrooms and closets of single-width manufactured houses typically provide very little protection because all of the rooms have at least one exterior wall. The BPAT observed a possible exception in some of the newer manufactured homes placed on permanent foundations, and designed and constructed to resist wind forces specified in U.S. Department of Housing and Urban Development's (HUD's) latest Manufactured Home Construction and Safety Standards (MHCSS). Specifically, improved sheltering is achieved in double-wide manufactured homes placed on permanent foundations since they offered the refuge of interior rooms.

FIGURE 6-27: Damaged and destroyed manufactured homes on non-permanent foundations in Wichita, Kansas, that were in the direct path of a strong tornado.

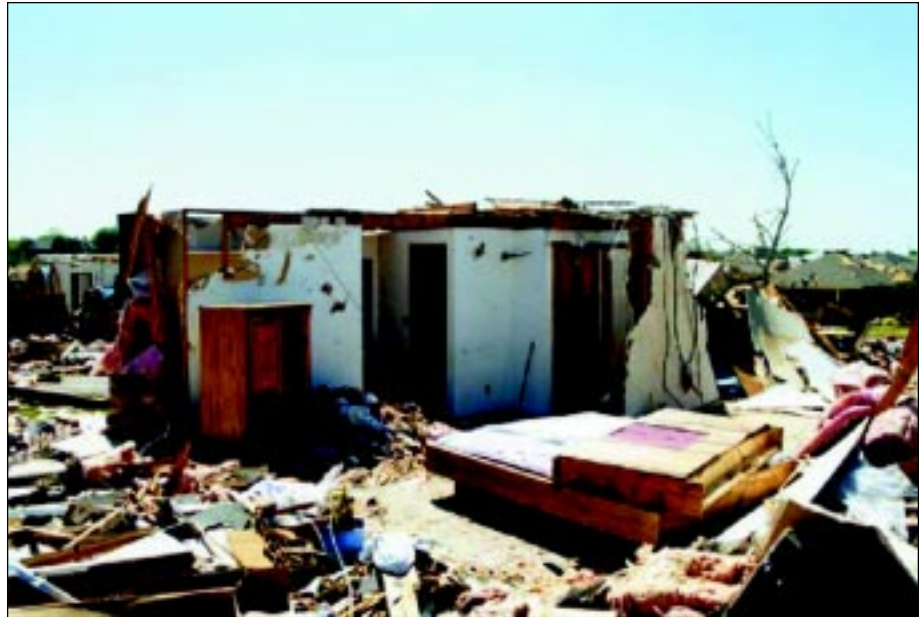
FIGURE 6-29: *The core remnant of this house consisted of a central room and adjacent closets.*

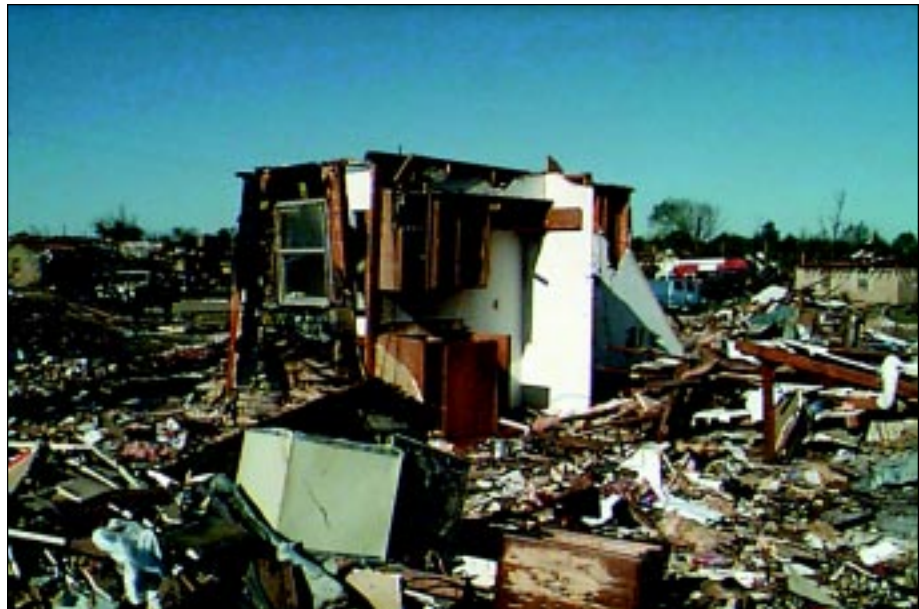
FIGURE 6-30: *The core remnant of this house was a central room on the back of the kitchen.*

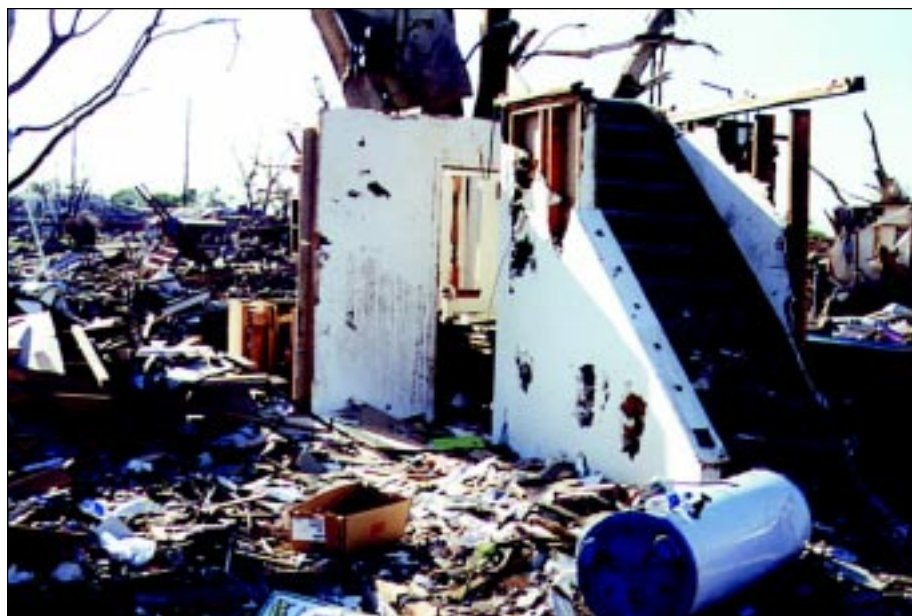
core remnant. Other observed core remnants had kitchen cabinets and counter tops mechanically attached to a least one surviving wall of the core remnant. In other cases, it is the added framing from staircases that may have provided the added stiffness to resist wind loads (Figure 6-31).

FIGURE 6-31: *The core remnant of this house was beneath the staircase to the second floor.*

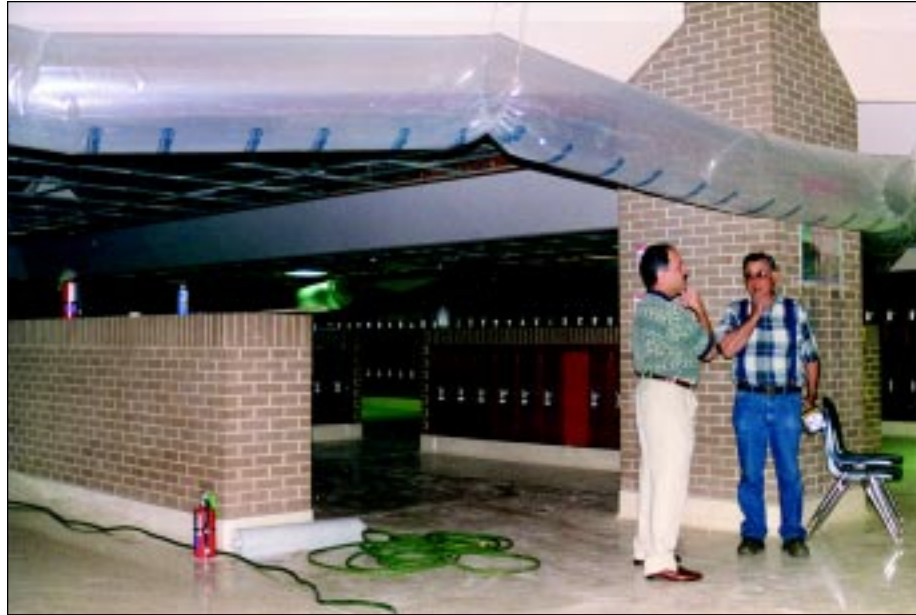
FIGURE 6-32: Westmoore High School, Moore, Oklahoma, central locker core – a designated place of refuge.

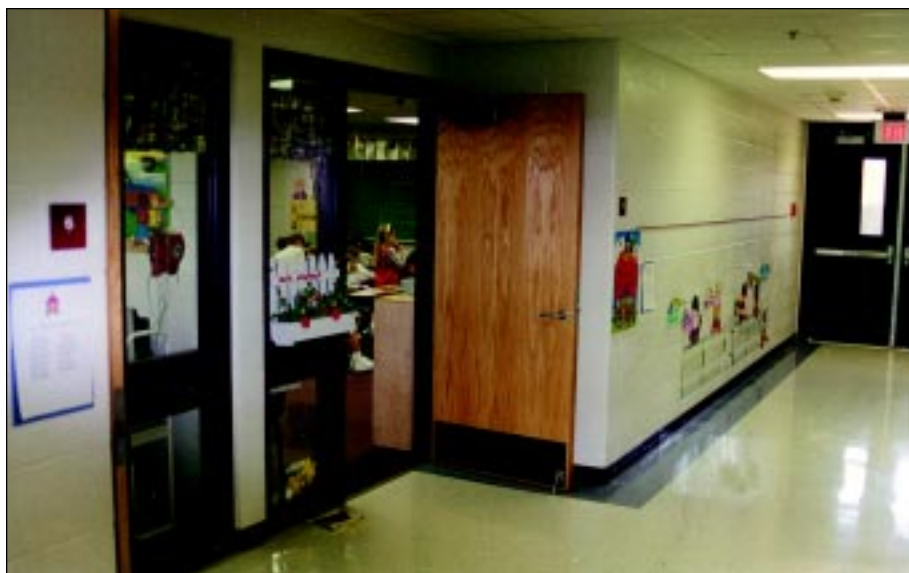
FIGURE 6-33: Eastlake Elementary, Moore, Oklahoma, glazed sidelight at classroom entrance.

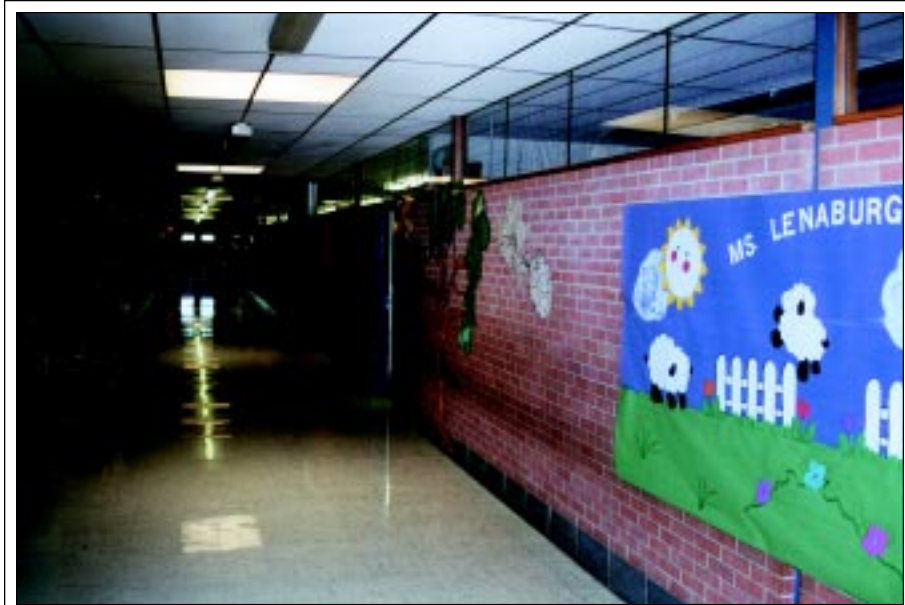
Figure 6-34 shows a central corridor of Northmoor that illustrates the corridor masonry walls topped with windows, called “clerestory”. These types of walls have limited capacity to resist lateral forces because of the windows located along the tops of the wall systems. Figure 6-35 shows a corridor in Kelly Elementary of nearly identical construction to the hallway in Figure 6-34. The inability of the corridor walls to withstand extreme loads due to lateral and uplift wind forces resulted in the collapse of this corridor. Many schools identify their central corridors as places of refuge in their tornado plans. Obviously, had these corridors been used for shelter during the tornado, numerous injuries or deaths would have occurred. Sooner Rose Elementary was a different construction type from the above, but contained similar windowed corridors (see Figure 6-36).

FIGURE 6-34: Northmoor Elementary place of refuge, Moore, Oklahoma – corridor with clerestory windows. This corridor offers little protection from tornadoes as shown in a school of similar design in Figure 6-35.

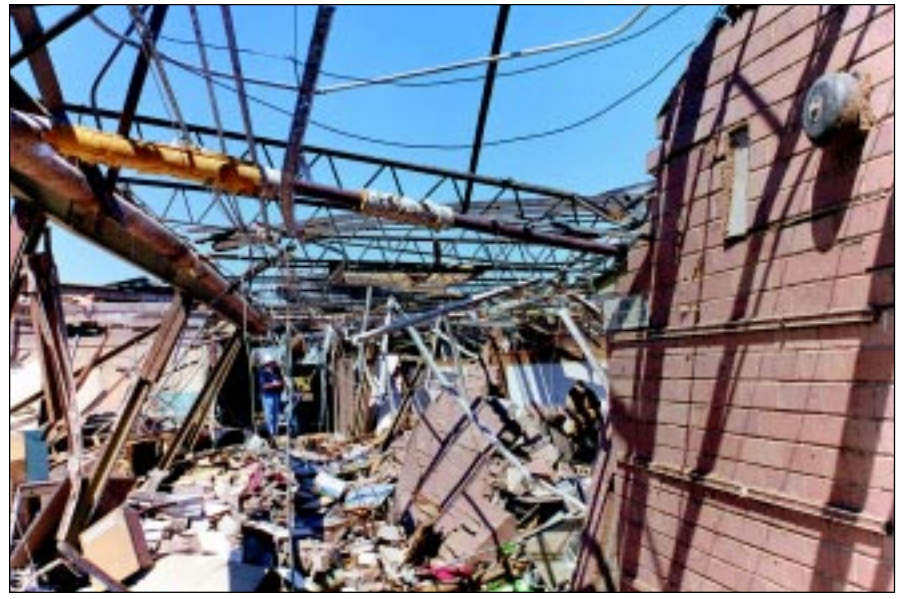
FIGURE 6-35: Kelly Elementary School, Moore, Oklahoma, place of refuge – corridor with clerestory windows. These interior corridor walls had brick masonry up to a height of approximately 7 ft. Glass extended from the top of the brick masonry to the top of the wall.

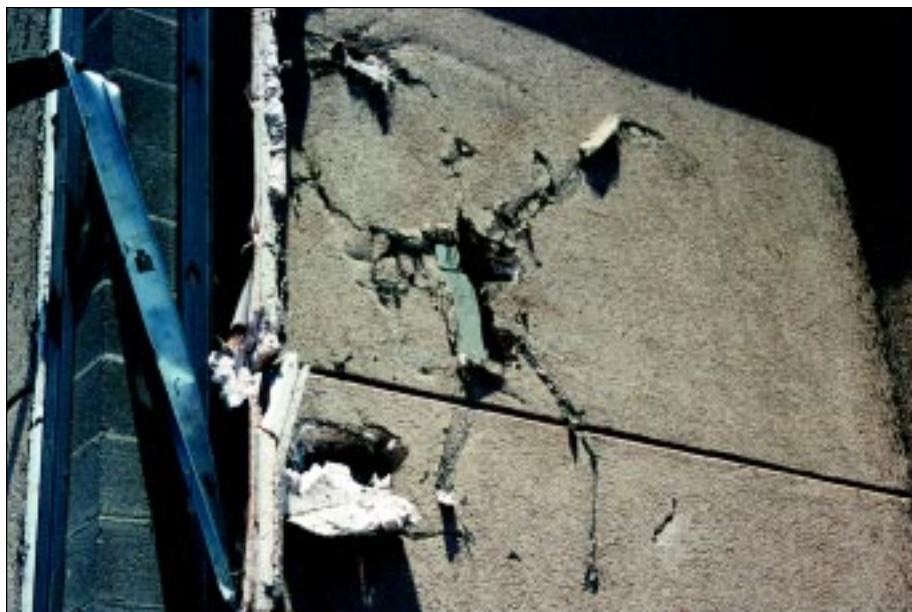
gypsum board that is supported by studs, and a layer of gypsum board on the interior side of the studs (Figure 6-37). Brick and CMU walls can also be deceiving. If they are adequately reinforced and braced, they can offer a significant level of protection. But if they are inadequately reinforced or braced, they can collapse, thereby trapping and crushing people (Figure 6-38).

FIGURE 6-37: *This EIFS wall system was penetrated by numerous windborne missiles.*

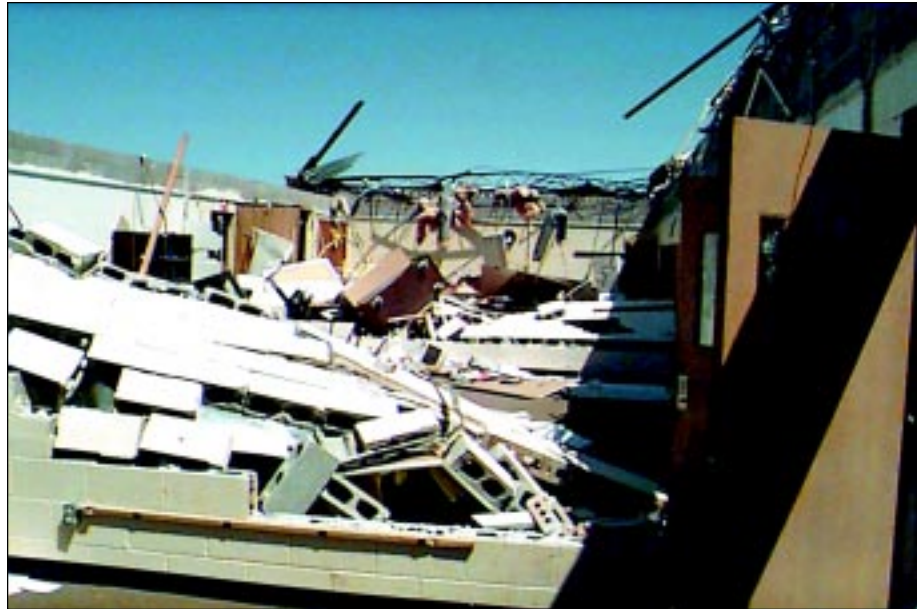
FIGURE 6-38: *The non-reinforced interior CMU walls in this area of Kelly Elementary collapsed after the roof system was removed by vortex winds of a violent tornado.*

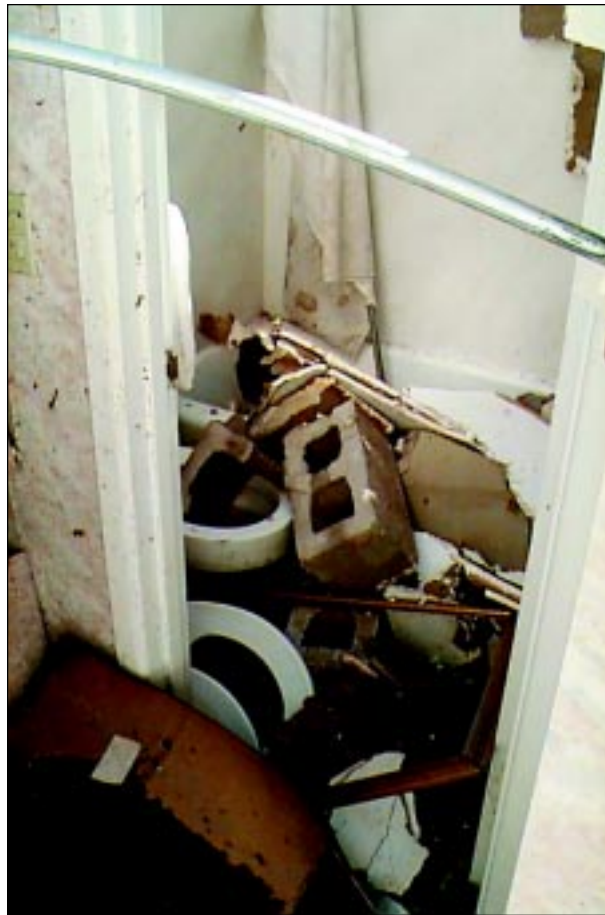
FIGURE 6-39: *The roof and ceiling over this interior bathroom blew off. CMU from a firewall a few feet away blew into the bathroom, which was located on a motel's second floor in Midwest City, Oklahoma. This bathroom would not have provided a safe refuge.*

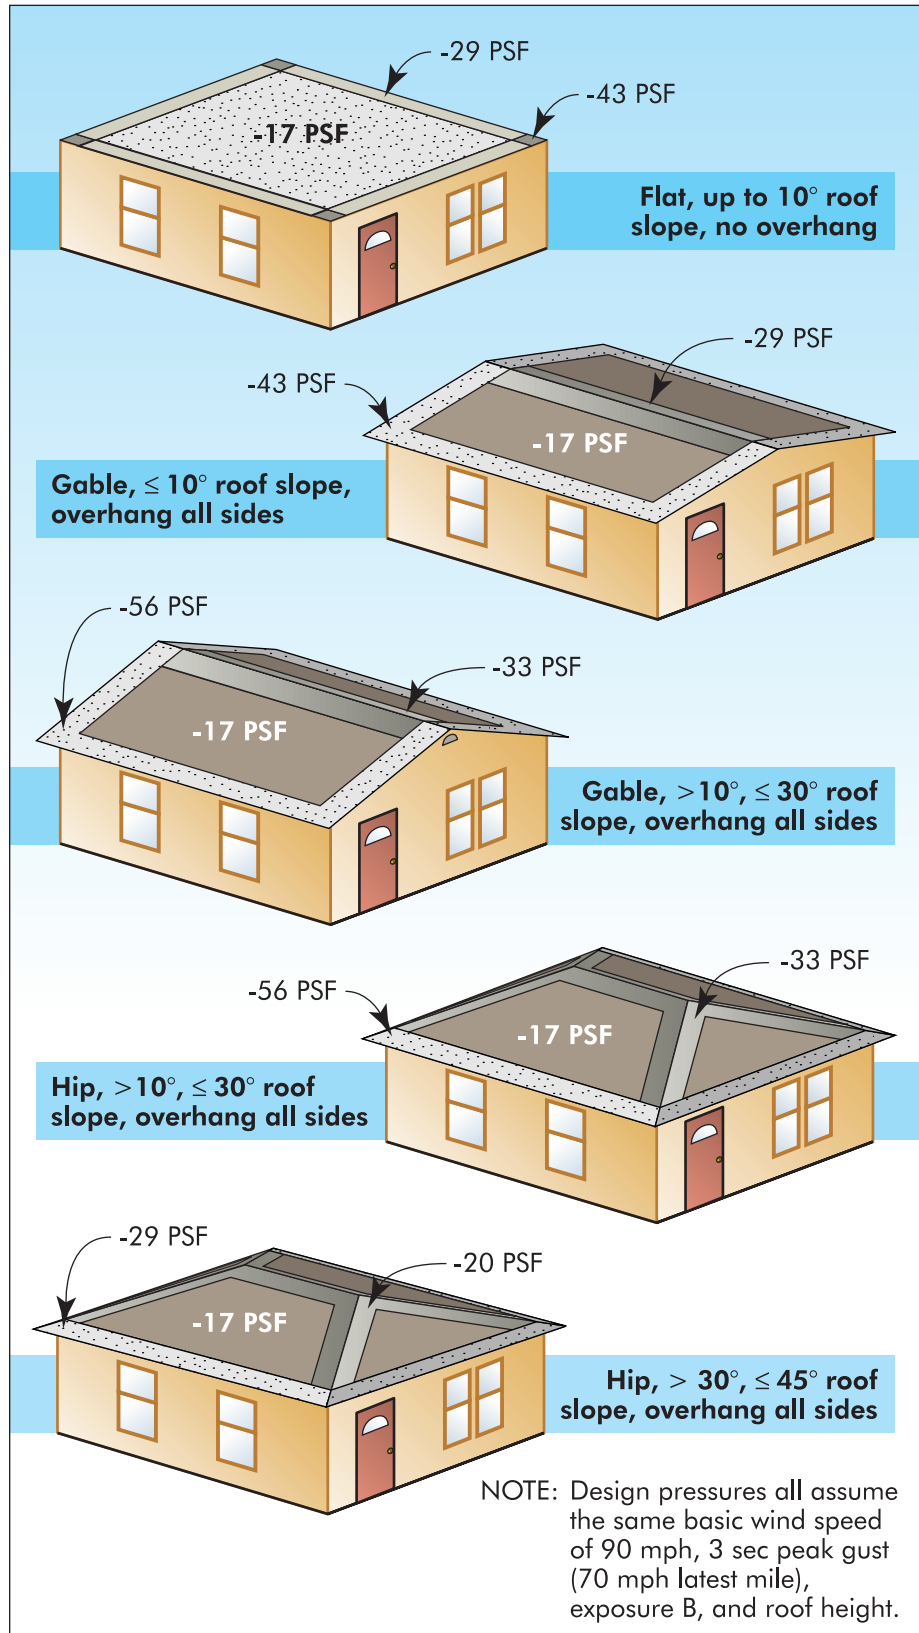
In general, for flat, gable, and hip roof geometry, the largest uplift loads occurred near the corners, the gable ends, and the edges of the roof ridge. However, the largest localized loads for gable roofs are noticeably higher than those for hip roofs. Although a localized load may fail a single piece of roof sheathing, it will not always cause the entire roof to fail. Such localized roof failures often allow rainfall to enter the structure, causing significant collateral damage to the building interior and furnishings. When the roof fails as a single entity, it is the overall combination of all wind loads that will cause this failure. The magnitude of the loads that will cause roof failures are influenced by the roof geometry, slope, pressure of roof overhangs, and location on the roof. Roof geometry and their effect on resultant wind loads are illustrated in Figure 7-1.

FIGURE 7-1: Relative uplift pressures as a function of roof geometry, roof slope and location on roof. Negative values indicate that wind pressures act upward and perpendicular to the roof surface.

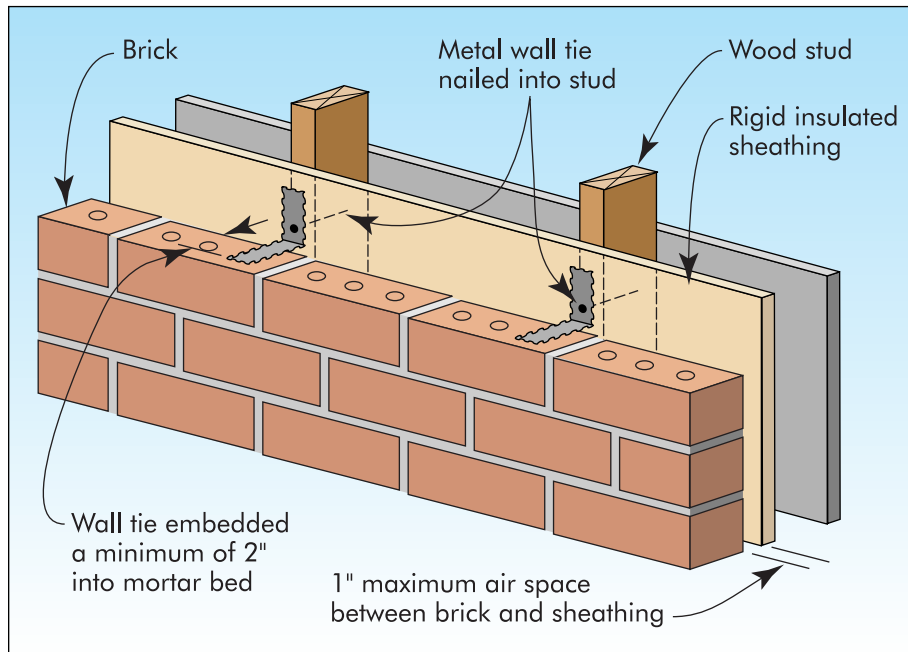
Many of the failures observed stemmed from brick-tie to mortar bond failure. In a majority of cases of masonry veneer loss, either corrugated or scalloped-edge galvanized steel brick ties remained attached to wall studs with one 6d common nail (withdrawal load = +/- 30 lb times a safety factor of 4 or 5), when a rigid insulation board was used as wall sheathing. The bond between mortar and brick tie was often not sufficient to even exceed the withdrawal capacity of the tie nail. Therefore, there was inadequate bond between mortar and brick tie to resist the wind forces experienced. The 1995 CABO One- and Two-Family Dwelling Code specifies that the maximum horizontal spacing of brick ties is 24 in on center, and each tie shall support not more than 3.25 sq. ft of wall area. At the code-required spacing to support 3.25 sq. ft, the maximum wind suction pressure on the veneer prior to failure could not have exceeded 37 psf, unless the rigid brick facing failed prior to the deflection required to allow the brick tie to develop its full capacity.

There were a few instances of nail pull-out at brick ties fastened to wall studs. Therefore, in these cases, the wind suction pressure exceeded the withdrawal strength of the one nail holding the brick tie. Causes of failure could be insufficient nail length or diameter, low withdrawal resistance, or ties having too high a tributary area. There were many instances of brick ties spaced at greater distances than stated in the building codes. Proper connection of brick masonry to a wood frame wall system is shown in Figure 7-2.

FIGURE 7-2: Illustration of a proper connection of brick masonry to a wood frame wall system.

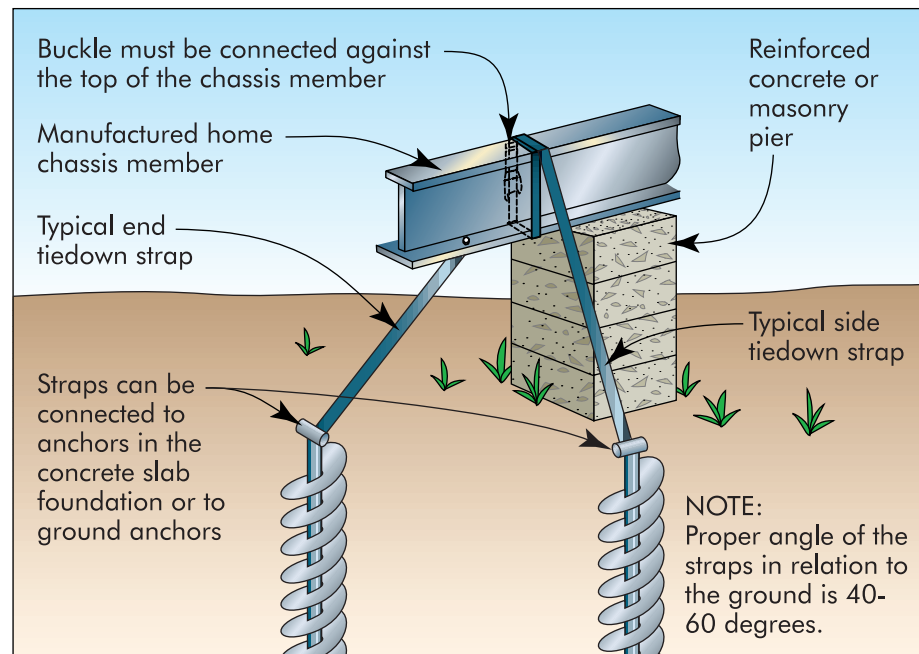
Galvanized steel strapping in several instances failed in tension from wind uplift and overturning forces, or became loose when the home moved laterally from wind forces. An example of a properly restrained chassis member is shown in Figure 7-3. In addition, connections of strapping to chassis beams often came loose and were on the ground, and there was no positive bolted or welded connection. The apparently premature failure of these ties was related to the number of ties, location of first ties from end of

FIGURE 7-3: Illustration of a proper connection of a manufactured home to a dry-stacked CMU foundation using straps only; L-clips are not illustrated here.

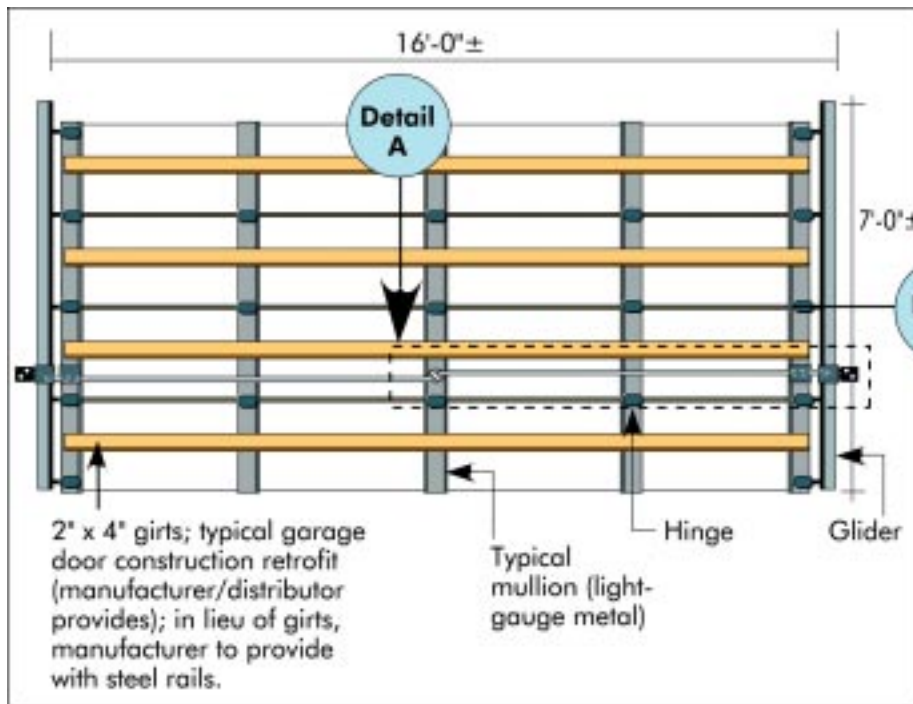
FIGURE 8-1: Typical double-wide garage door elevation.

- Garage doors are an extremely important residential building component. Failure of these doors led to catastrophic progressive failures of primary structural systems that could have been significantly reduced in areas other than those impacted by violent and strong tornado vortices. New garage doors should be manufactured to comply with design wind loads using a safety factor of 2. Retrofits should be made to improve the wind resistance of existing garage doors, particularly double-wide garage doors. Figures 8-1, 8-2, and 8-3 present retrofit measures that have been successfully implemented in Florida after Hurricane Andrew. Use of these retrofits and installation of new reinforced doors should better resist wind forces and, as a result, reduce the type of roof and wall damage that was observed in homes that experienced garage door failures.
