# Okeechobee Storm

August 1, 2003

ON FRIDAY EVENING...A NATIONAL WEATHER SERVICE DAMAGE SURVEY TEAM INVESTIGATED WIND DAMAGE WHICH OCCURRED APPROXIMATELY BETWEEN 2:30 AND 2:40 PM IN AND NEAR THE TAYLOR CREEK ESTATES ON THE SOUTH SIDE OF THE CITY OF OKEECHOBEE.

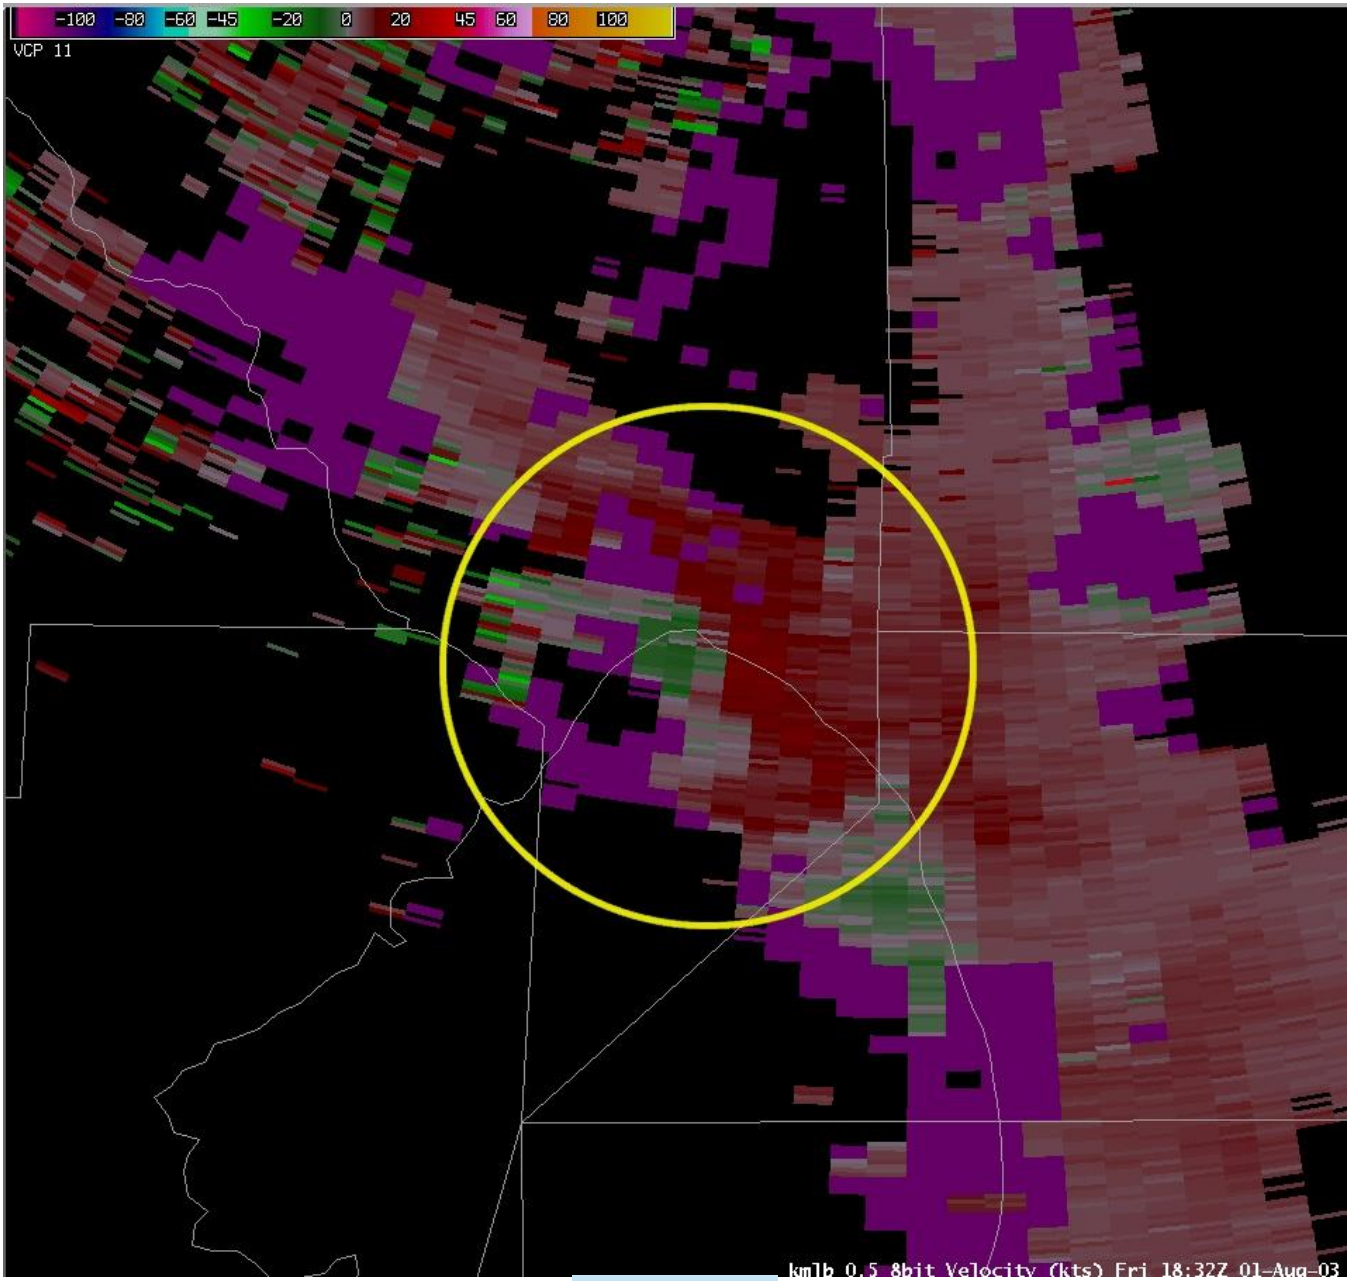
Velocity Image

THE DAMAGE PATTERN, WHICH WAS DIVERGENT ALONG THE ENTIRE LENGTH OF THE STORM TRACK, FITS FUJITA'S MODEL OF A TRAVELING MICROBURST. MUCH OF THE DAMAGE WAS DONE BY WIND SPEEDS ESTIMATED BETWEEN 55 AND 65 MPH WHILE THE MOST SIGNIFICANT DAMAGE WAS ASSUMED TO HAVE BEEN CAUSED BY WIND SPEEDS AS HIGH AS 75 TO 85 MPH.
