December 16, 2007 Land O' Lakes Tornado Damage Survey

Anthony Reynes, Daniel Noah - NWS Tampa Bay

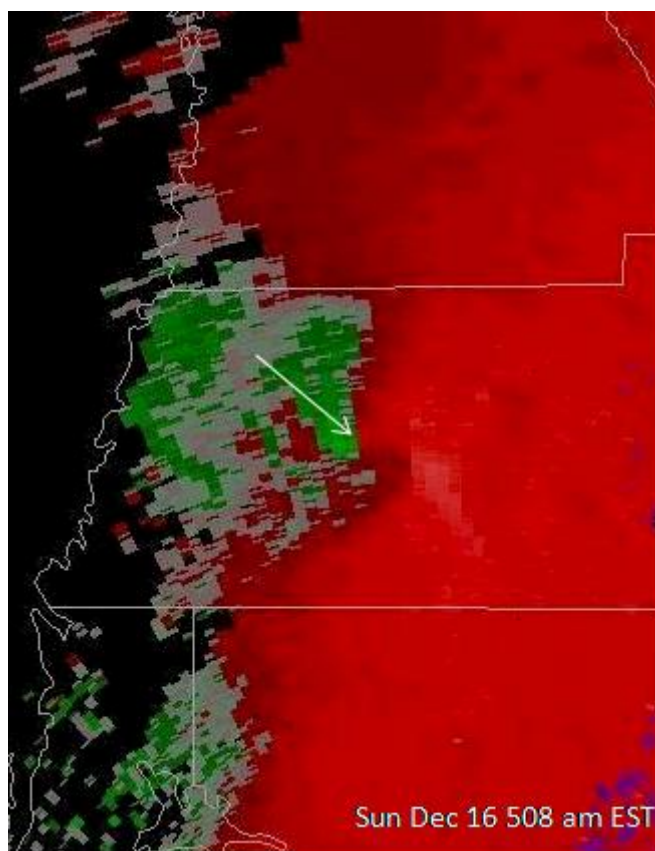
Figure 1. Base Velocity from NWSTBW Radar at 5:05 am EST showing a well defined rotation couplet at 0.5 degrees of elevation.

The event began around 5:00 am EST as a couple of strong thunderstorms moved from the coastal waters into western Pasco county. The northernmost cell was showing clear signs of low level rotation with a hook echo signature clearly visible on the 5:30 am EST base velocity and reflectivity (not shown) radar images from the National Weather Service Doppler Radar in Ruskin, Florida.
