Jan. 27, 2012 EF-1 Port Charlotte Tornado

DETAILS
• Tornado Rating: EF-1 (around 95 MPH)
• Begin: 5:35 AM, 26.998° latitude, -82.028° longitude
• End: 5:45 AM, 26.999° latitude, -82.024° longitude
• Path Length Over Land: 0.75 miles, interrupted path
• Path Width: 20 yard

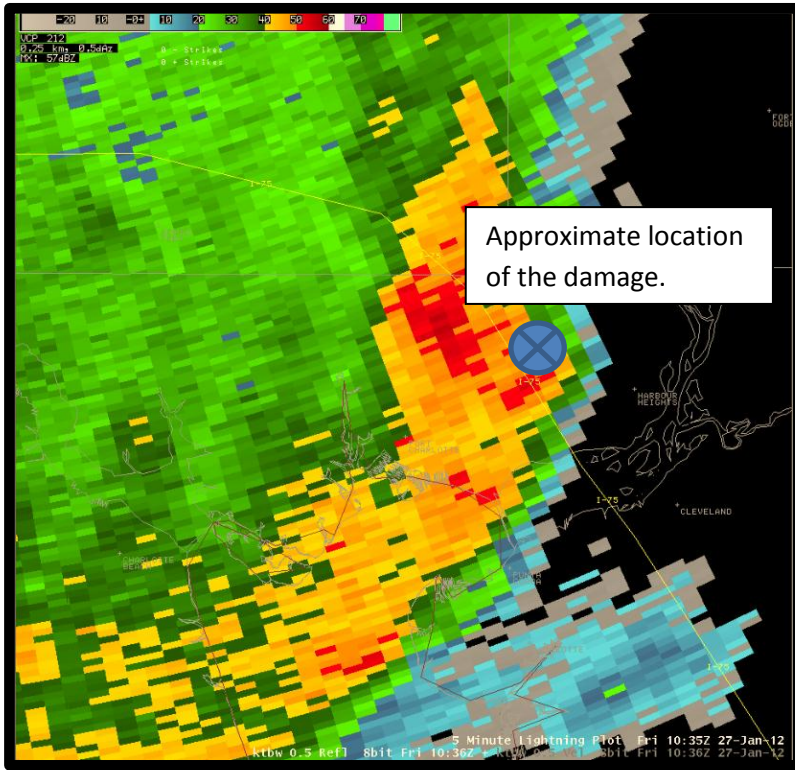
0.5 deg KTBW Reflectivity at 1036 UTC.

This reflectivity image from the KTBW radar shows a line of thunderstorms beginning to “bow” as it moves through Charlotte County.

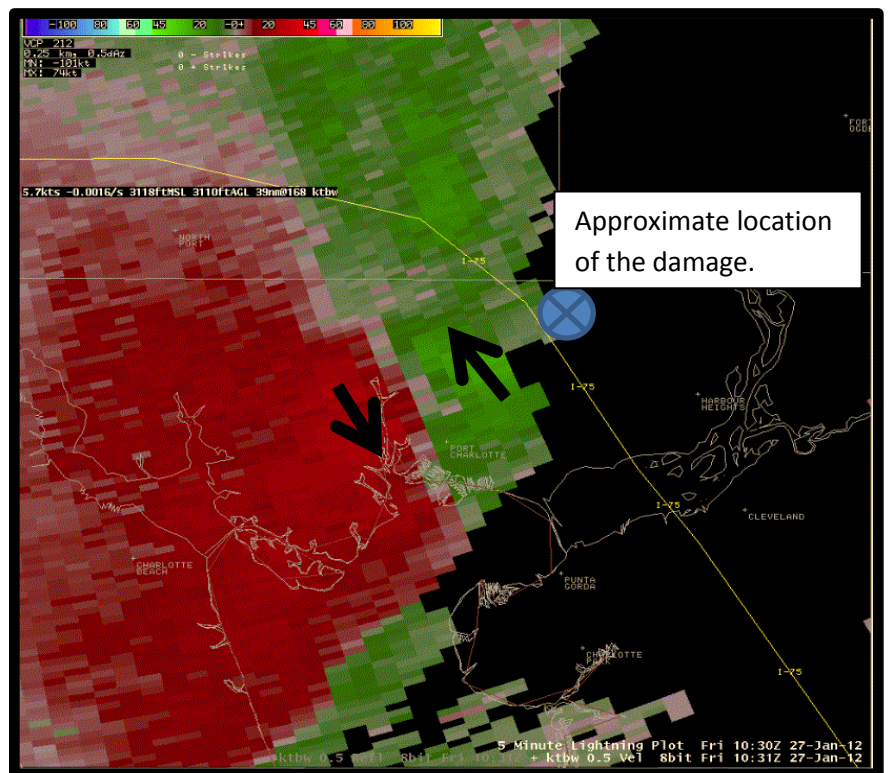
0.5 deg KTBW Base Velocity at 1031 UTC

The velocity image from KTBW shows a broad area of relatively weak rotation near Port Charlotte. Since the lowest level that radar can sample in this area is around 4,000 ft., it is difficult to determine what is actually going on closer to the surface.
