5.3 Damage Survey of the Tuscaloosa-Birmingham Tornado on 27 April 2011

Timothy P. Marshall, P.E.¹, Jim Stefkovich², John DeBlock³, James G. Ladue⁴, Chris Karstens⁵

¹Haag Engineering Co.

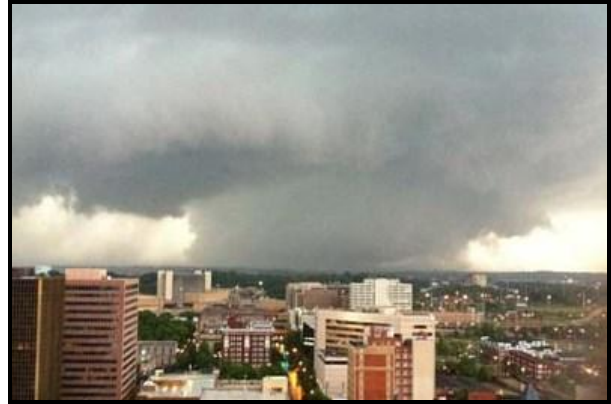
The tornado entered western Jefferson County about 9 km west of North Johns and traveled through Concord, Pleasant Grove, McDonald Chapel, Pratt City, and Fultondale, all northern suburbs of Birmingham (Fig. 18). More than 200 homes had all walls knocked down or were removed from their CMU foundations (DI 2, DOD 9). In many cases, front porch slabs remained in place, and cars remained in their driveways or garages (Figs. 19 and 20). Thus, we estimated failure wind speeds to have been at or below 76 m s^{-1} (170 mph) or EF-4.

Figure 18. Large wall cloud with tornado passing northwest of downtown Birmingham. AP Photo.

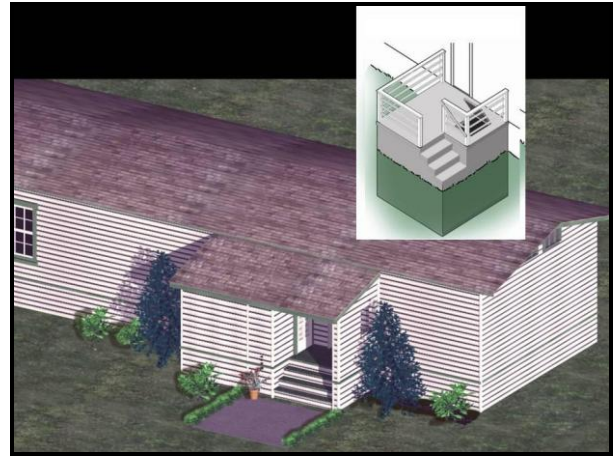
Figure 25. The porch shelter.

According to NOAA (2011), many people died in their homes, both conventionally constructed and manufactured homes. In cases where homes sustained complete destruction, we noticed many front porches remained intact. We believe that porch type shelters would have been effective in saving lives. These concrete or steel box shelters are placed partially below grade and can provide substantial occupant protection (Figs. 25 and 26). Unfortunately, few companies make porch shelters. A general internet search showed them to cost between \$3,000 to \$5,000. We did not observe any porch shelters during our survey.

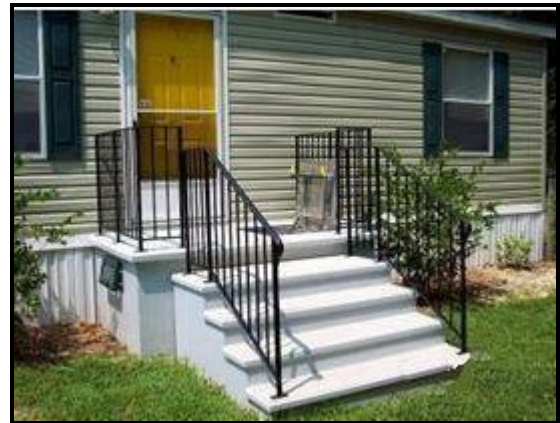
Figure 26. Example of an installed concrete porch shelter with steel entry door.

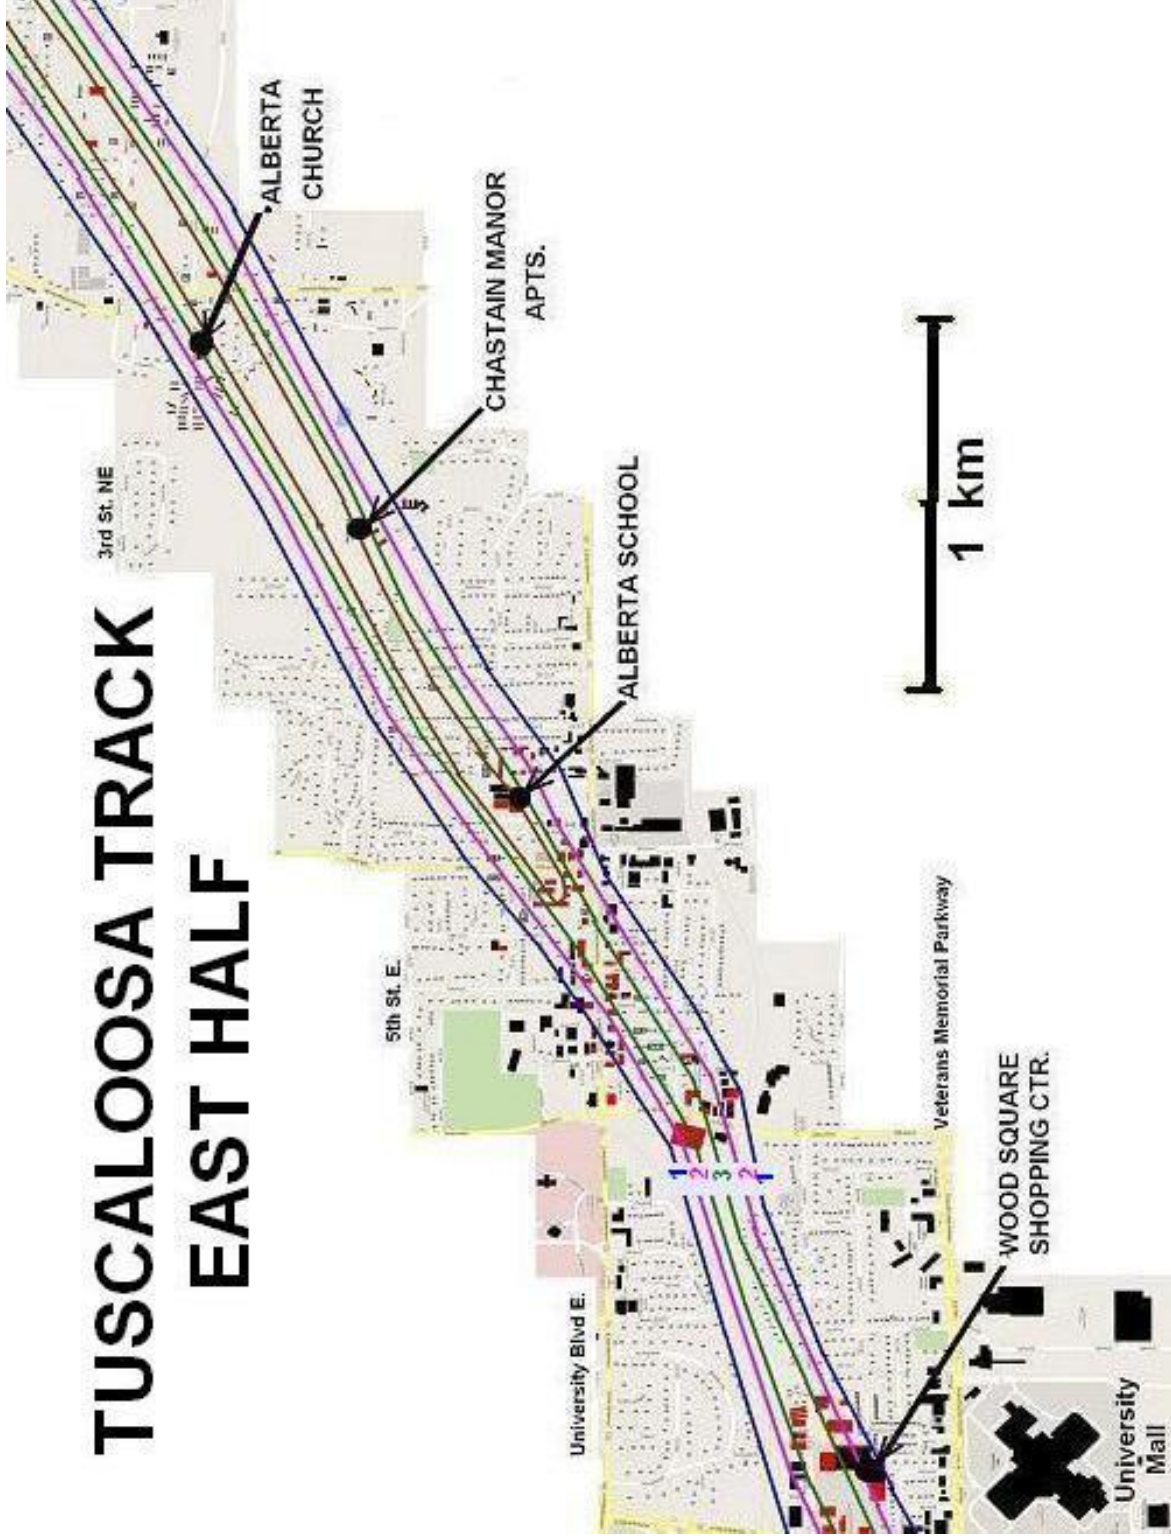
TUSCALOOSA TRACK EAST HALF

We have attached damage maps developed from our analysis of the Tuscaloosa-Birmingham tornado. Only populated areas are shown. Rural areas were omitted. Houses were rated EF-0 to EF-4 per the EF-scale. Boxes around the numbers indicated where homes had slid off their foundations. The maps are contoured EF-1 through EF-4.
