Timothy P. Marshall*
Haag Engineering Co.
Dallas, TX

1. Introduction

A large, destructive tornado moved across Butler and Black Hawk Counties in northeast Iowa traveling through the south end of Parkersburg on 25 May 2008 (Fig. 1). The tornado damaged or destroyed more than three hundred residences in addition to two bank buildings, a high school, and many other buildings. Seven people died.

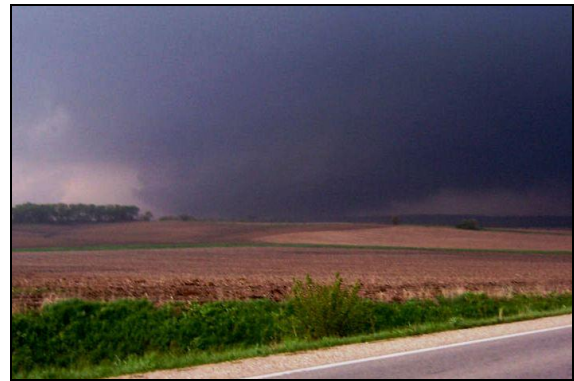
Figure 1. Large “wedge-shaped” tornado east of Parkersburg. Photograph courtesy of Rod Donovan NWSFO/DSM.

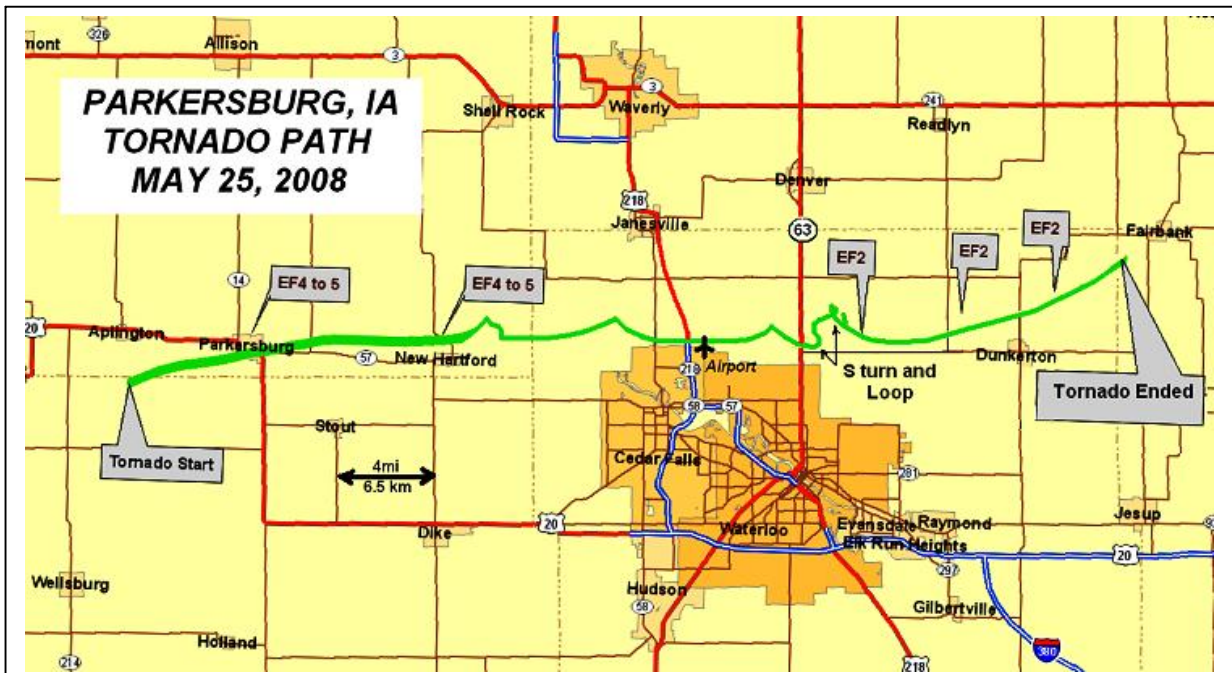
Aerial and ground damage surveys revealed the tornado traveled east-northeast for approximately 70 km with 98 percent of the track traversing rural farmland (Fig. 6) and the remaining two percent going through the south end of Parkersburg. The initial touchdown occurred near the Butler and Grundy county lines, two miles south of Aplington and quickly grew in size and intensity as it approached Parkersburg. Spiral ground marks were first detected in an open field about 1 km west of Parkersburg. Corn stubble and other debris had been gathered in wind rows. The oblong shaped spirals were approximately 150 m long in the north-south direction. Fujita and Smith (1992) have documented numerous examples of such ground marks in corn fields.

Figure 6. Track of the Parkersburg, IA tornado. Note the irregular shape to the path east of New Hartford.
