# **The Tornadoes of Oklahoma City of May 3, 1999**

a report prepared by

Wind Science and Engineering Research Center  
Texas Tech University  
Lubbock, Texas

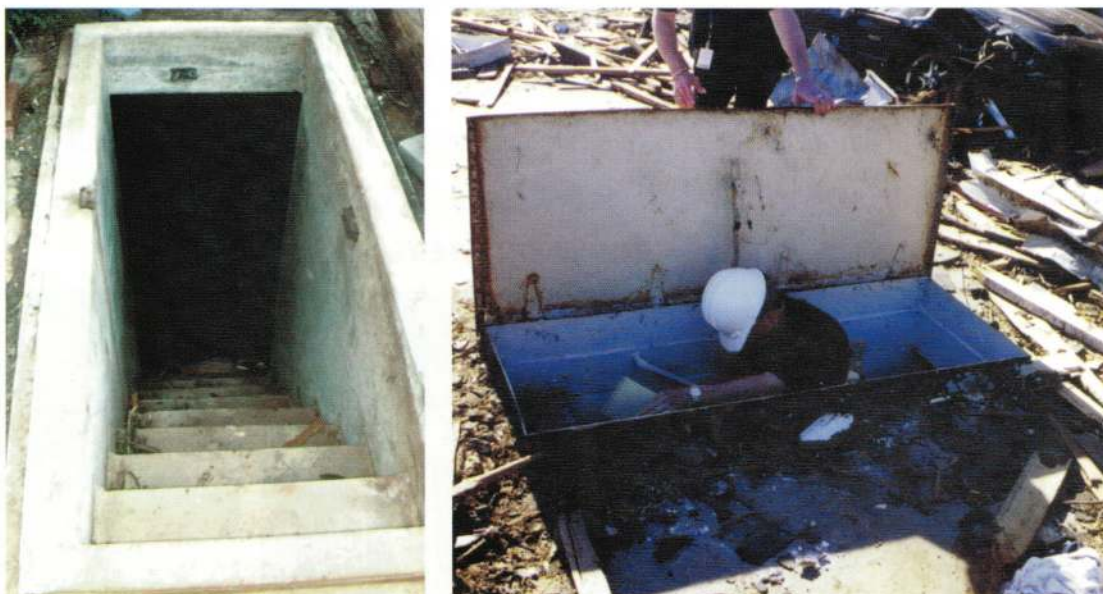
**FIGURE 14. SELF-CONTAINED BELOW-GROUND SHELTERS**

Although common in many parts of the country, residential basements are not common in Oklahoma and were not observed by the damage documentation team. However, self-contained shelters located below-ground and out of the building footprint, commonly referred to as cellars, were observed. These storm cellars were constructed of cast-in-place concrete (Figure 14, left) or prefabricated steel with a concrete cover (Figures 14, right).

*Cast-in-place concrete (left); prefabricated steel (right).*

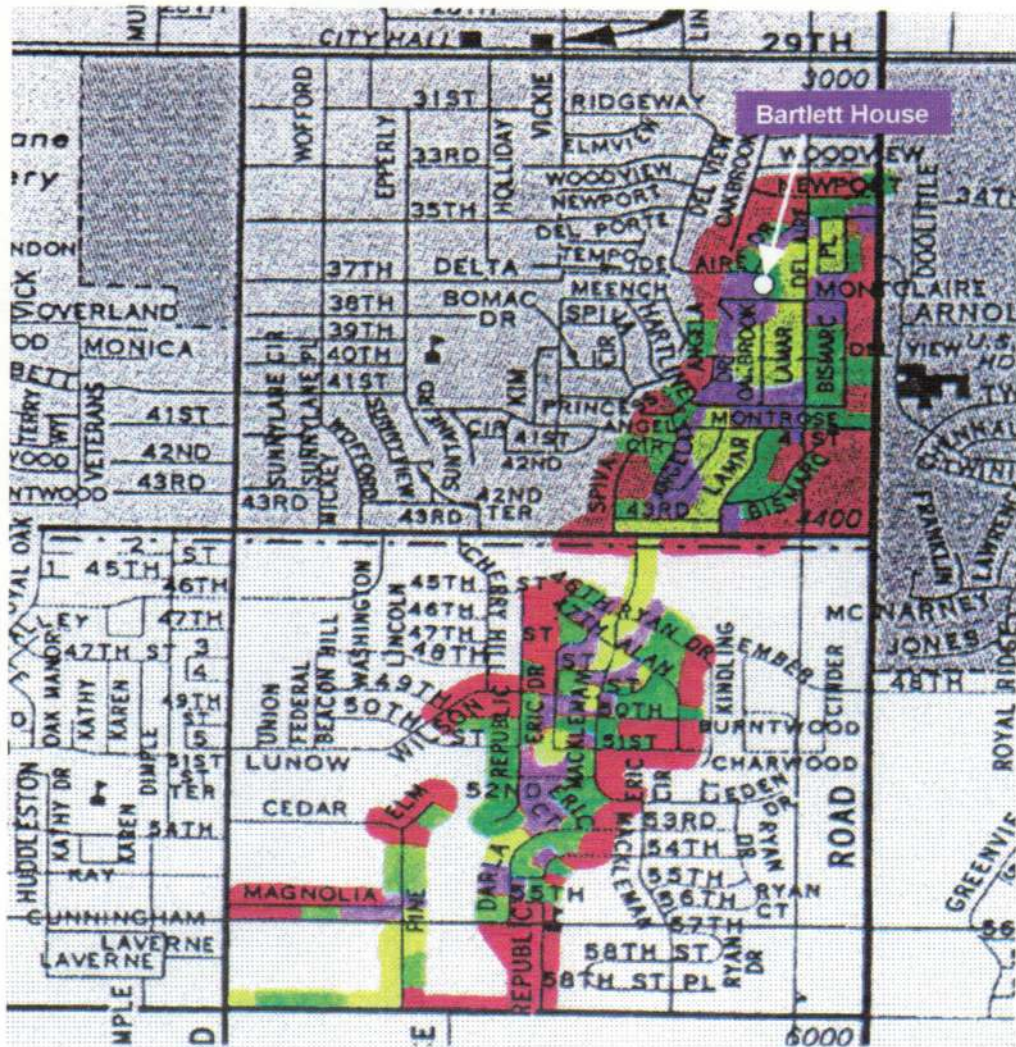
**FIGURE 15. BARTLETT NEIGHBORHOOD**

The Bartlett Shelter was located in Del City, Oklahoma. The Bartlett neighborhood experienced extensive to severe damage (Figure 15). The Lewis shelter was located in the Bridge Creek Estates in Bridge Creek, Oklahoma, an area which experienced minor/moderate damage. Both shelters survived without any damage, even though the Bartlett home was classified as having severe damage (Figure 16).

*Red-minor/moderate damage, Green-extensive damage, Purple-severe damage, and Yellow-destroyed damage.*

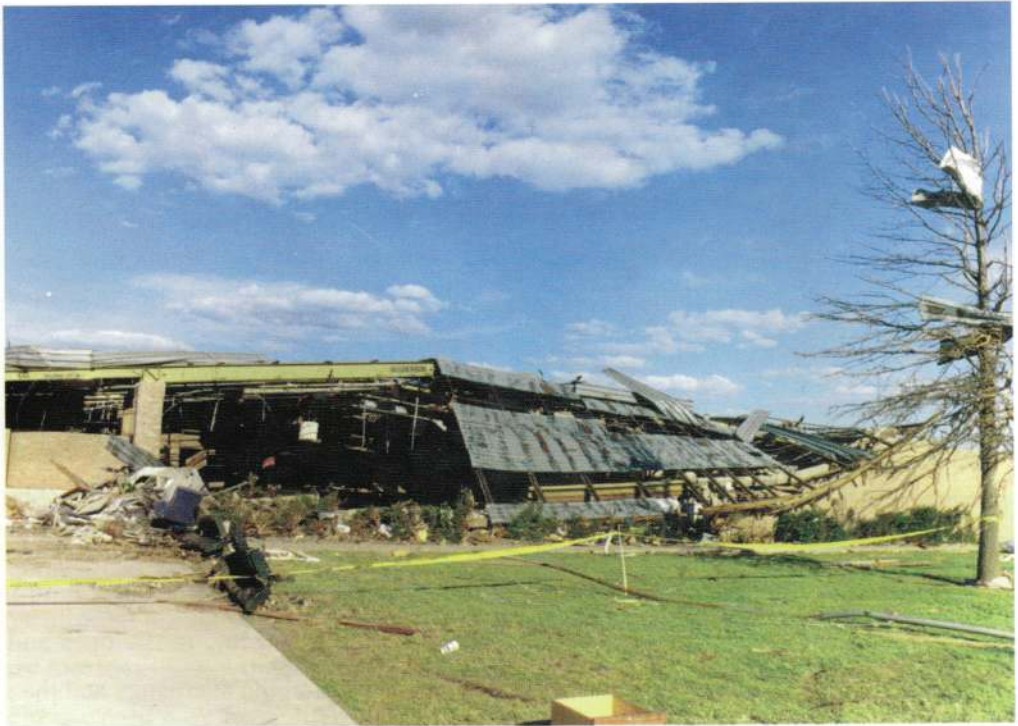
**FIGURE 21. KELLY ELEMENTARY SCHOOL, MOORE, OK**

Kelly Elementary (Figure 21) had a load-bearing concrete masonry wall construction with light steel columns and beams with bar joists supporting a built-up roof over metal roof deck. The 1960's vintage building had low roof slopes and large overhangs. The strong wind forces produced uplift on the overhangs and the storm debris compromised the building envelope allowing internal wind forces coupled with the external wind forces, to remove the roof decking. Initial structural failure occurred at the roof deck to joist connections. The sequential failure of the decking probably produced eccentric loading on the structural steel frame causing racking of the frame (Figure 22) and eventual failure of the beam blocks in the bearing wall (Figure 23). It is of interest to note that the planned areas of emergency refuge within the building were the corridors, each of which was filled with toppled masonry walls and twisted building elements.

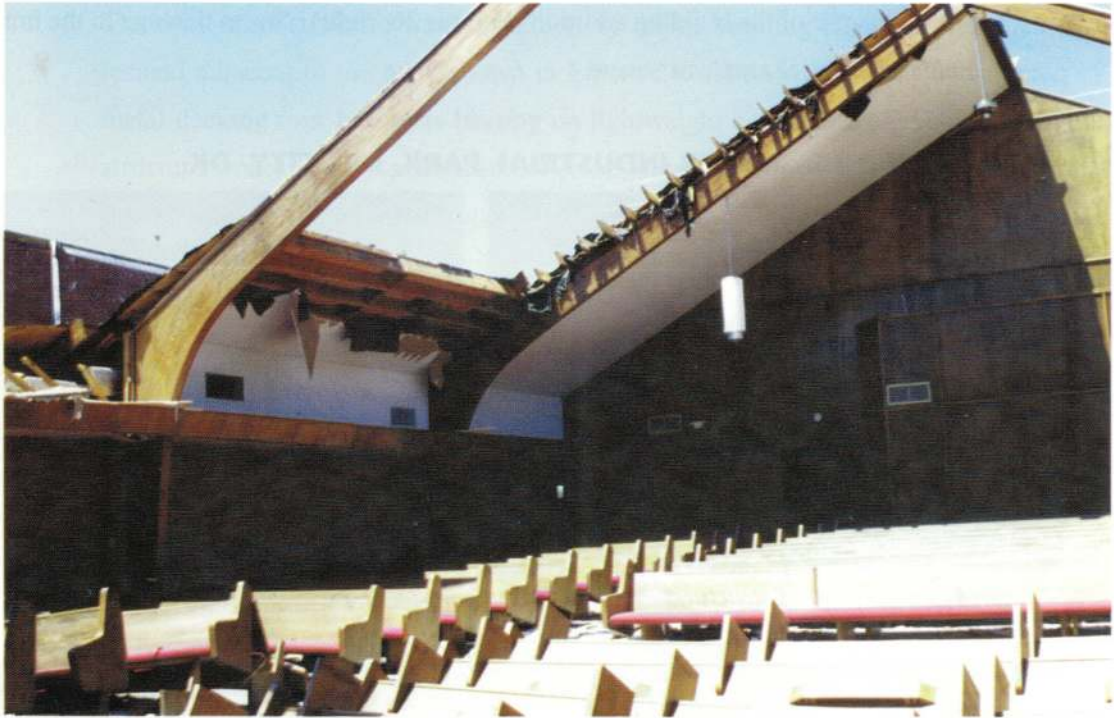
**FIGURE 27. REGENCY PARK BAPTIST CHURCH, MOORE, OK**

Regency Park Baptist Church was located approximately one block from Kelly Elementary shown in Figure 21. The damage in the surrounding residential areas was extensive. The sanctuary's long span roof experienced the majority of the damage. The sanctuary was constructed of stick framed roof joists bearing on glued laminated timber arches with a heavy masonry wall. Wind forces removed the toenailed roof joists (Figure 27) with the nails failing in withdrawal. The heavy timber structure and walls were virtually undamaged.

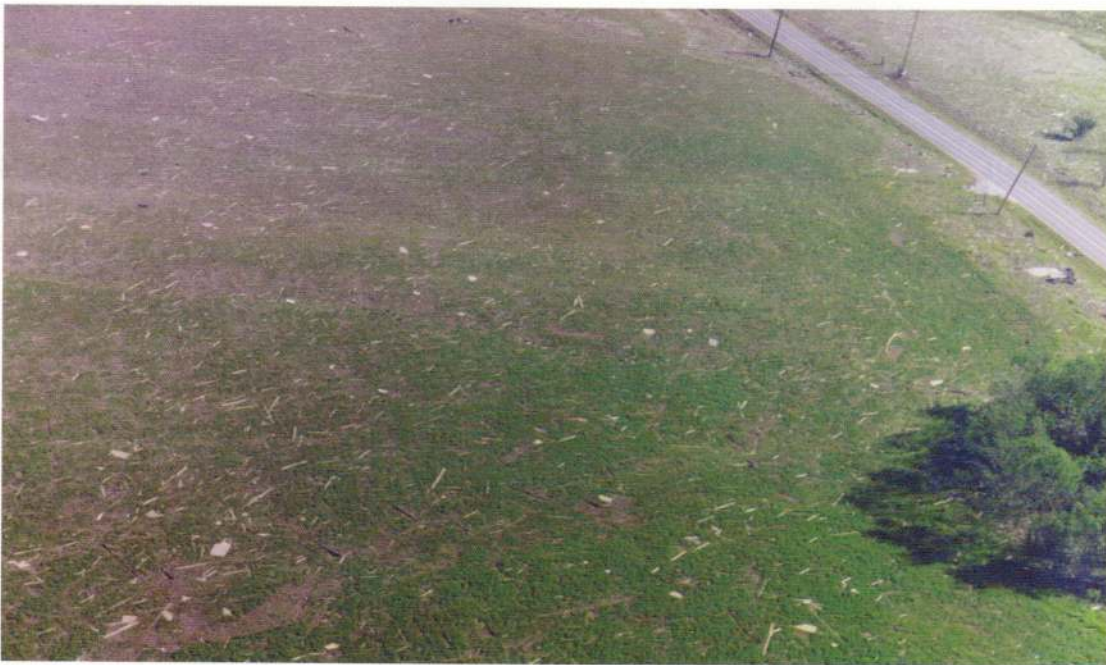
**Figure 31. Debris Field**

Debris of different materials, shapes and weights may or may not become windborne. Some building parts may become windborne and disintegrate into several components. Documentation of debris would include original and final locations of debris pieces and the size and shape of debris pieces. The documentation teams did not document general debris (Figure 31), but focused on projectiles: pieces of debris that impacted and were found penetrating walls and other surfaces and objects. Note that projectiles are a small subset of debris. Since the sample size is relatively small, no attempt is made to perform statistical analysis of debris or projectiles.

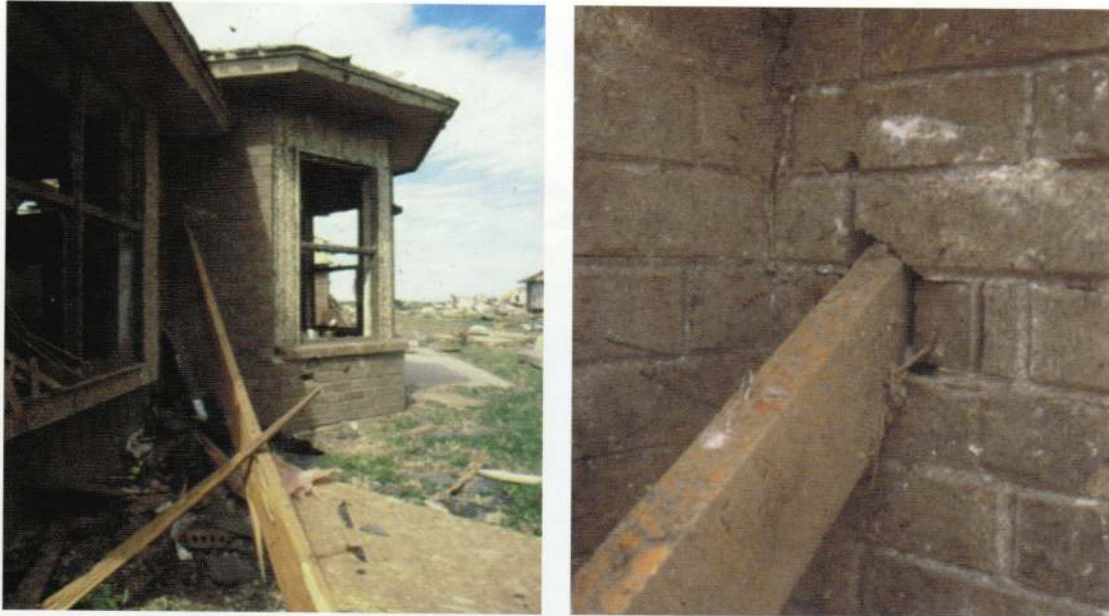
**Figure 32. Large 2x6 Wood Projectile**

The majority of buildings surveyed were residential buildings of wood-frame construction, thus most of the debris and projectiles observed were broken wood boards. **Wood board projectiles** consisted of a wide variety of shapes, from small 3 cm x 3 cm (1 in x 1 in) pieces to a 4 m (14 ft) long 5 cm x 15 cm (2 in x 6 in) member. Out of the 27 wood projectiles documented, there were two 3 cm x 15 cm (1 in x 6 in), nine 5 cm x 10 cm (2 in x 4 in), and sixteen 5 cm x 15 cm (2 in x 6 in) members. The average weights of documented 5 cm x 10 cm (2 in x 4 in) and 5 cm x 15 cm (2 in x 6 in) projectiles were 13 and 44 N (3 and 10 lbs), respectively. An unusually large 5 cm x 15 cm (2 in x 6 in) projectile (4 m, 14<sup>+</sup>ft long) with an estimated weight of 151 N (34 lb) was observed (Figure 32). Wood projectiles penetrating brick veneer were typically 5 cm x 15 cm (2 in x 6 in) wood boards (Figure 33). Wood projectiles penetrating wood roof decks (Figure 34) and automobiles included 3 cm x 15 cm (1 in x 6 in), 5 cm x 10 cm (2 in x 4 in) and 5 cm x 15 cm (2 in x 6 in) wood boards (Figure 35). The weights of documented wood projectiles ranged from 9 to 151 N (2 to 34 lbs), with lengths from 25 cm (10 in) to 4 m (14 ft).
