# PARKERSBURG - NEW HARTFORD, IOWA EF-5 TORNADO

May 25, 2008

43 Mile Damage Track

National Weather Service - Des Moines, Iowa

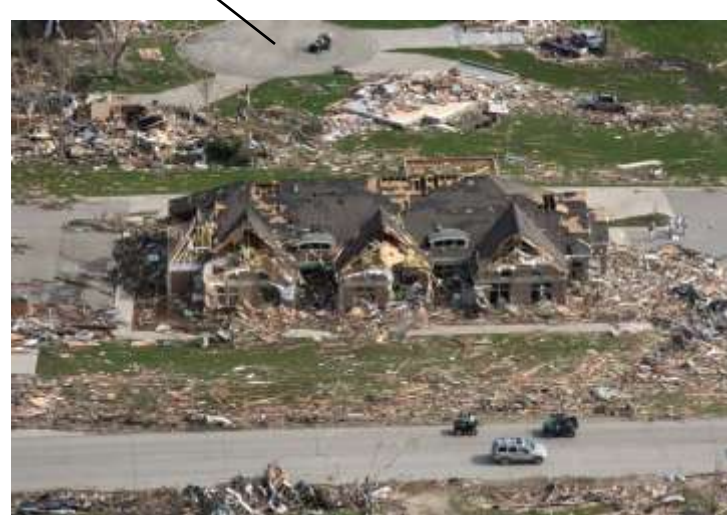
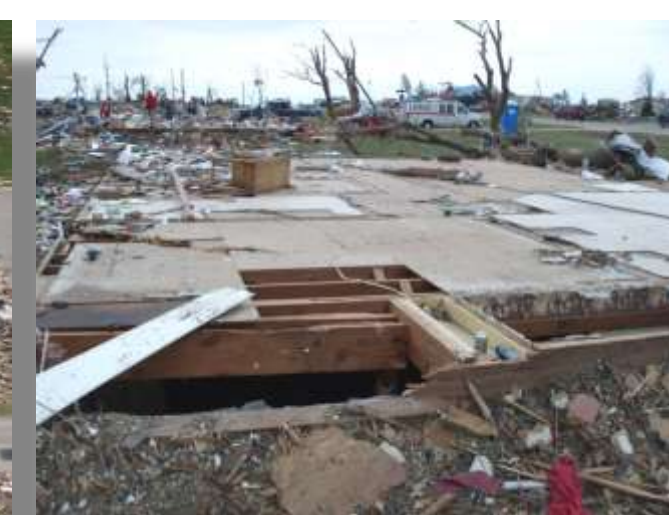
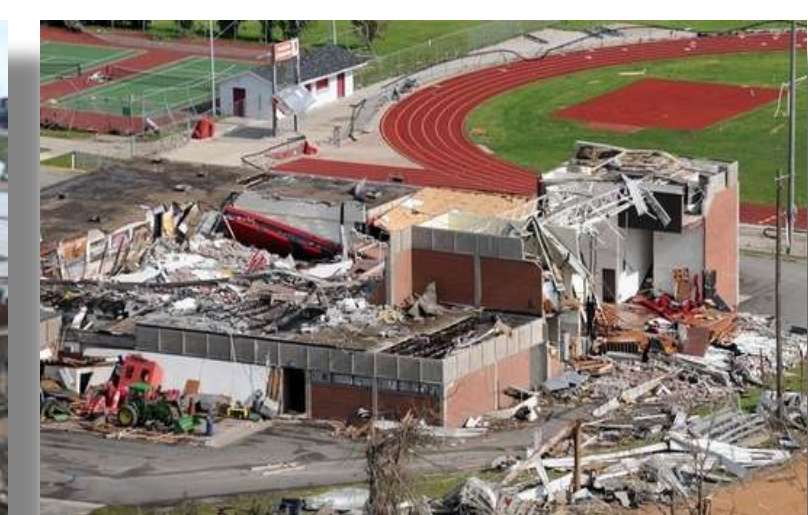
The most severe destruction in Parkersburg occurred south of the tornado core, which tracked directly over the First State Bank (left photo). Several fatalities occurred in the neighborhood of the center photo, as floors were swept away exposing basements. Mature trees were reduced to debarked stubs. The high school (right photo, Getty Images) received EF2-3 damage.

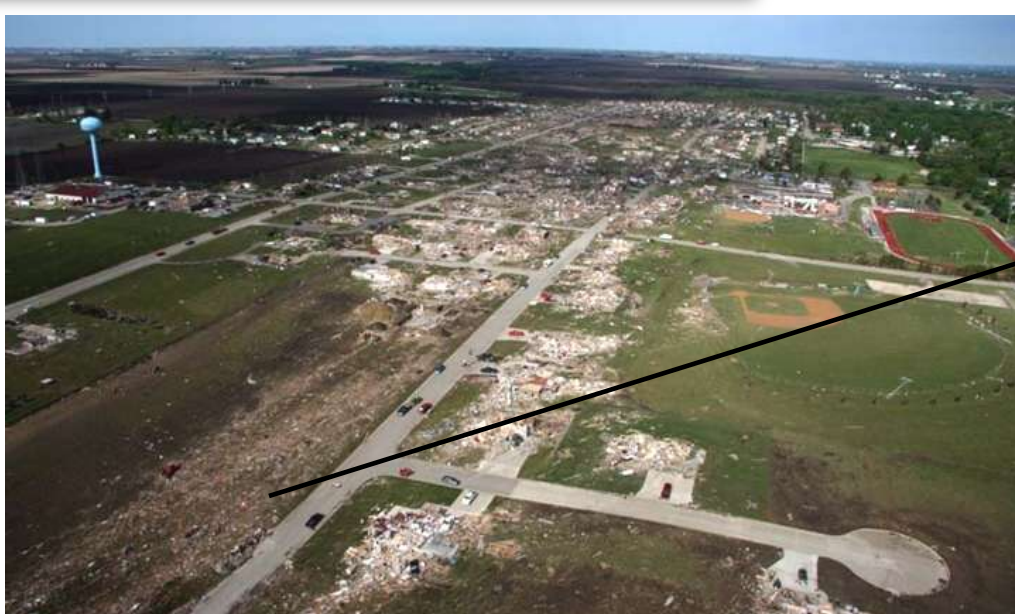
Aerial photos from the Civil Air Patrol and IowaHelicopter.com show the path of the destruction through south and east Parkersburg. Damage was EF4-5 at the core of the track.
