National Weather Service Des Moines

June 12, 2013 Tornado Event Summary

Updated on February 23, 2014

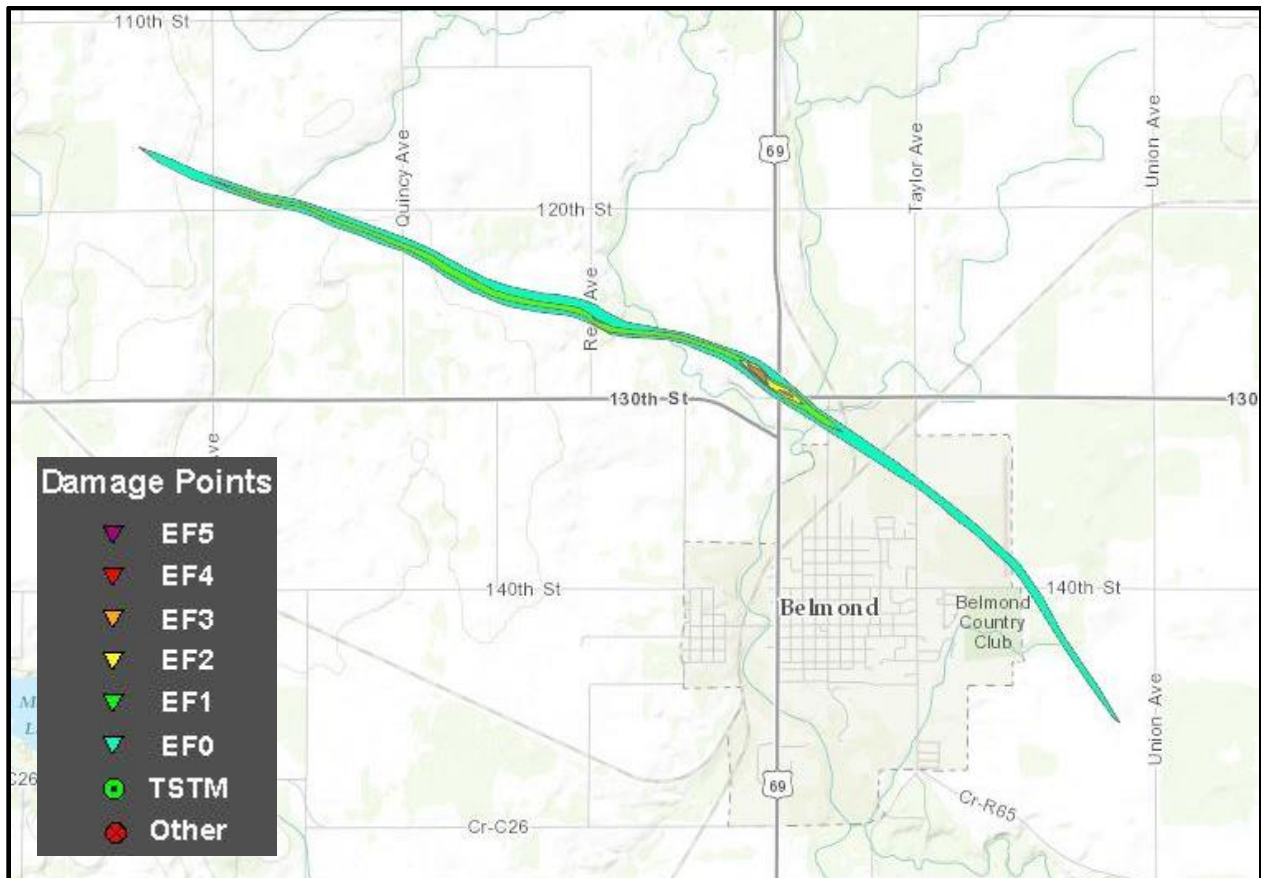
Tornado 1 Path Map:

This tornado touched down a little over four miles northwest of Belmond just after 4:00pm, initially damaging a machine shed. It strengthened to an EF-2 as it tracked over a farmstead two miles NW of Belmond. Still tracking SE, the tornado heavily damaged a home and several businesses along US HW 69 north of town where high end EF-3 wind speeds were estimated. The tornado then continued to the southeast and weakened to an EF-0 as it skirted the northeast side of town and crossed the city airstrip. At the airstrip, the tornado bisected the path of another tornado ("Tornado 2") that had touched down less than 10 minutes beforehand. As the tornado crossed 140th St, it quickly roped out and dissipated.

Tornado Strength: EF-3

Peak Wind Speed: 155 mph

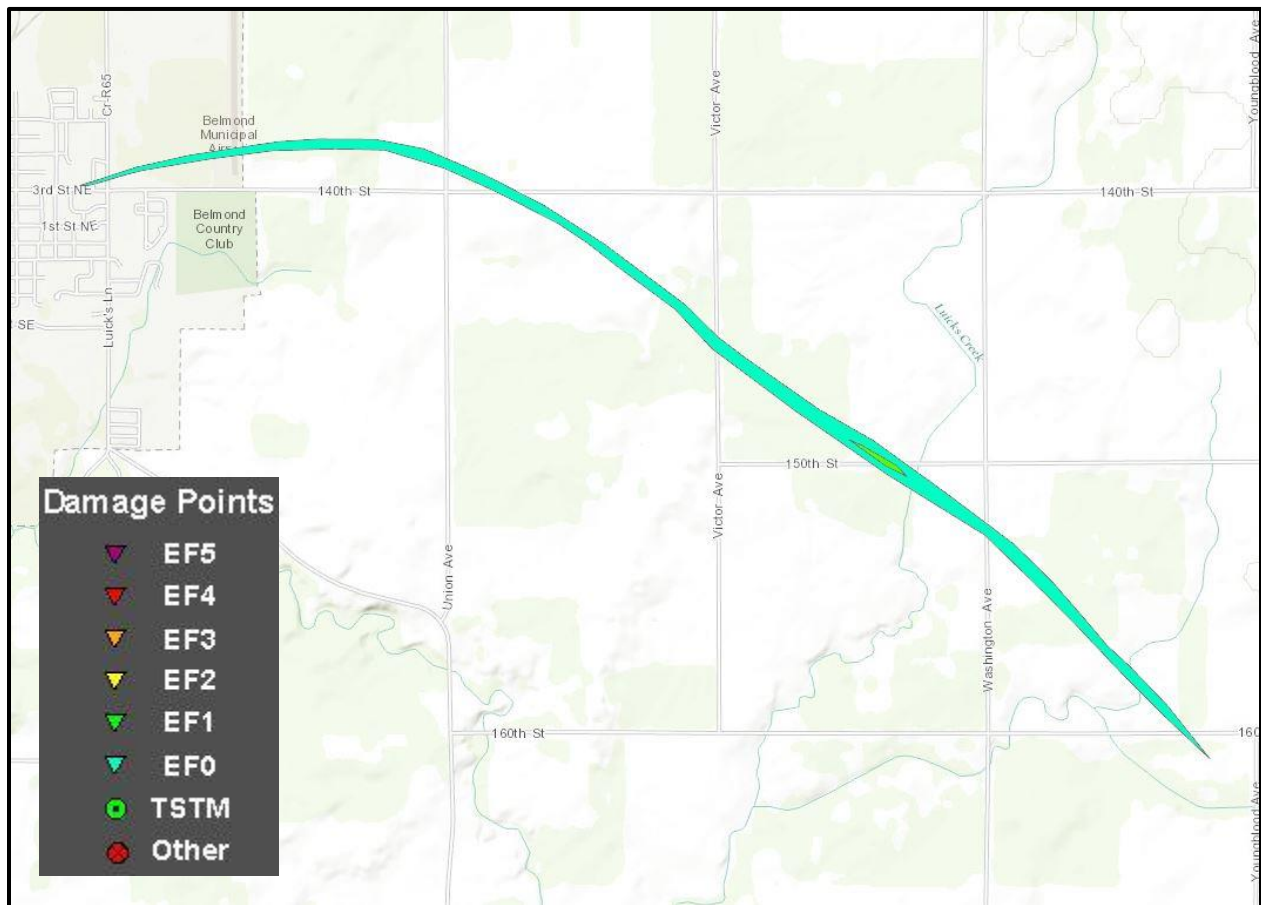
Tornado 2 Path Map:

This tornado formed on the east side of Belmond at 4:19pm and knocked a weather mesonet station off the roof of the elementary school. The weak tornado then tracked eastward across the city airstrip before turning southeast and crossing 140th St. a mile east of town. Strengthening to an EF-1, the tornado heavily damaged a grove of trees before weakening and eventually dissipating 5 miles SE of Belmond.

Tornado Strength: EF-1

Peak Wind Speed: 103 mph

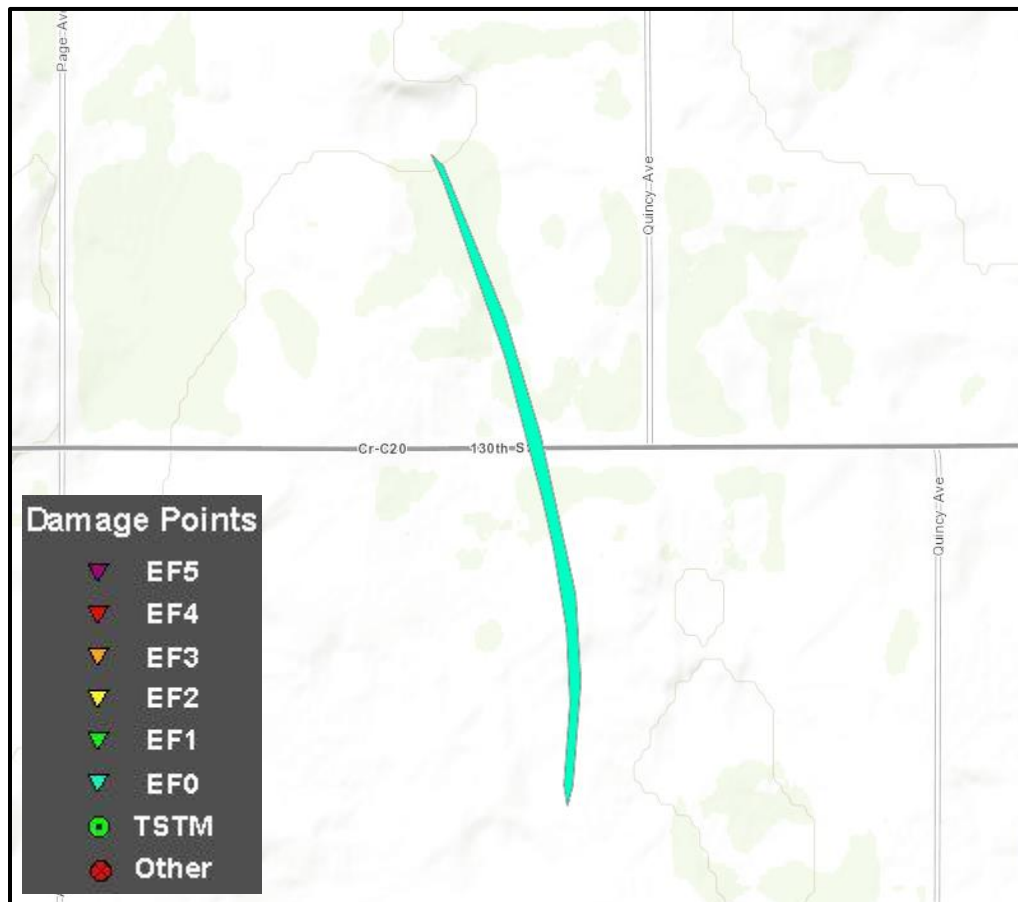
Tornado 3 Path Map:

This tornado formed as a larger EF-3 tornado was passing through the NE side of Belmont. This tornado tracked to the SSE across open farm land before dissipating. The track was determined based on photographs of the tornado and satellite imagery of the area. The location of the tornado in the storm, track direction, and streaks in satellite imagery suggest that this tornado rotated anti-cyclonically.

Tornado Strength: EF-0

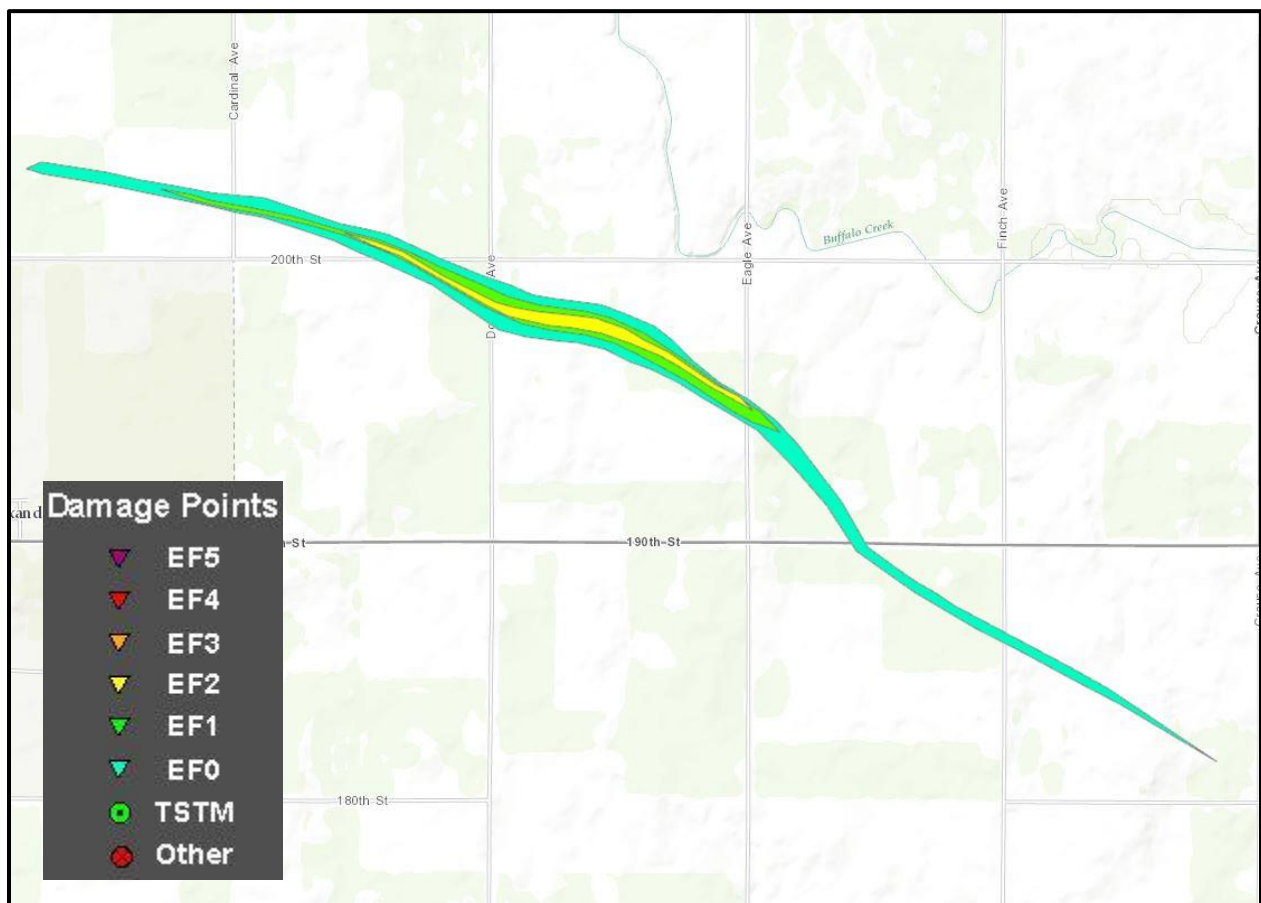
Tornado 4 Path Map:

This tornado formed as the EF-1 to the west was roping out and dissipating. It heavily damaged several farms while straight-line winds produced an even wider damage path to the south of the tornado. The tornado then turned more towards the SE and weakened, dissipating just before reaching Interstate 35.

Tornado Strength: EF-2

Peak Wind Speed: 112 mph

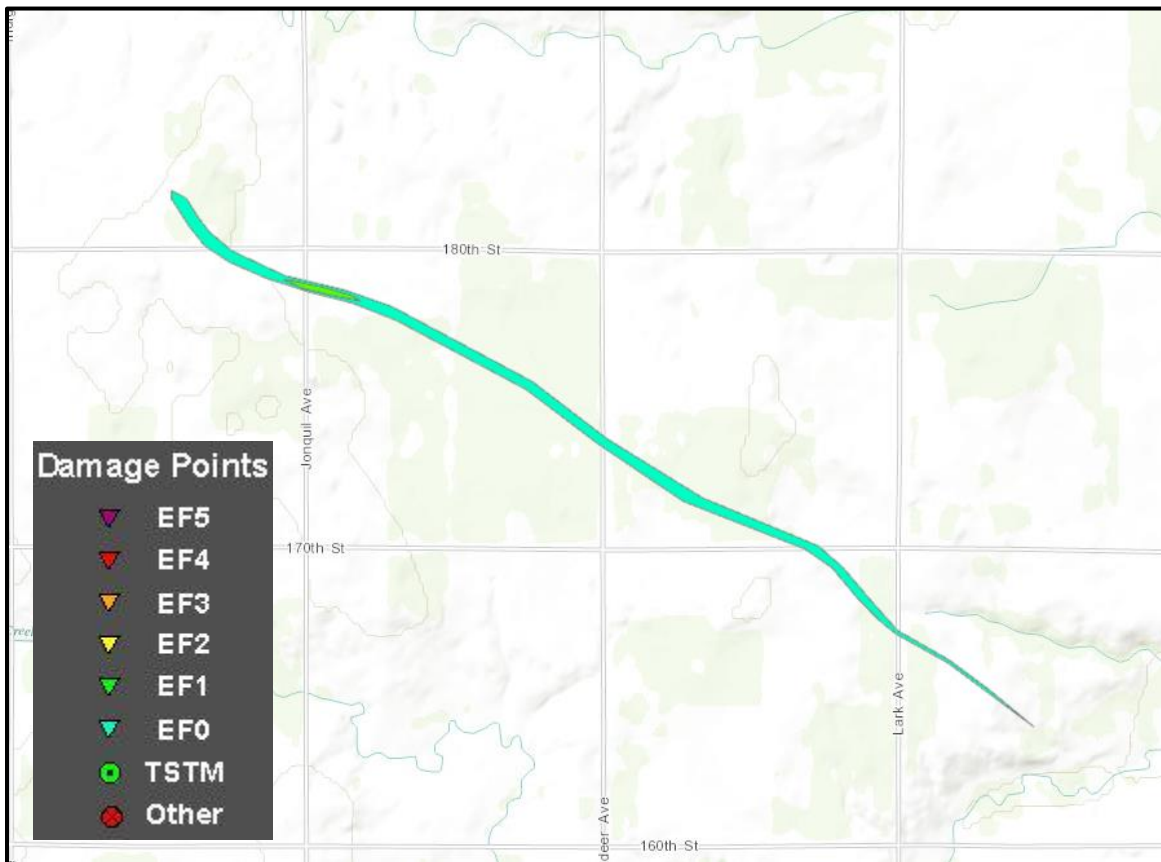
Tornado 5 Path Map:

This small EF-1 tornado formed 2.5 miles NE of Latimer and damaged a barn roof and about a dozen trees on two farmsteads. It then weakened and dissipated about 3.8 miles NW of Hampton.

Tornado Strength: EF-1

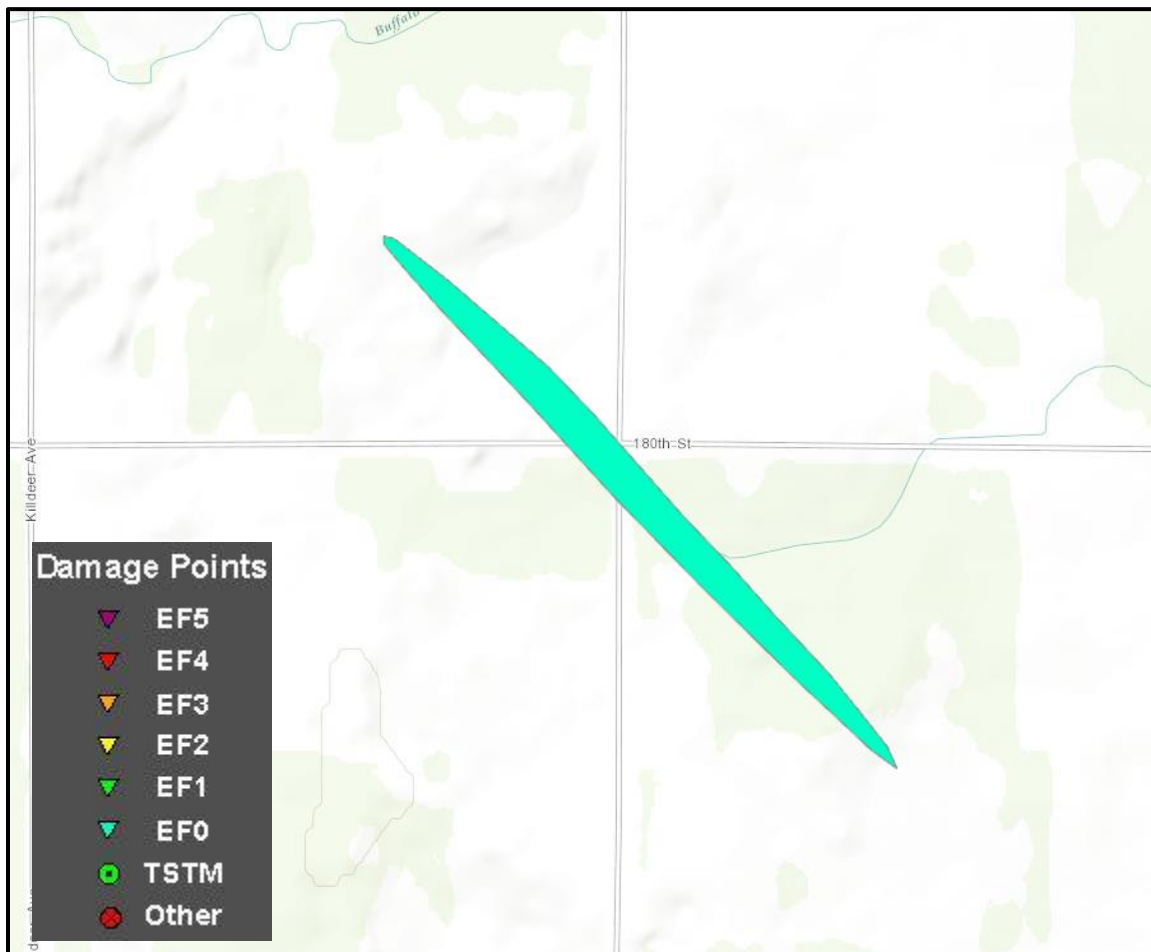
Tornado 6 Path Map:

This brief EF-0 tornado travelled through open fields NW of Hampton and caused no reported damage. It touched down while Tornado #5 was nearing the end of its track and dissipated less than a minute after Tornado #5 roped out. This tornado was widely photographed and captured by at least five different video cameras.

Tornado Strength: EF-0

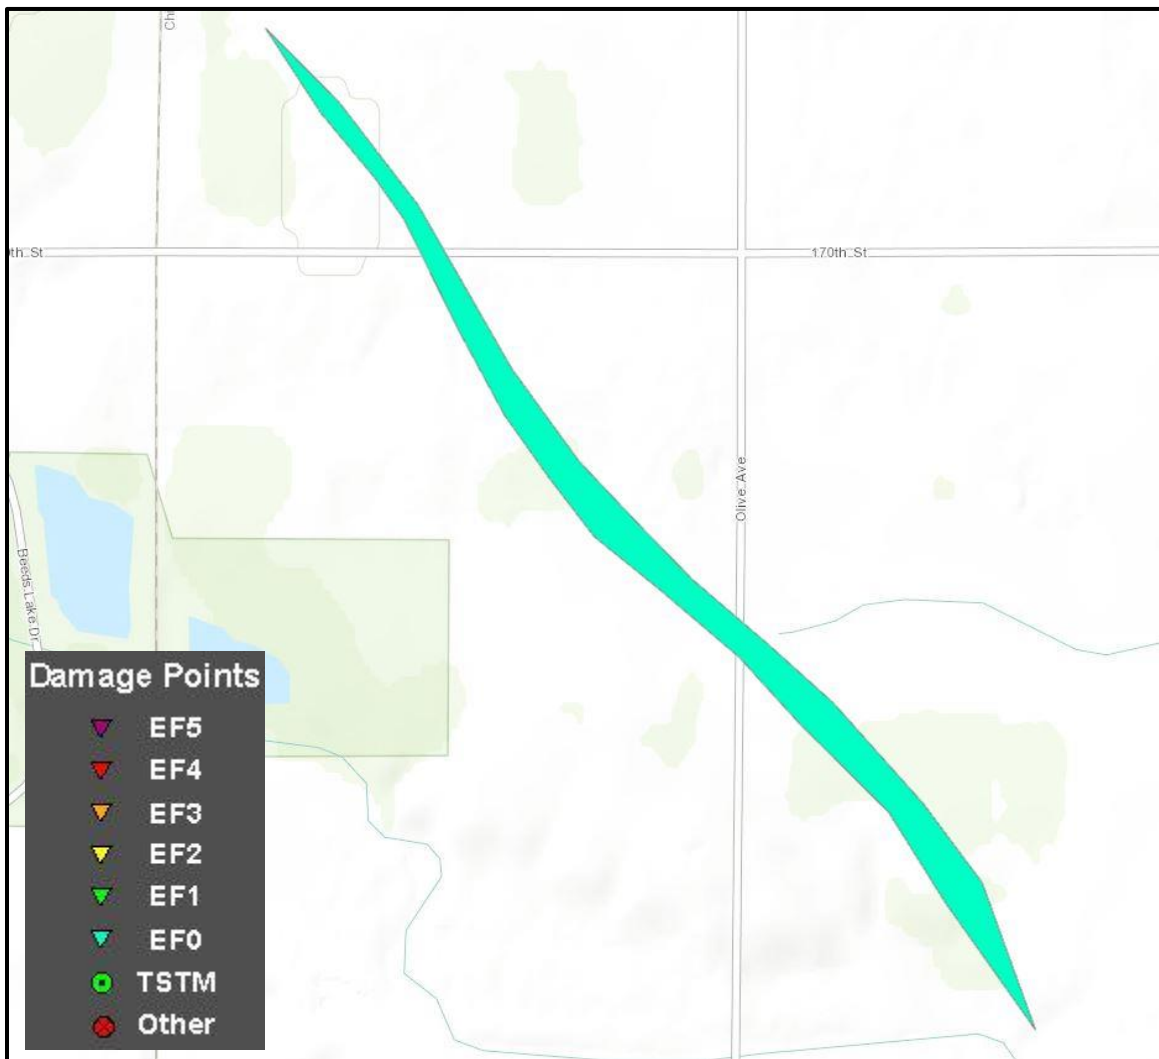
Tornado 7 Path Map:

This brief EF-0 tornado lightly damaged a barn roof and some trees northwest of Hampton
