# The April 27, 2014 Windstorm

## Summary

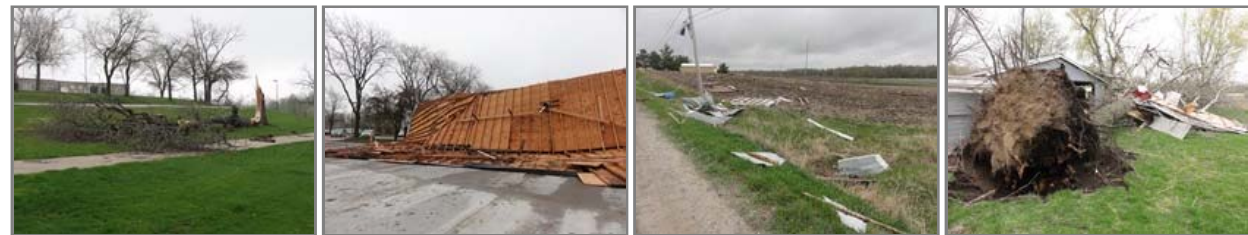
## Lovilia to Oskaloosa

A survey team from the NWS in Des Moines assessed the damage path from Lovilia to Oskaloosa and concluded that it was all the result of downbursts/straight-line winds. Contrary to initial reports, there was no evidence of a tornado touchdown in Lovilia. The only damage found in town was three broken tree sections and light siding damage to one building. This intermittent and weak straight-line wind damage trail continued northeastward through southwestern Mahaska County before strengthening to the southwest of Beacon at 3:10pm CDT. This increase in intensity is supported by data from the Des Moines WSR-88D radar. These winds snapped 4-5 large wooden power lines to the west of town, with winds estimated at 80 to 90 mph. Two large sheds/small outbuildings were destroyed just southwest of Beacon, with the debris thrown into power lines and a trailer park just across the road to the northeast. The wind removed sections of roofs from at least two trailers and tossed the debris almost 200 yards to the northeast. Other intermittent tree and roof damage took place on the southern and eastern sides of Beacon. Estimated winds in the town were between 70 and 75 mph.

These straight-line winds progressed rapidly into southwest Oskaloosa just after 3:15pm CDT. Dozens of trees were snapped or uprooted in the town, with the greatest concentration of damage running from Edmundson Park on the southwest corner of the city northeast to the city hospital on the town's eastern side. While trees suffered the bulk of the damage there was light shingle damage to some roofs and several pole lines were snapped. The Oskaloosa Family Medical Center had its roof peeled back and draped over the northern side of the building. Despite the severity of the damage to the building, the roof decking remained in one piece and there was no damage to surrounding buildings and trees. Wind speeds in this area were estimated to be around 85 mph.

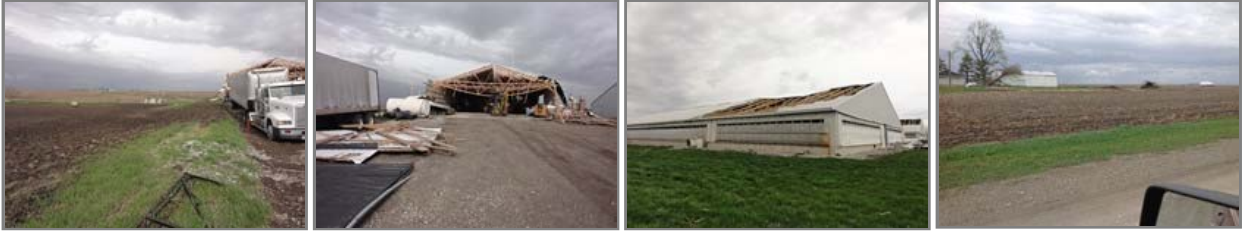
## Far Northern Wapello County

There was little to no damage for five miles to the northeast of Ottumwa. However, the storm strengthened 3 miles south of the Keokuk

County line with damage to multiple farm buildings, trees and power lines. This damage exhibited some characteristics of a broad, cyclonic circulation. It is believed that an EF1 tornado formed 2 miles south of the county line, west of Agency-Hedrick Road, and tracked northeastward out of Wapello County and into the town of Martinsburg.
