**NCHRP REPORT 350 TEST 4-10 OF THE
ALASKA MULTI-STATE BRIDGE RAIL**

Research Project 404311-1
Contract No. T97232

December 1998

**TEXAS TRANSPORTATION INSTITUTE
THE TEXAS A & M UNIVERSITY SYSTEM
COLLEGE STATION, TEXAS**

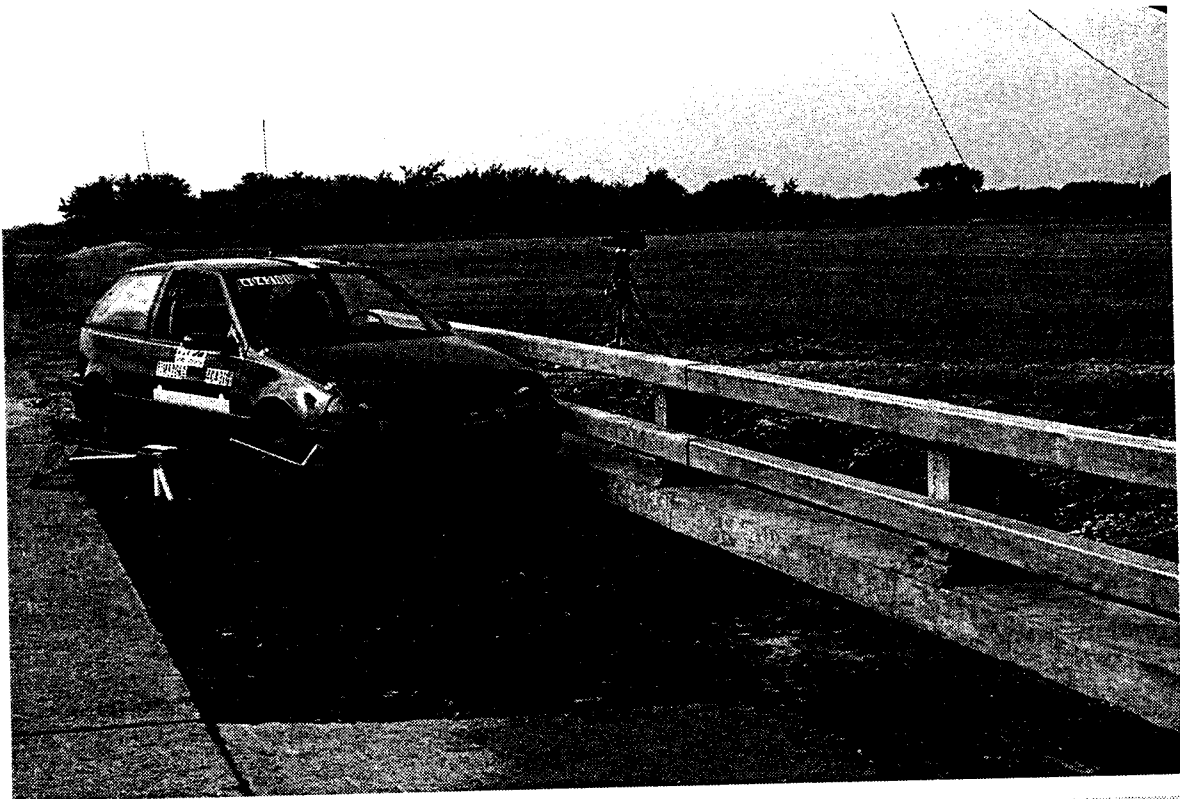
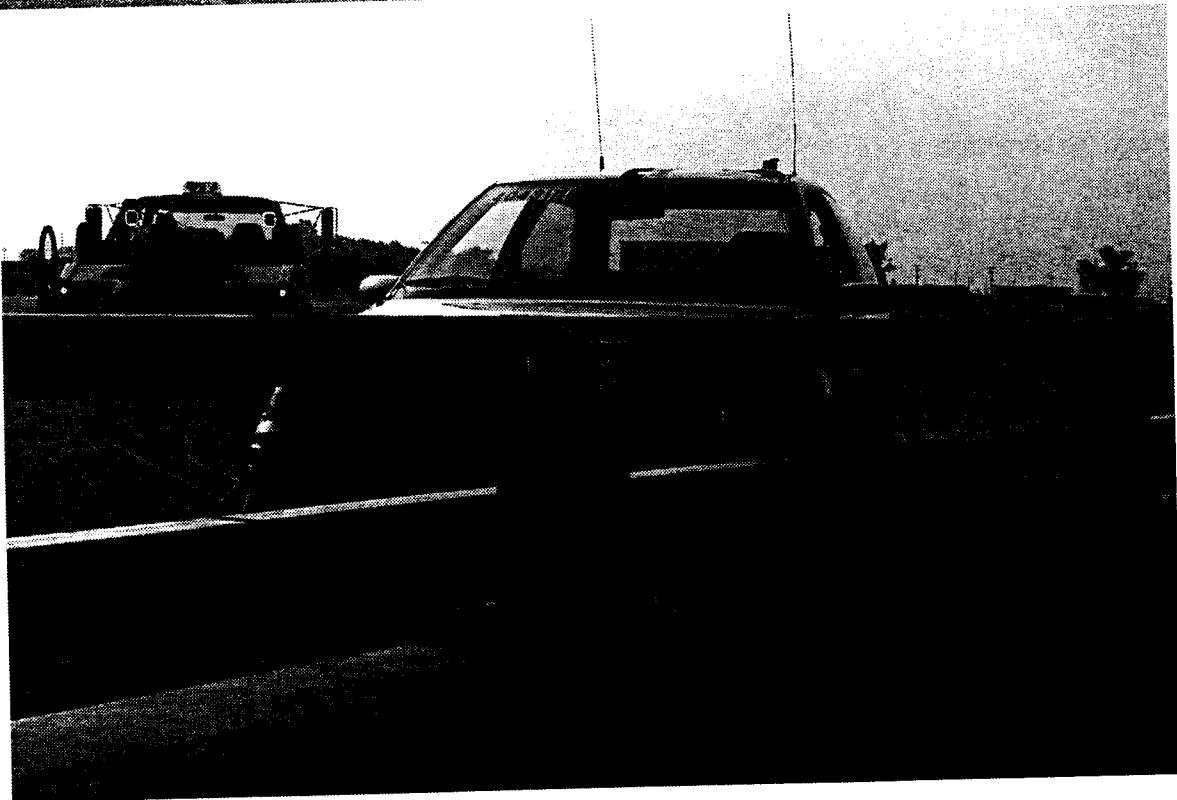
Figure 5. Vehicle/installation geometrics for test 404311-1.

The vehicle, traveling at 100.0 km/h, impacted the curb of the Alaska Multi-State Bridge Railing 1.1 m upstream from post 3 at a 20.8 degree angle. Shortly after impact, the bridge railing moved. At 0.015 s the front left tire contacted the concrete curb, and at 0.020 s the front left wheel steered to the right and became parallel with the bridge rail. The front left tire lost contact with the ground, while still in contact with the bridge rail at 0.025 s. The vehicle began to redirect at 0.032 s. By 0.039 s, the vehicle contacted post 3, and by 0.41 s, the front right wheel steered toward the rail. The front left corner of the vehicle snagged on post 3 and some sheet metal was pulled from the vehicle at 0.046 s. At 0.51 s the front left tire returned to the road surface, and at 0.071 s the hood latch of the vehicle released. The driver's side window shattered at 0.083 s. Traveling at 87.6 km/h, the vehicle was parallel to the rail at 0.132 s. At 0.147 s the rear of the vehicle contacted the rail elements, and at 0.183 s the right tire lost contact with the ground. The vehicle lost contact with the bridge railing at 0.278 s, traveling at a speed of 86.7 km/h at a 6.0 degree angle. At 0.484 s the hood of the vehicle flew back and hit the windshield. Brakes on the vehicle were applied at 2.6 s, bringing the vehicle to rest 51.8 m downstream from impact and 4.6 m behind the bridge railing. Sequential photographs of the test period are shown in appendix D, figures 13 and 14.

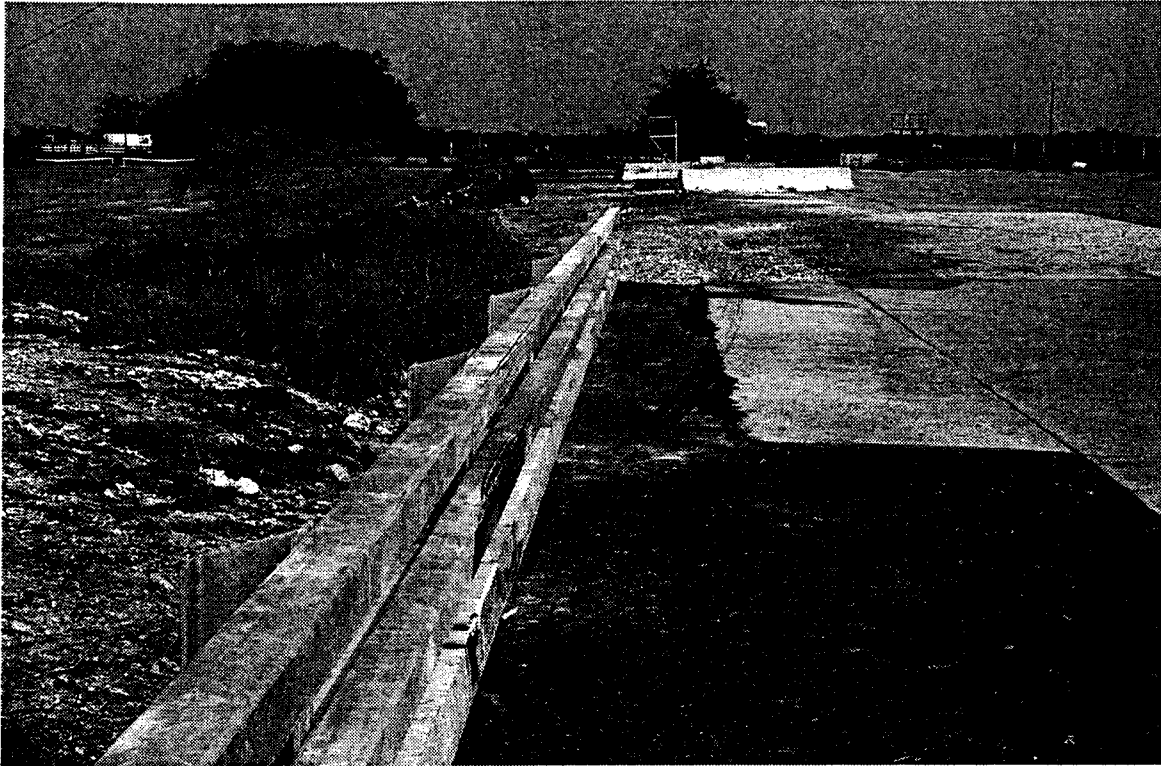
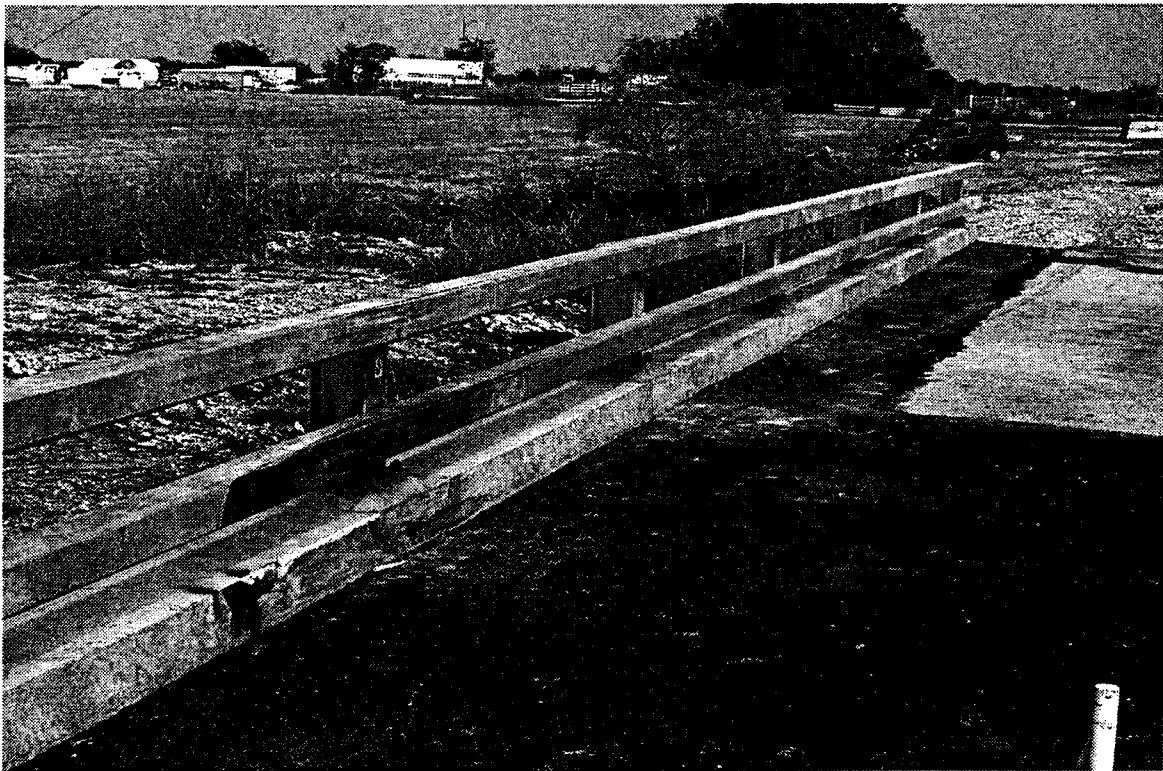
Figure 7. After impact trajectory for 404311-1.

Damage to the Alaska Multi-State Bridge Railing mounted on the curb is shown in figures 7 and 8. At impact the edge of the curb was scraped, and tire marks were along the face of the curb. The front face of post 3 was marred with red paint from the vehicle and the curb was chipped. Cosmetic damage with no measurable deformation occurred to the rail elements. The top rail was contacted, but did not move. Total length of contact of the vehicle with the bridge railing was 4.5 m.
