POSTFLIGHT EVALUATION OF ATLAS-CENTAUR AC-5

(Launched March 2, 1965)

Lewis Research Center

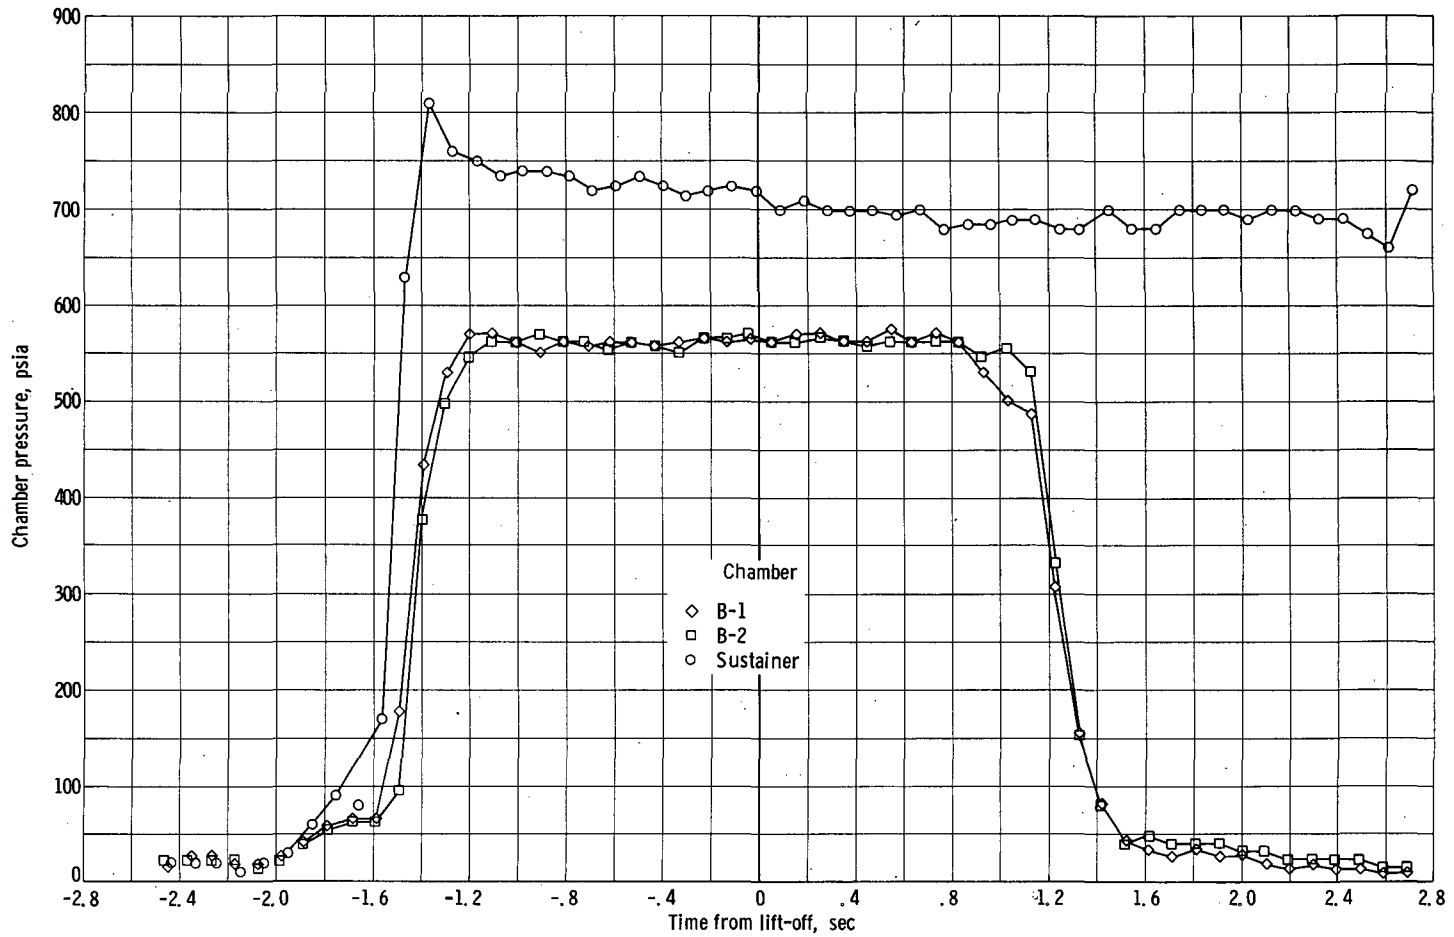
Figure V-3. - Atlas engine chamber pressures for AC-5 flight.

All Atlas propulsion system parameters were normal through lift-off for the AC-5 launch. Table V-1 compares some propulsion system nominal values with those obtained at lift-off on AC-5. The first indication of trouble occurred with the loss of fuel pump inlet pressure (FPIP). From 0.7 to 0.9 second the B-1 FPIP decayed from 56.0 to 5.5 psia, and the B-2 FPIP from 56.0 to 8.0 psia (fig. V-2). Following 1.1 seconds the inlet pressures for both the B-1 and B-2 sides remained below 3.0 psia. The fuel tank ullage pressure remained essentially constant until vehicle disintegration at 2.8 seconds, indicating the source of the problem was somewhere between the main fuel supply and the turbopump inlets. The B-1 and B-2 thrust chamber pressures (fig. V-3) were 560 psia at 0.8 second. At 1.1 seconds, the B-1 pressure was 487 psia and the B-2 was 530 psia. By 1.5 seconds both chamber pressures had decayed to approximately 40 psia. The sustainer chamber pressure remained normal, approximately 700 psia, until flight termination.

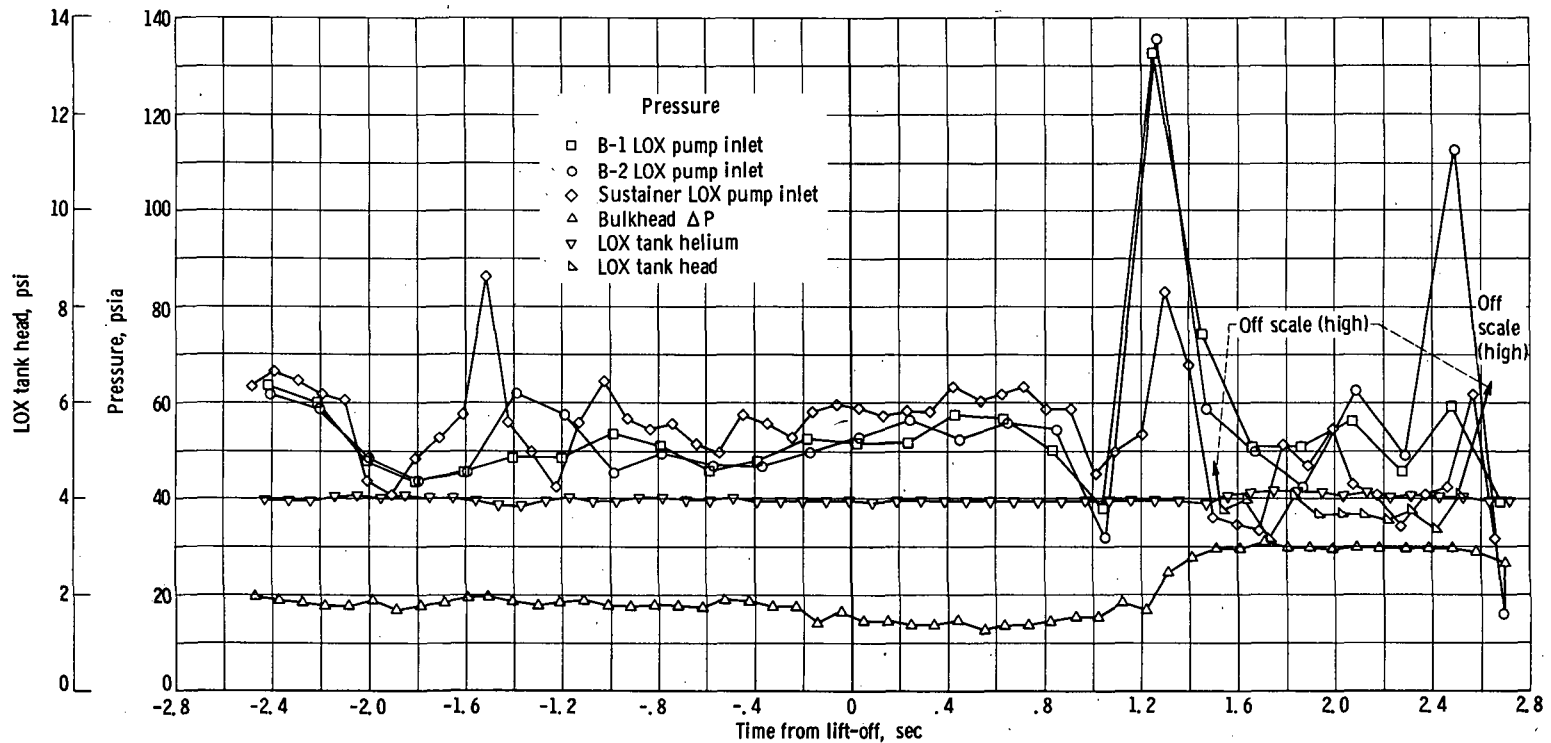
Figure V-6. - AC-5 flight Atlas engine LOX pump inlet pressures bulkhead ΔP.

The B-1 turbopump started to overspeed from its normal speed of 6350 rpm at 0.8 second (see fig. V-5). The B-2 turbopump started to overspeed at 0.95 second with a value of 6150 rpm, reached a peak value of 6850 rpm at 1.1 seconds, and decayed to 1500 rpm by 2.7 seconds. The turbopumps initially oversped because the loss of fuel unloaded the system. The only discrepancies in the sustainer system and the booster LOX system performance (fig. V-6) are considered a result of the vehicle failure.

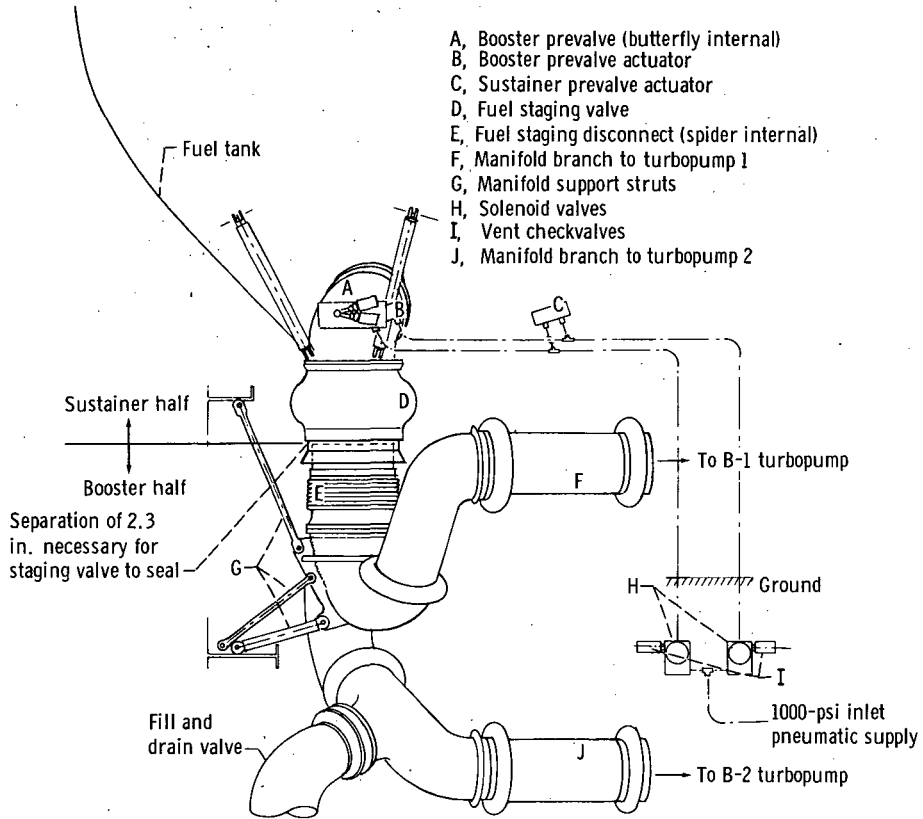
Figure V-7. - Fuel system low pressure ducting configuration between main fuel supply and turbo-pump inlets.

Duct blockage. - Hardware inspection of the pertinent areas uncovered no obstruction considered adequate to block fuel flow. It is highly doubtful that a foreign object could have so completely terminated flow as to result in the rapid pressure decay indicated in figure V-2.

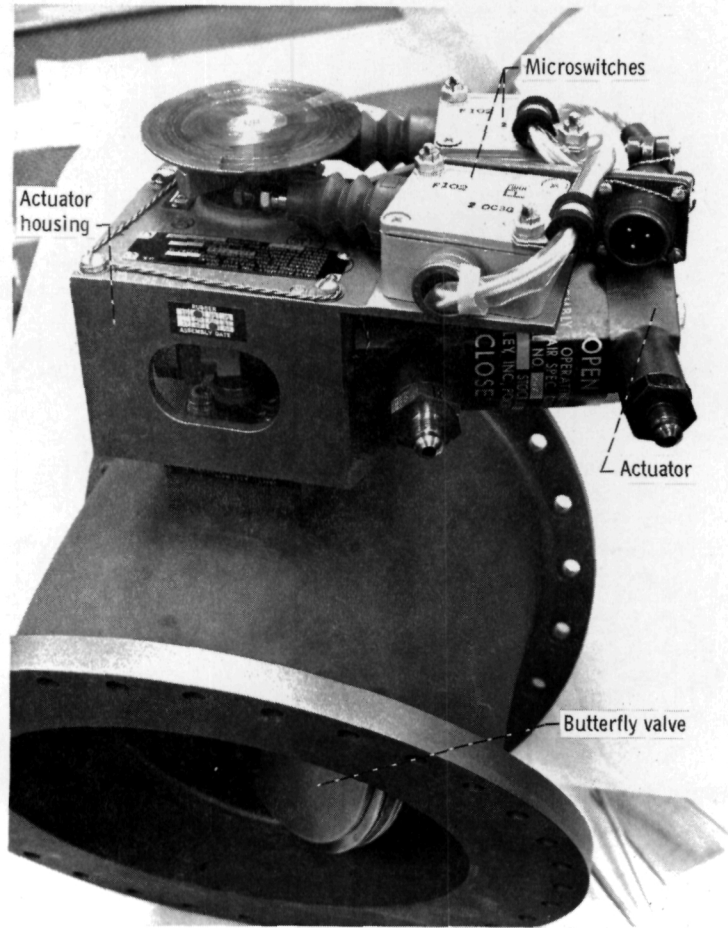
Figure V-8. - Booster fuel prevalue assembly. (Disk in upper left portion of figure installed for testing purposes only).

Prevalve. - Examination of hardware after the fire indicated that the pre-valve actuator was unlocked and the butterfly valve was near the closed position. Evaluation of data revealed there was no command given to close the pre-valve. Flow tests indicated the maximum torque that fuel flow can exert on the butterfly valve was approximately 260 inch-pounds. With the prevalve in the locked open position the minimum torque required to cause system failure was de-

If the prevalve failed on AC-5, it did not fail in the locked open position. The valve was either locked and became unlocked prior to failure, or was partially open but unlocked.

The AC-5 prevalve actuator was recovered, disassembled, and examined for failure analysis. Testing and examination of the components were compared with failure history reports on other actuators. The only significant anomaly was the presence of a foreign fluid behind the actuator piston. The fluid was analyzed and found to be a mixture of RP-1 fuel and "firex" water. Firex water was used to quench the flames after vehicle impact. The fluid is assumed to have entered the actuator following vehicle destruction.

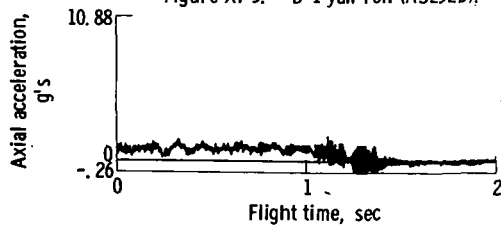
Figure XI-4. - Axial acceleration (CM101A).

A longitudinal oscillation of 0.8 g P-P amplitude at a frequency of 8 cps occurred at  $T + 0.3$  second of flight (fig. XI-4). It was believed that this perturbation was caused by Atlas LOX pressurization instability at lift-off. However, it did not compare well with Atlas LOX pressurization instability oscillations at lift-off of 0.35 g P-P and 6 cps, which have been evident on other Atlas-Centaur flights. More analysis must be performed to ascertain the cause and possible effect from this oscillation.
