**NATIONAL
TRANSPORTATION
SAFETY
BOARD**

RAILROAD ACCIDENT REPORT

**DERAILMENT OF
SOUTHERN PACIFIC TRANSPORTATION COMPANY
FREIGHT TRAIN ON MAY 12, 1989
AND SUBSEQUENT RUPTURE OF
CALNEV PETROLEUM PIPELINE ON MAY 25, 1989
SAN BERNARDINO, CALIFORNIA**

1. Report No. NTSB/RAR-90/02	2. Government Accession No. PB90-916302	3. Recipient's Catalog No.	
4. Title and Subtitle Railroad Accident Report-- Derailment of Southern Pacific Transportation Company Freight Train on May 12, 1989, and Subsequent Rupture of Calnev Petroleum Pipeline on May 25, 1989, San Bernardino, California		5. Report Date June 19, 1990

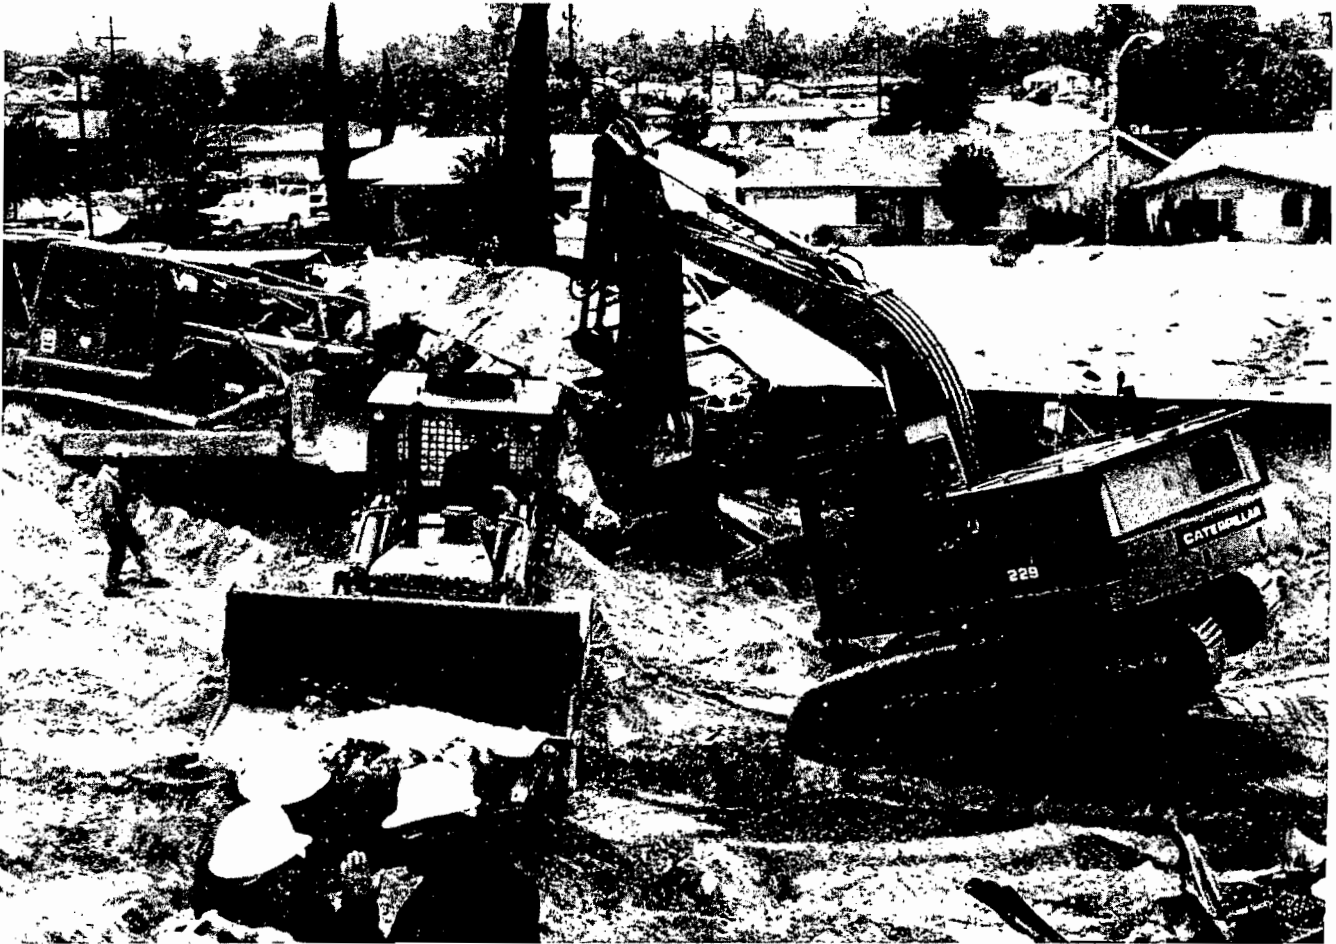
Figure 7.--Equipment used during wreckage removal.

that morning, with a backhoe and shovels, Calnev personnel dug two holes on either side of the locomotive engine that came to rest inverted over the pipeline and determined that the depth of the pipeline in that area was between 7 and 8 feet.

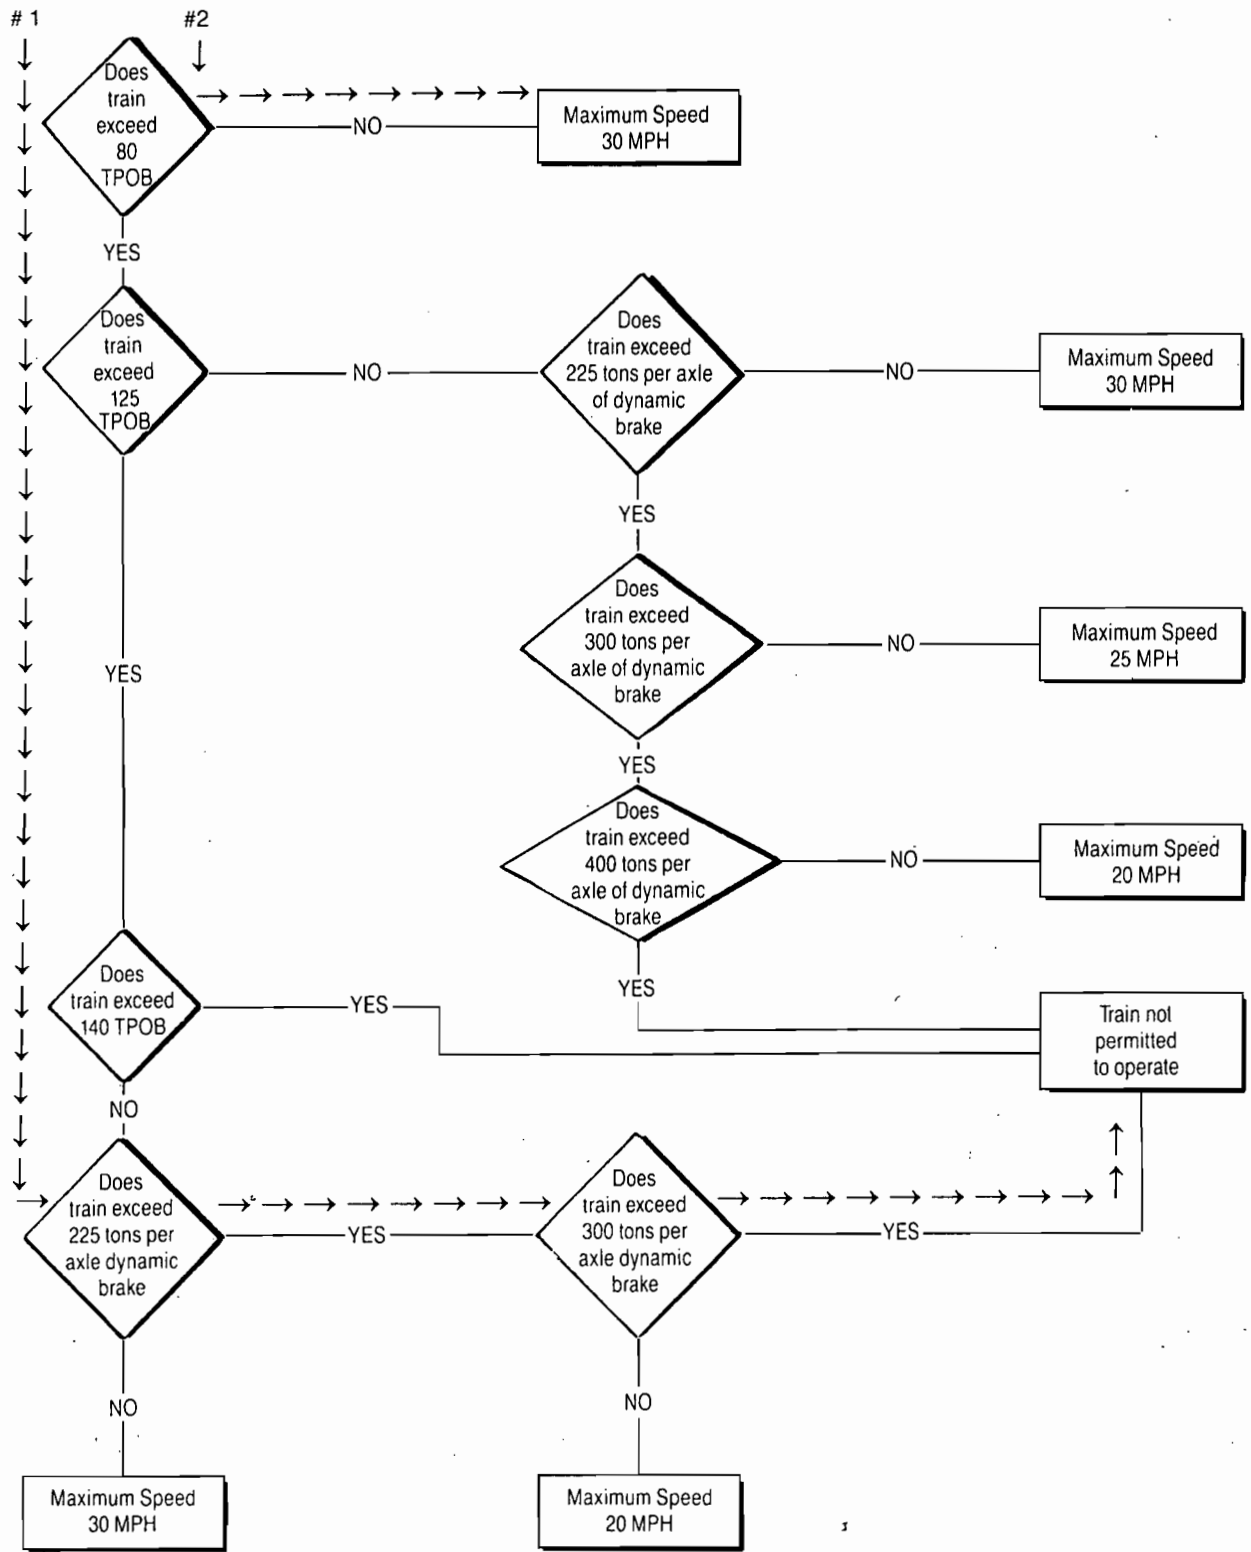
Figure 15.--Speed decision flow chart for Rule 33.

The SP's general road foreman of engines provided the Safety Board with a speed decision flow chart for Rule 33 (see figure 15). According to his testimony, "A train consisting of 69 cars with a weight of 8,900 tons and that had 18 operative dynamic brake axles" would not have been allowed to descend the grade east of Hiland. Extra 7551 East on the day of the accident had 128 tons per operative brake (8,900 trailing tons divided by 69 (number of cars in train, not using the 1 1/2 braking equivalence)) and 494 tons per axle of dynamic braking (8,900 trailing tons divided by 18 (three locomotive units with six axles each)). Using the speed decision flow chart, the general foreman illustrated why the train was not permitted to operate (follow arrow #1 on figure 15). Using the chart, the general foreman also illustrated the decision process the engineer would have made on the day of the derailment with the information that he had 69 tons per operative brake³⁰ (follow arrow #2 on figure 15). According to the general road foreman, "If the train would have had 6,151 tons, with the information that [the head-end

engineer] had and the dynamic brakes [he] thought he had working, he could easily have controlled the train down the hill." He further stated that the engineer, based on the information provided to him, could have taken the train down the hill without any dynamic brakes. According to the head-end engineer, based on the information he had, rule 33 did not apply to his train.

Extra 7551 East had an actual trailing tonnage of about 9,000 tons, 69 cars calculated with a braking equivalence of 1, and 18 axles (three locomotive units) of dynamic braking. Consequently, the train would have had 130 tons per operative brake (TPOB) and 500 tons per axle of dynamic brake. Based on Rule 33 of the company's operating rules, Extra 7551 East would not have been permitted to be operated down the 2.2-percent grade. (See figure 15, arrow 1.)

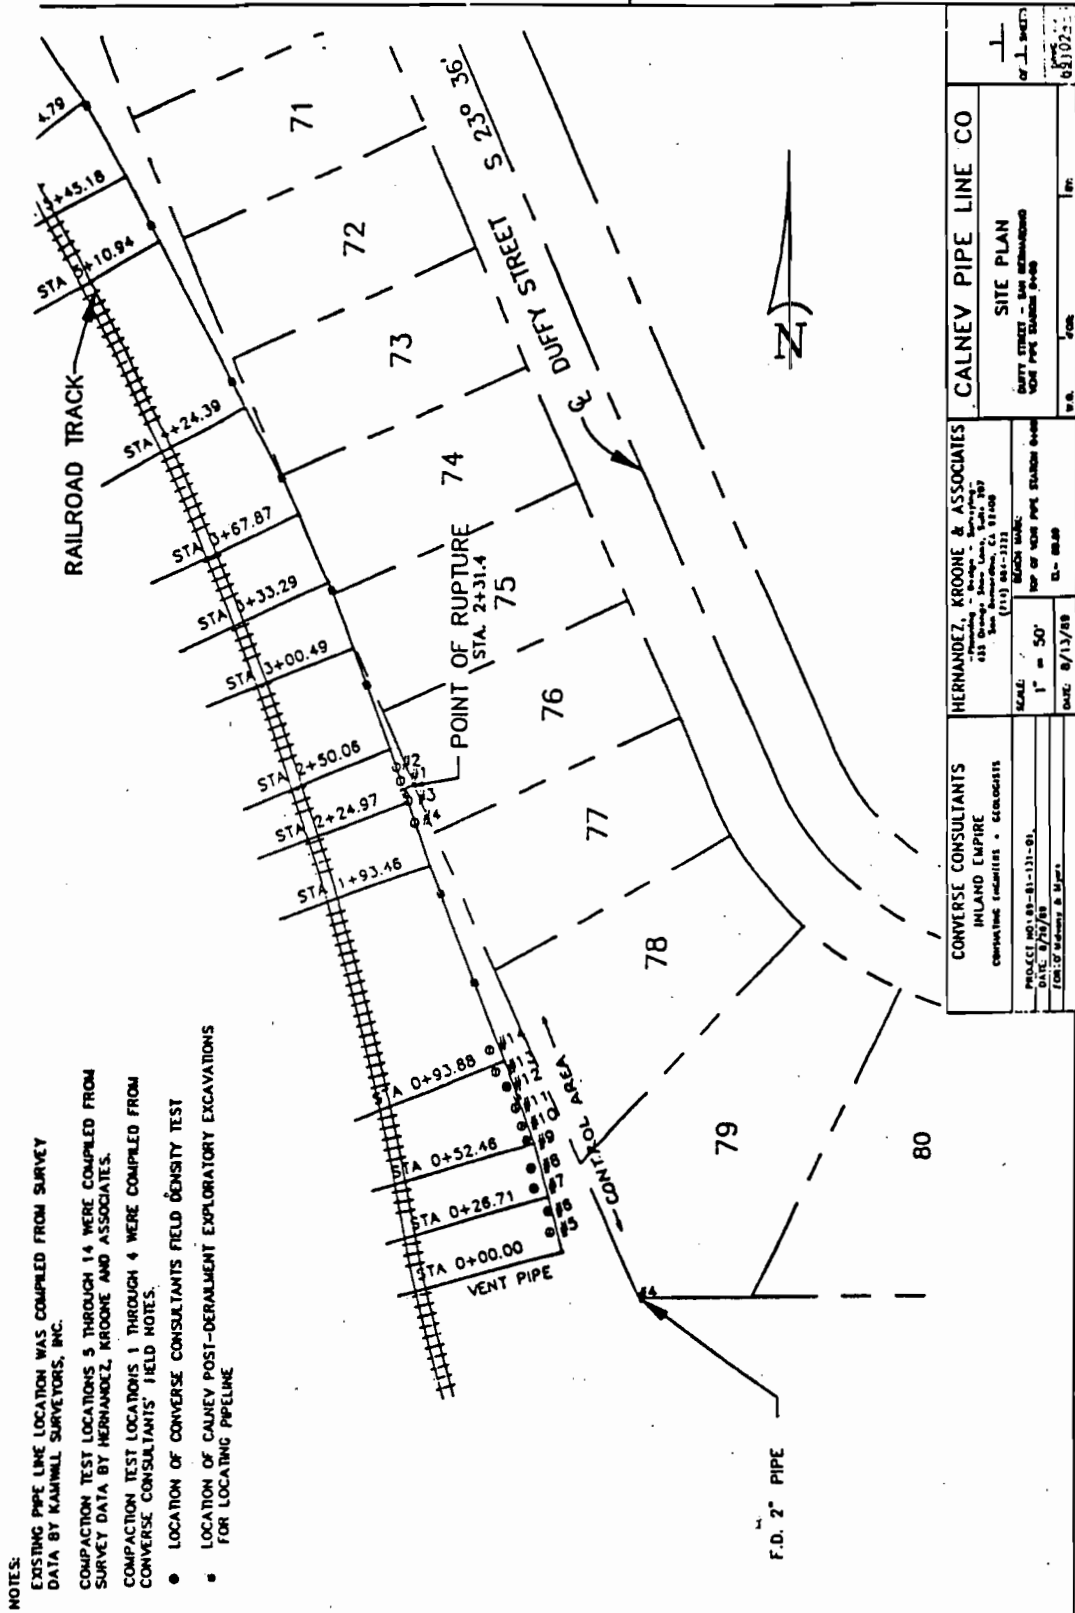
Figure 16.--Map from Converse Consultants' soil inspection report.

Soil Inspection Report.--On May 25, the day of the pipeline rupture, Calnev contracted with Converse Consultants, a geo-technical and environmental consulting organization, to perform work in the area of the pipeline rupture. As stated in its August 30, 1989, report of findings (appendix N), Converse Consultants' investigation "...was performed to evaluate the subsurface conditions in the vicinity of the pipeline rupture in order to locate areas where the soils may have been disturbed by excavating equipment. It is our understanding that excavating equipment may have been utilized in the vicinity of the pipe rupture during Calnev post derailment pipe inspection and/or during clean-up of the derailment debris." A total of 14 tests were conducted; tests 1 through 4 (figure 16) were performed within the area of the rupture, and tests 5 through 14 were conducted in an area ("control area") where Converse Consultants believed there had been no excavation or disturbance of the soil. According to Converse Consultants' report, tests of samples taken at locations 1 through 4 indicated "...disturbed or poorly compacted earth materials...and contained significant quantities of the mineral trona." Tests of samples taken at locations 5 through 14 indicated that the earth materials had not been recently disturbed. The tests indicated no presence of the material trona at these locations. A representative from Converse Consultants testified, "...my interpretation and conclusion is that the materials, backfill materials, which prior to the derailment would have been just clean, natural soils without the presence of trona, had become contaminated with trona by means of excavation and replacement, probably as backfill or certainly as materials that had been exposed to trona and mixed, by whatever means."
