NIST Technical Note 1796

# **A Case Study of a Community Affected by the Witch and Guejito Fires: Report #2 – Evaluating the Effects of Hazard Mitigation Actions on Structure Ignitions**

This publication was a joint effort between the National Institute of Standards and Technology and the United States Forest Service (USFS).

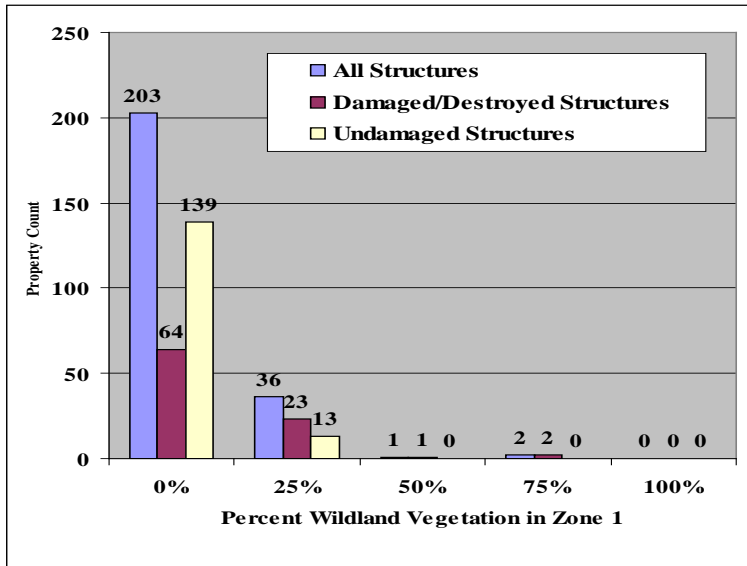
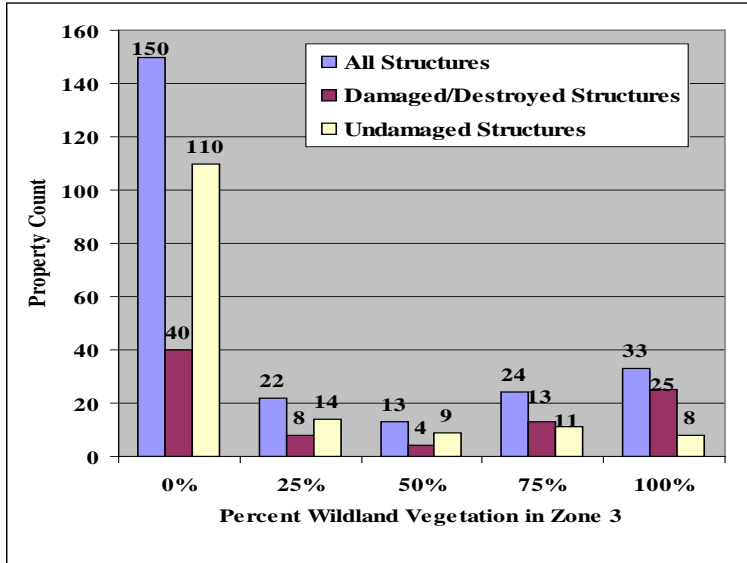
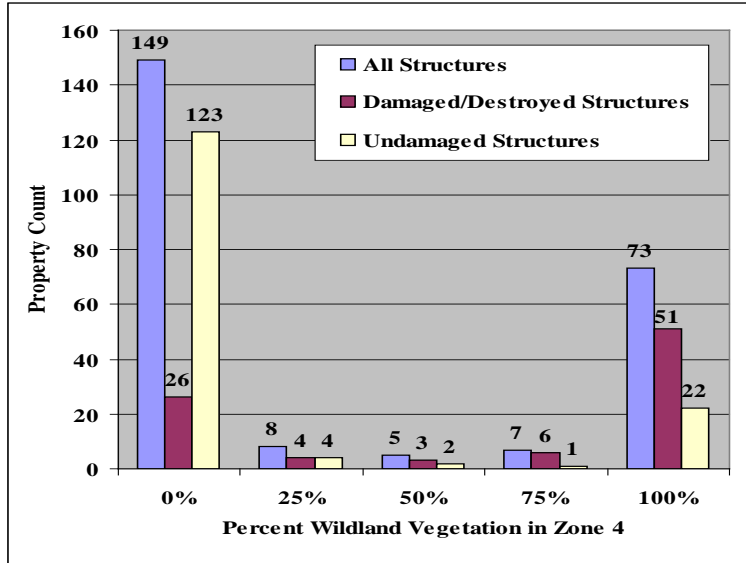
Figure 20 Frequency counts of structures by bins of percent of wildland vegetation found on the property for four zones.

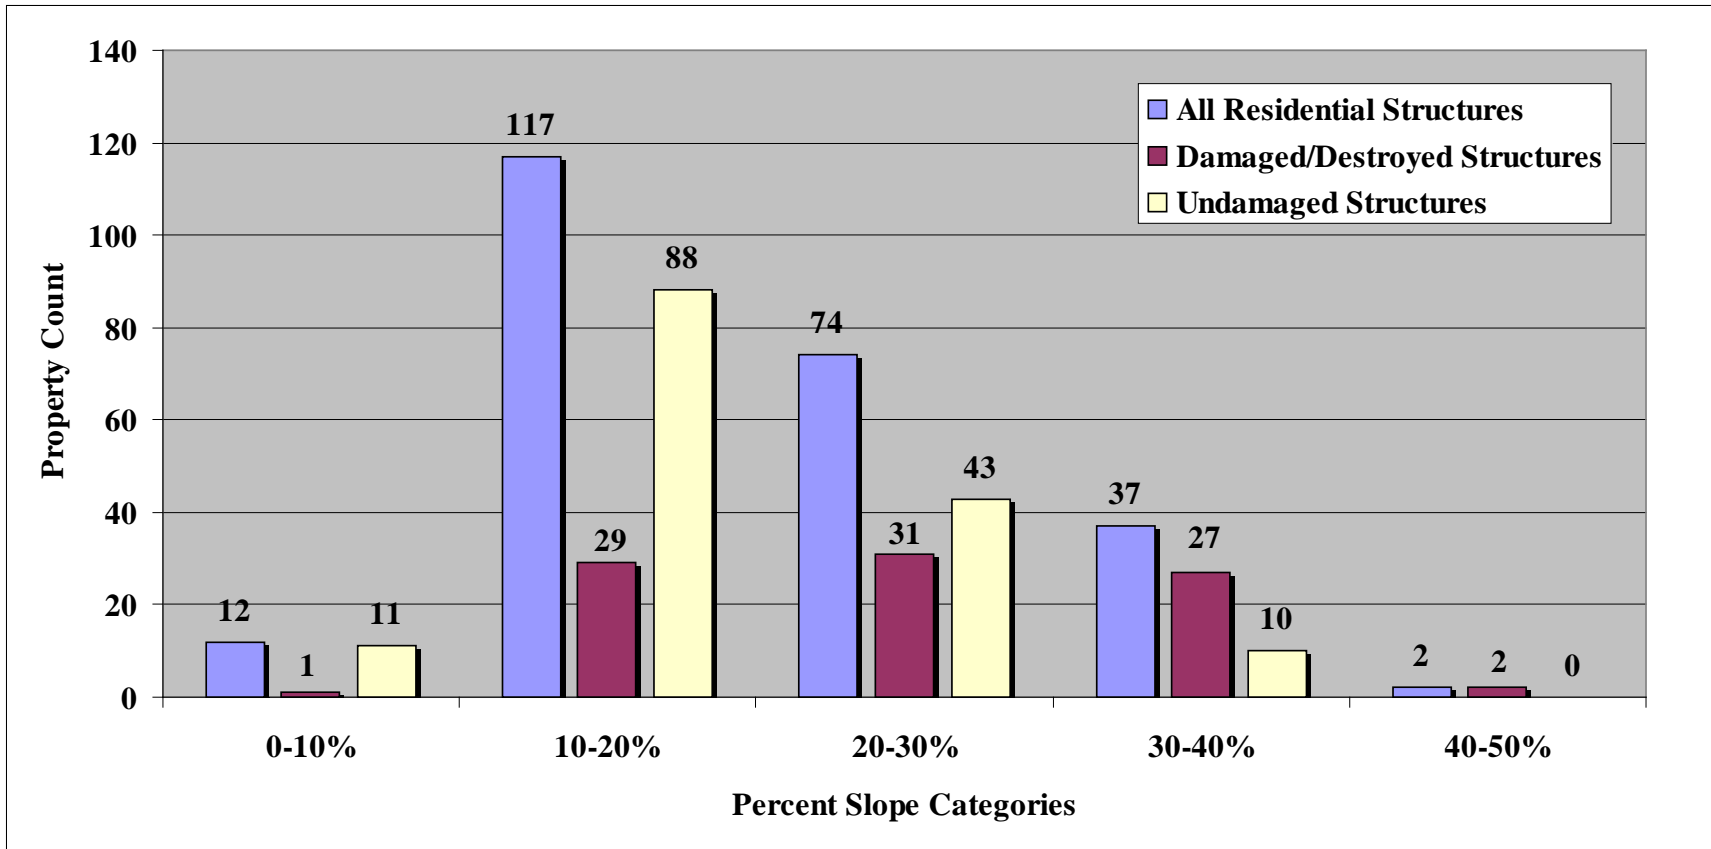
Figure 21 Frequency counts of properties by bins of average percent slopes found on properties for all structures, undamaged structures and damaged/destroyed structures.

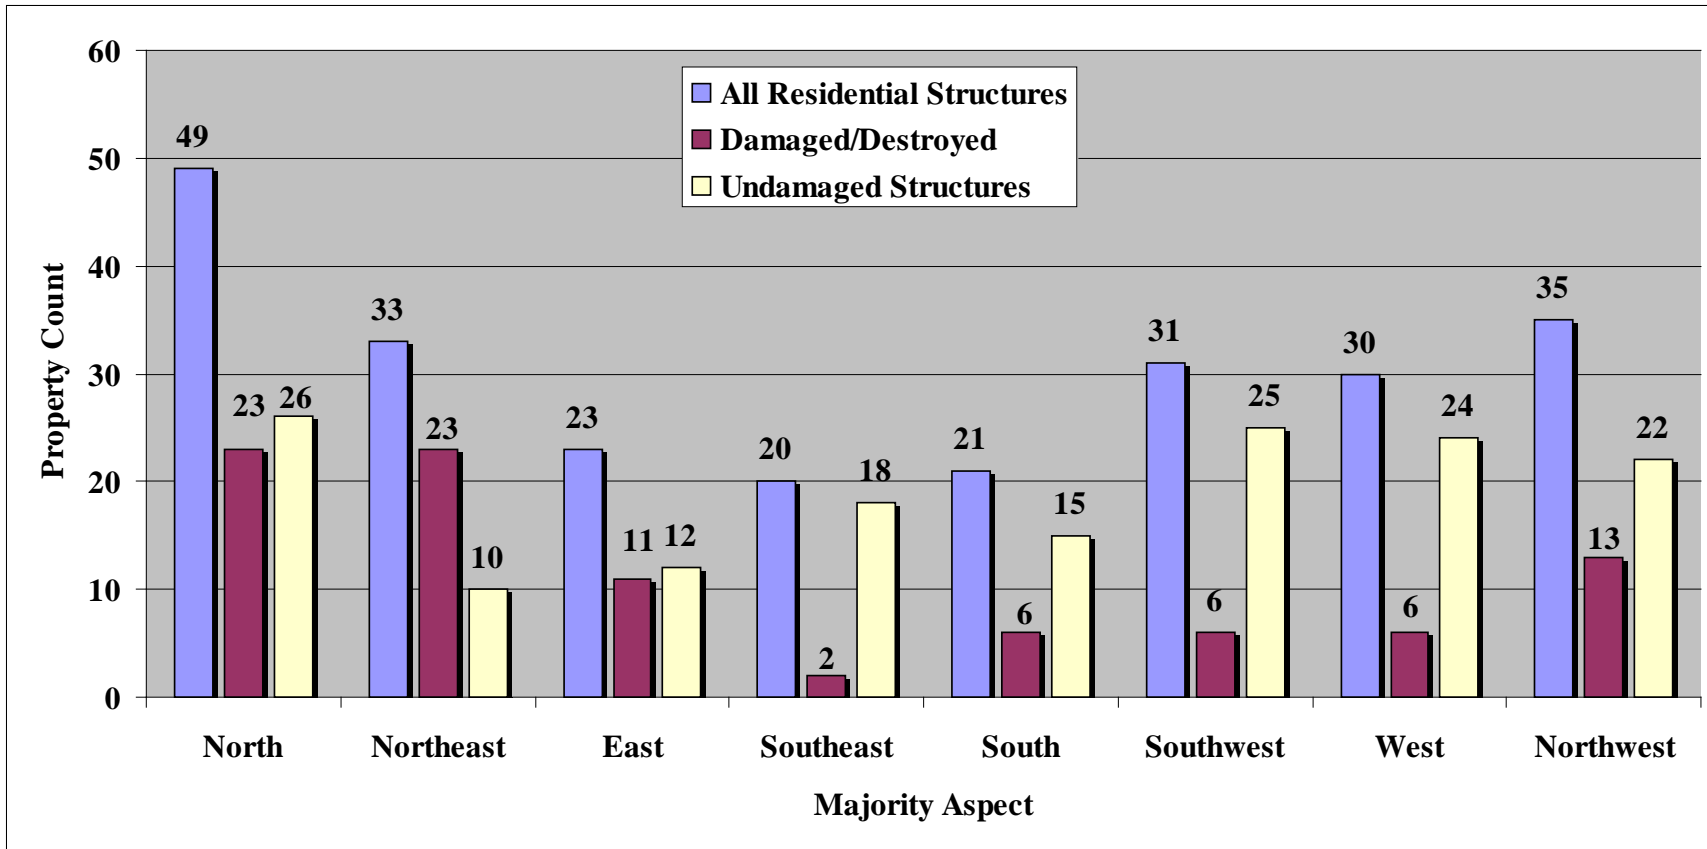
Figure 22 Frequency counts of properties by bins of the majority of aspects found on properties for all structures, undamaged structures and damaged/destroyed structures.

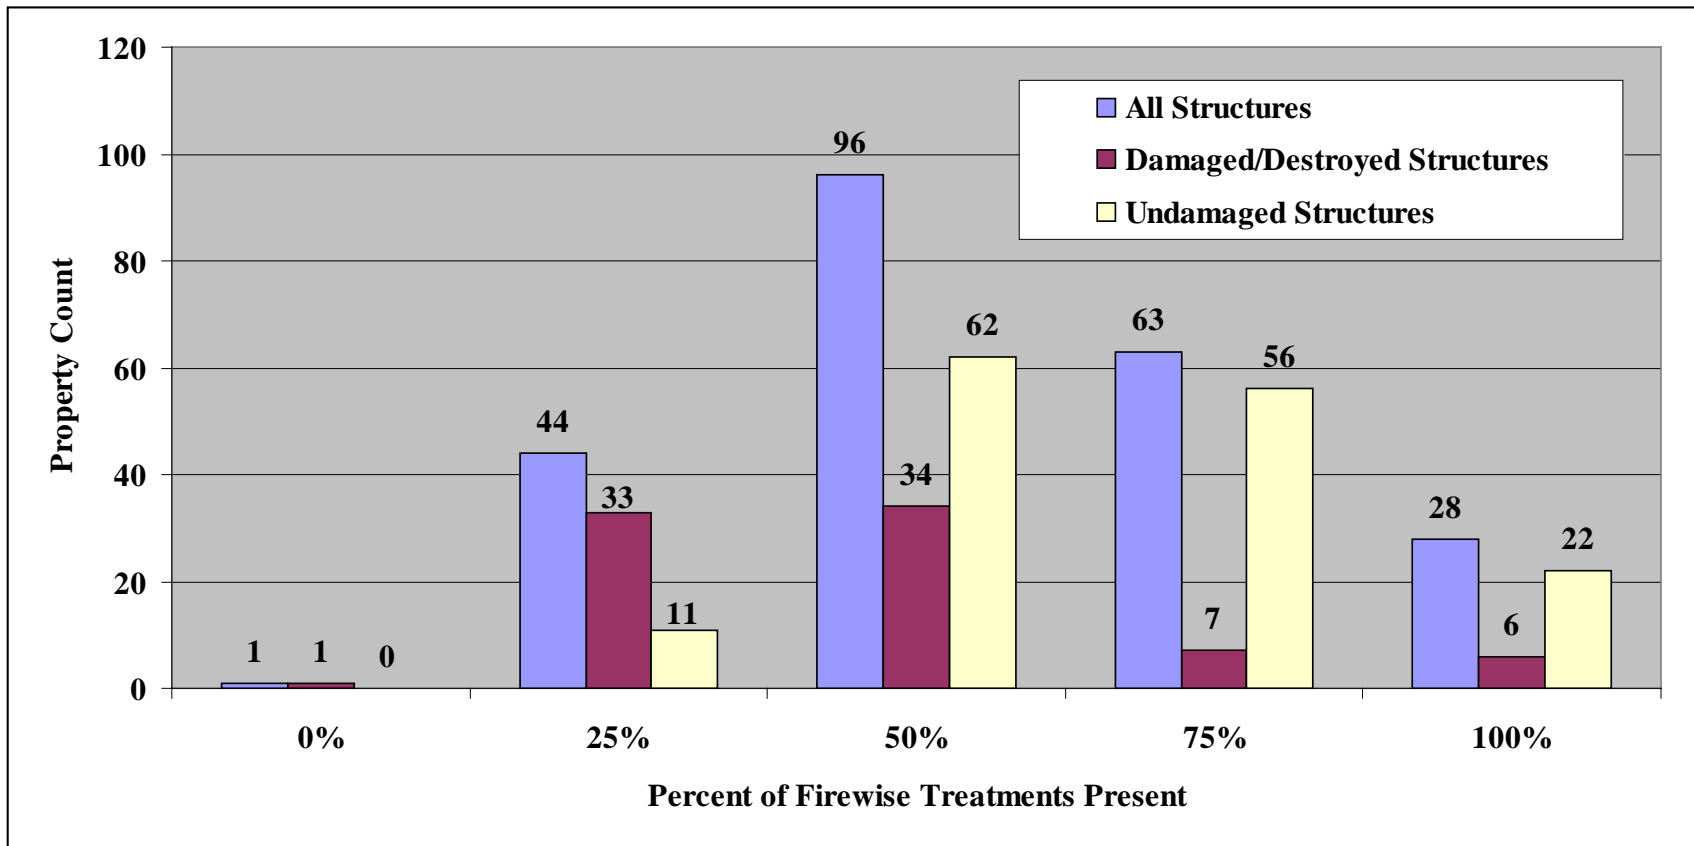
Figure 23 Frequency counts of properties by bins of percent of Firewise Treatments present on property for all structures, undamaged structures and damaged/destroyed structures where the presence of treatments on the property could be determined for greater than 50% of the Firewise Treatments assessed.
