A Restoration Management Plan for North Beach Park

Luke McGuff

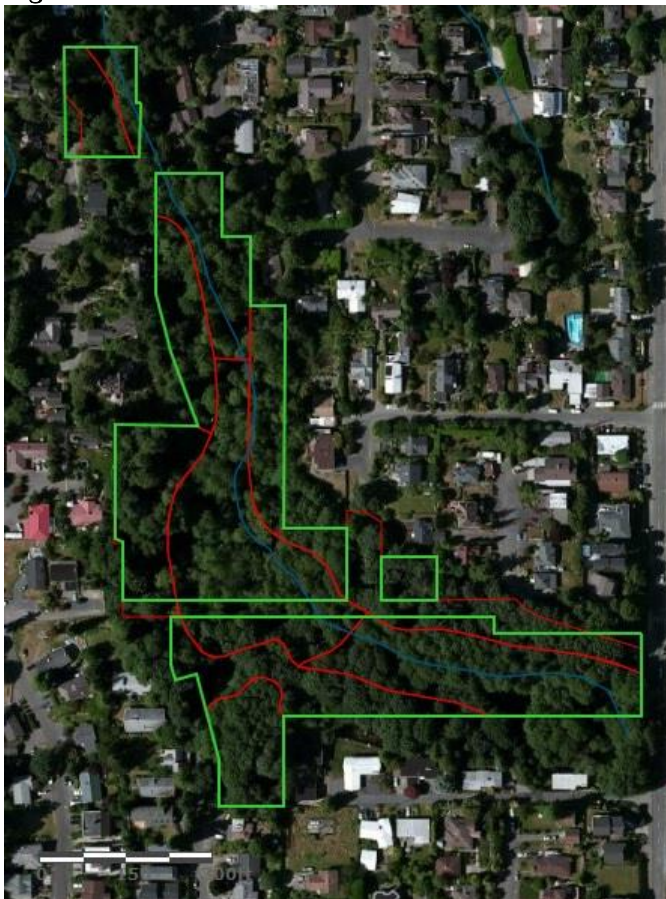
Figure 2: North Beach Park.

North is to the top. Park boundaries are green, HMU boundaries are red. The stream is a blue line. Entrance to the park is at the lower right. The section of the park at the top left corner of this map is inaccessible without trespass and won't be discussed in detail in this document. (Map from Green Seattle Partnership ArcGIS Reference Map.)

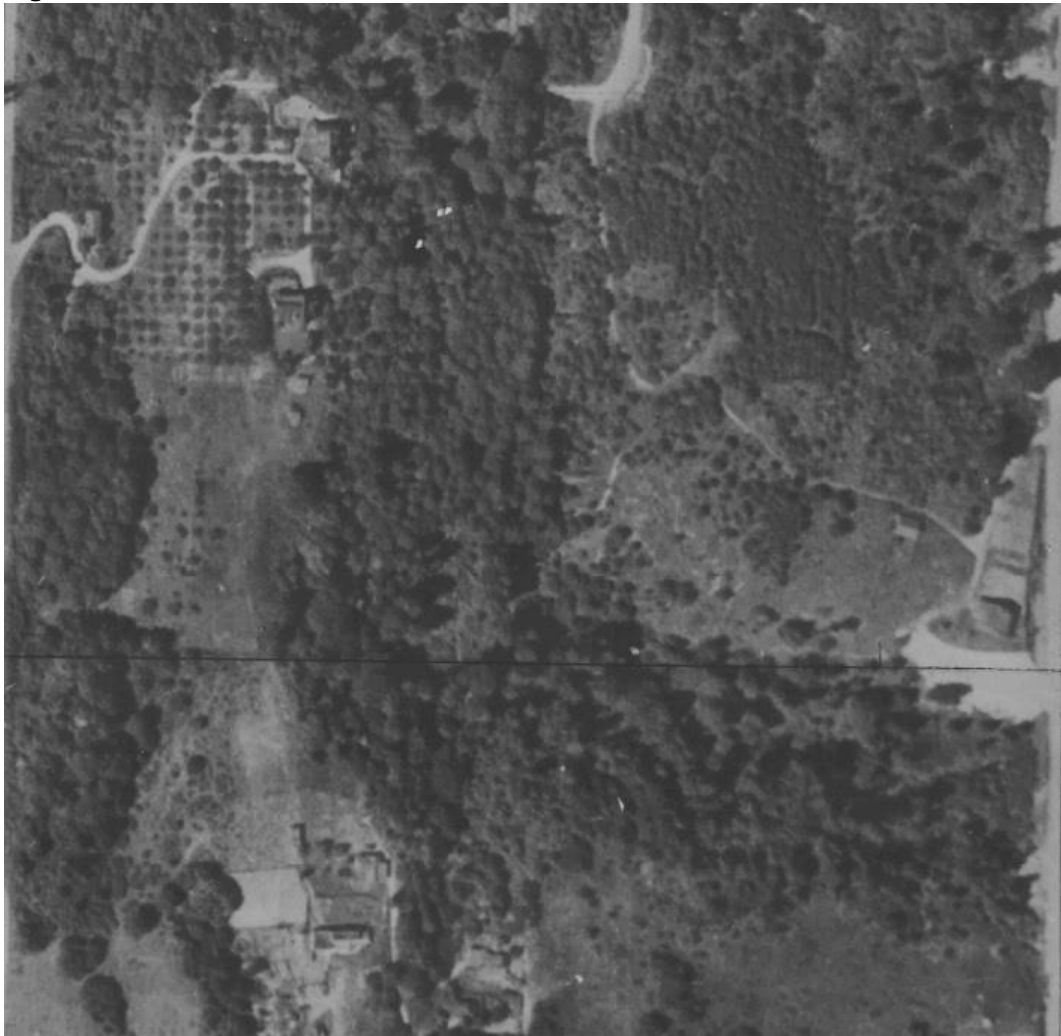
Figure 2: North Beach ravine in 1936.

North Beach Ravine is in the center of this picture. Fletcher's Orchard, now Fletcher's Village, is at the top left of the picture. Note gap, center of picture, in what is now the Central Valley, and gappiness in what is now the Headwaters Bowl. (Source: King County Road Services Map Vault, #33486.)

The aerial photo from 1936, Figure 2 above, shows the area that will become North Beach Park. The gap in the center today has large, old *Alnus Rubra* (Red alder) and a dense *Rubus spectabilis* cover. This is an indication of logging or other disturbance (Apostol, 2006). Evidence of disturbance also exists in the number of large cedar stumps that are now nurse logs in the stream.

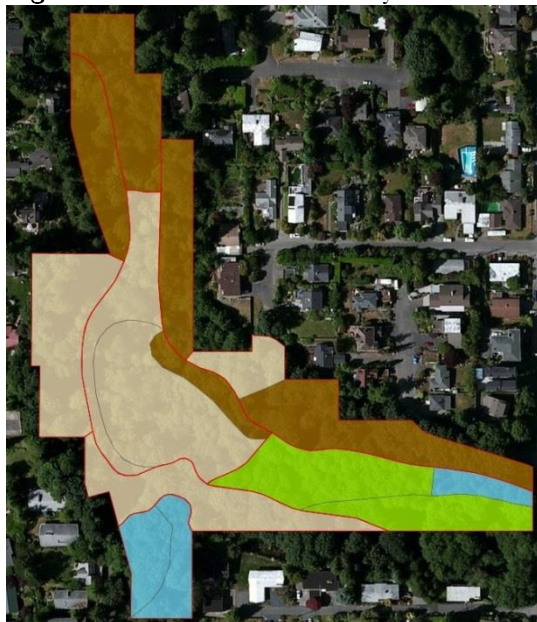
Figure 4: North Beach Park by restoration phase.

Beige areas are not yet in active restoration. Phase 1 (invasive removal) is brown. Phase 2 (planting) is green. Phase 3 (establishment) is blue. Phase 4 would be dark green.

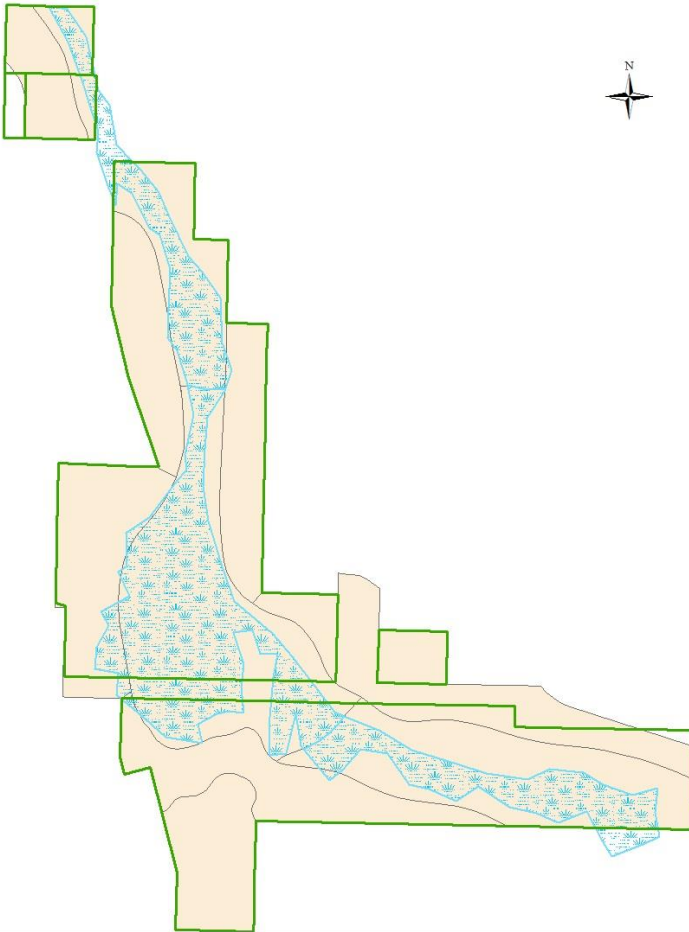
Figure 1: Wetlands in North Beach Park

Thick green lines indicate park boundaries. Light grey lines indicate HMU boundaries. The filled blue area are the wetlands. Wetland delineation by Doug Gresham of Gresham Environmental (2012). (Map by the author.)

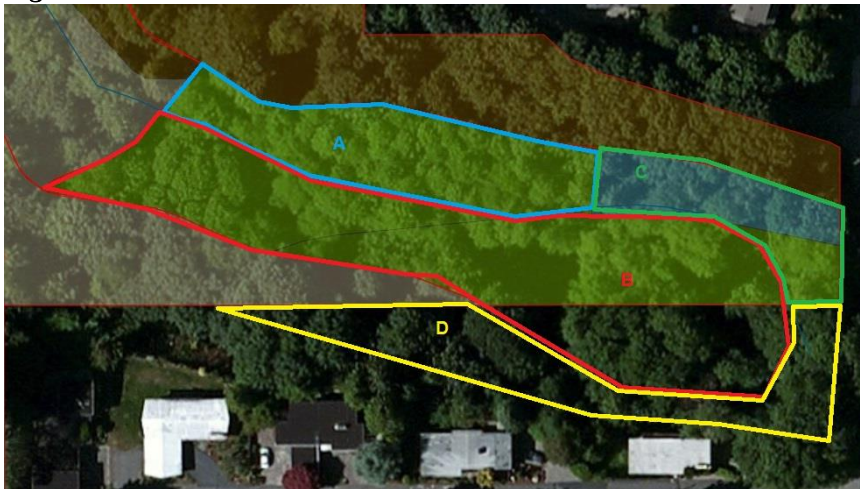
Figure 4: Headwaters Bowl and subareas

A: All volunteers can work here. B: Forest stewards and experienced volunteers. C: Parks District Natural Area Crew (slope). D: Privately contracted crew (slope, private property).

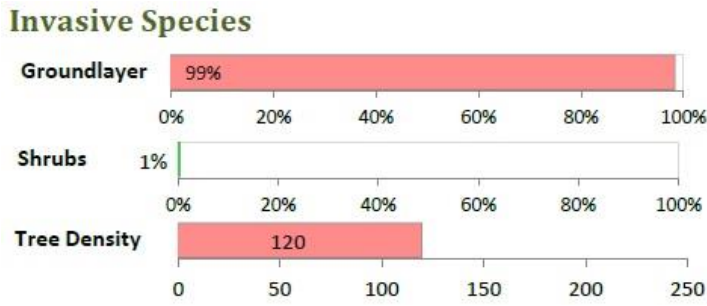
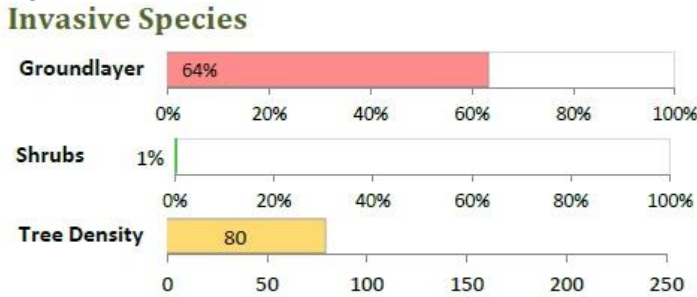
Figure 8: 2011 invasive cover in Central Valley forest monitoring plot

Figure 9: 2012 invasive cover in Central Valley forest monitoring plot

Key: Groundlayer and shrub percentages are for percent cover. Tree density is trees per acre. Red bar indicates immediate attention needed; light orange bar means attention needed soon. Source: EarthCorps, 2011 and 2012.

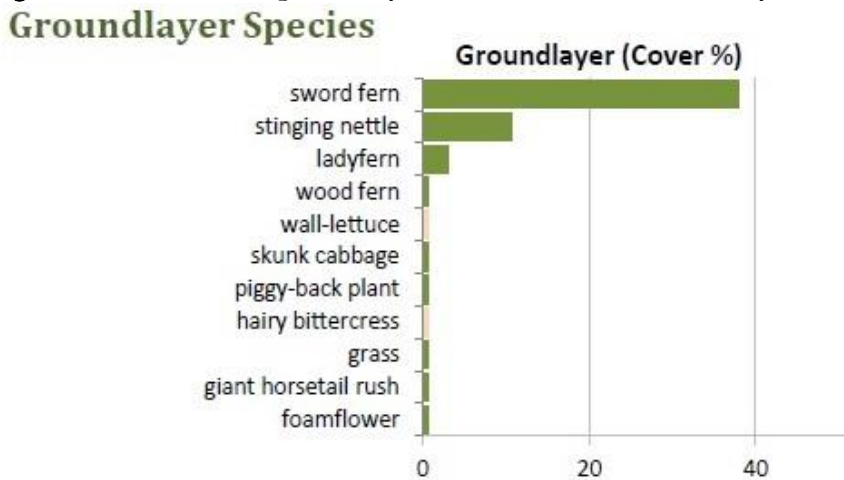
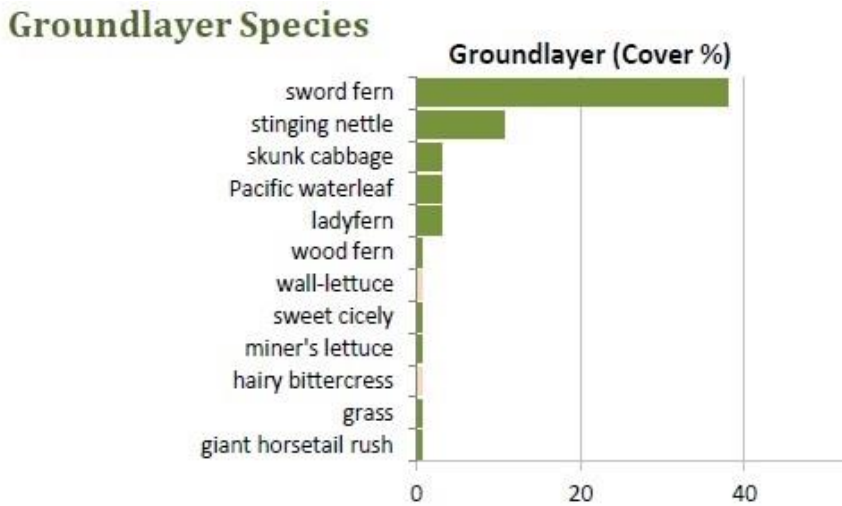
Figure 10: 2011 native groundlayer cover in the Central Valley forest monitoring plot.

Figure 11: 2012 native groundlayer cover in the Central Valley forest monitoring plot.

Figures 10 and 11 below compare native groundlayer change between 2011 and 2012. Note in particular the return of *Hydrophyllum tenuipes* (Pacific water leaf) and *Lysichiton americanum* (skunk cabbage) both of which returned from the seed bank.

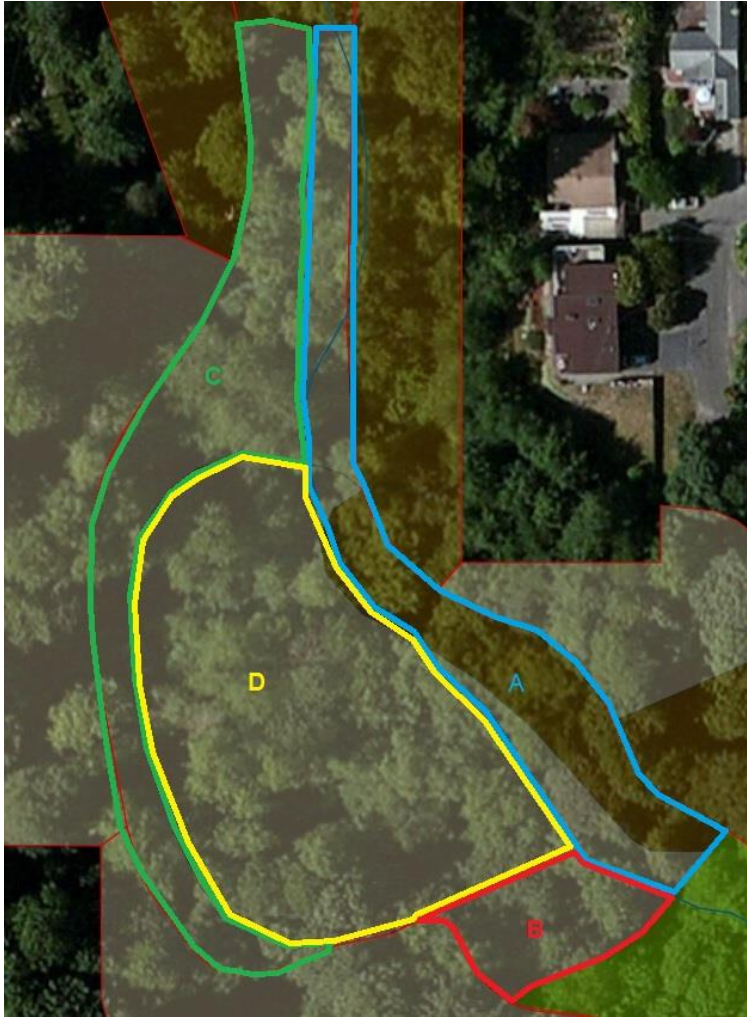
Figure 13: Sub areas of the Central Valley.

North is to the top. A: All volunteers can work here. B: Forest stewards and experienced volunteers. C: Parks District Natural Area Crew (slope). D: Forest stewards and experienced volunteers.

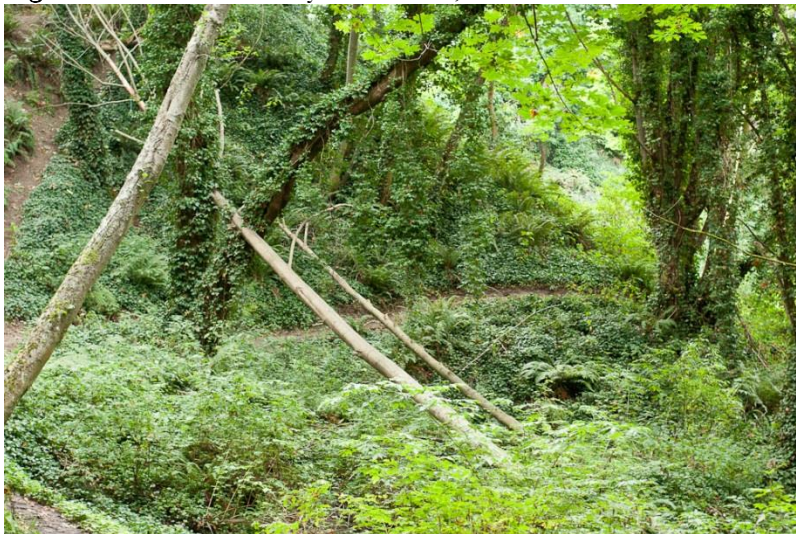
Figure 14: Central Valley subarea B, 2011.

There is a large conifer nurse log (obscured in the photo above) lying across the seep that provides some stability. *Tsuga heterophylla* (Hemlock) trees have been planted into the nurse log and are doing well.

Hedera helix (English ivy) grows down from the slope, under the trail, and then over the seep. The ivy is not firmly rooted in the seep and provides little or no stability or erosion control. However, clearing the ivy would destabilize the sides of the seep and disrupt the trail.

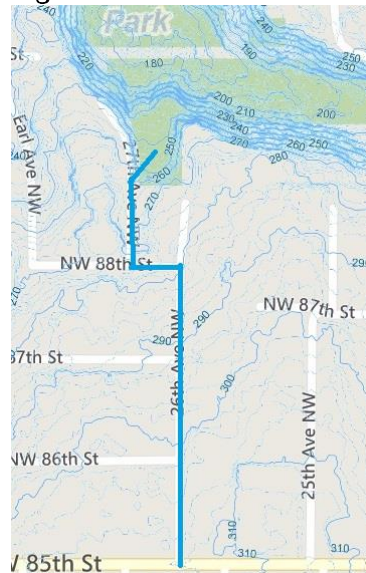
Figure 1: Path of water flow into the South Plateau

Blue line indicates path of water, which flows toward the top of the map, from 85th St. to the South Plateau. (Source: Seattle Department of Public Development DPDGIS map.)

Before clearing, the dense ivy and blackberry cover dissipated a lot of the energy of this water flow, spreading it out over the surface of the plateau. However, invasive removal caused a serious erosion problem was caused.

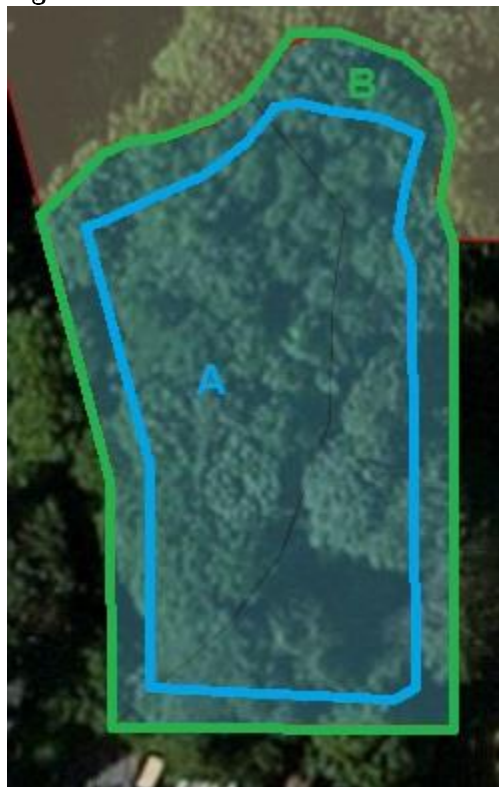
Figure 3: South Plateau

South Plateau: A: Accessible to volunteers. B: Contract or Natural Area Crew. (Source: GSP Reference Map on ArcGIS.com)

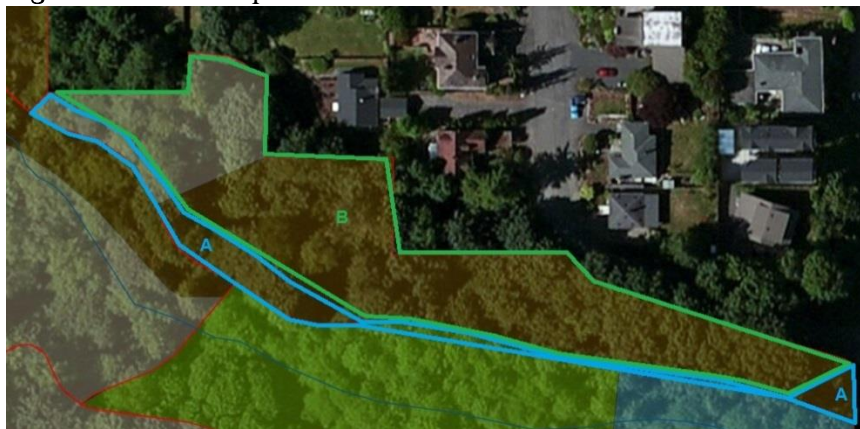
Figure 5: North Slope

A: Trailside, less-steep area accessible to volunteers. B: Steeper, needs work by contract crew.

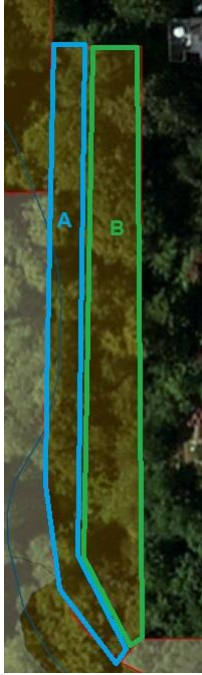
Figure 6: 91st St. Slope

A: Accessible to volunteers. B: Contract Crew.
