**QUATERNARY GEOLOGIC MAP OF THE POOLE
7.5-MINUTE QUADRANGLE, WESTERN KENTUCKY**
By Michael L. Murphy
2007

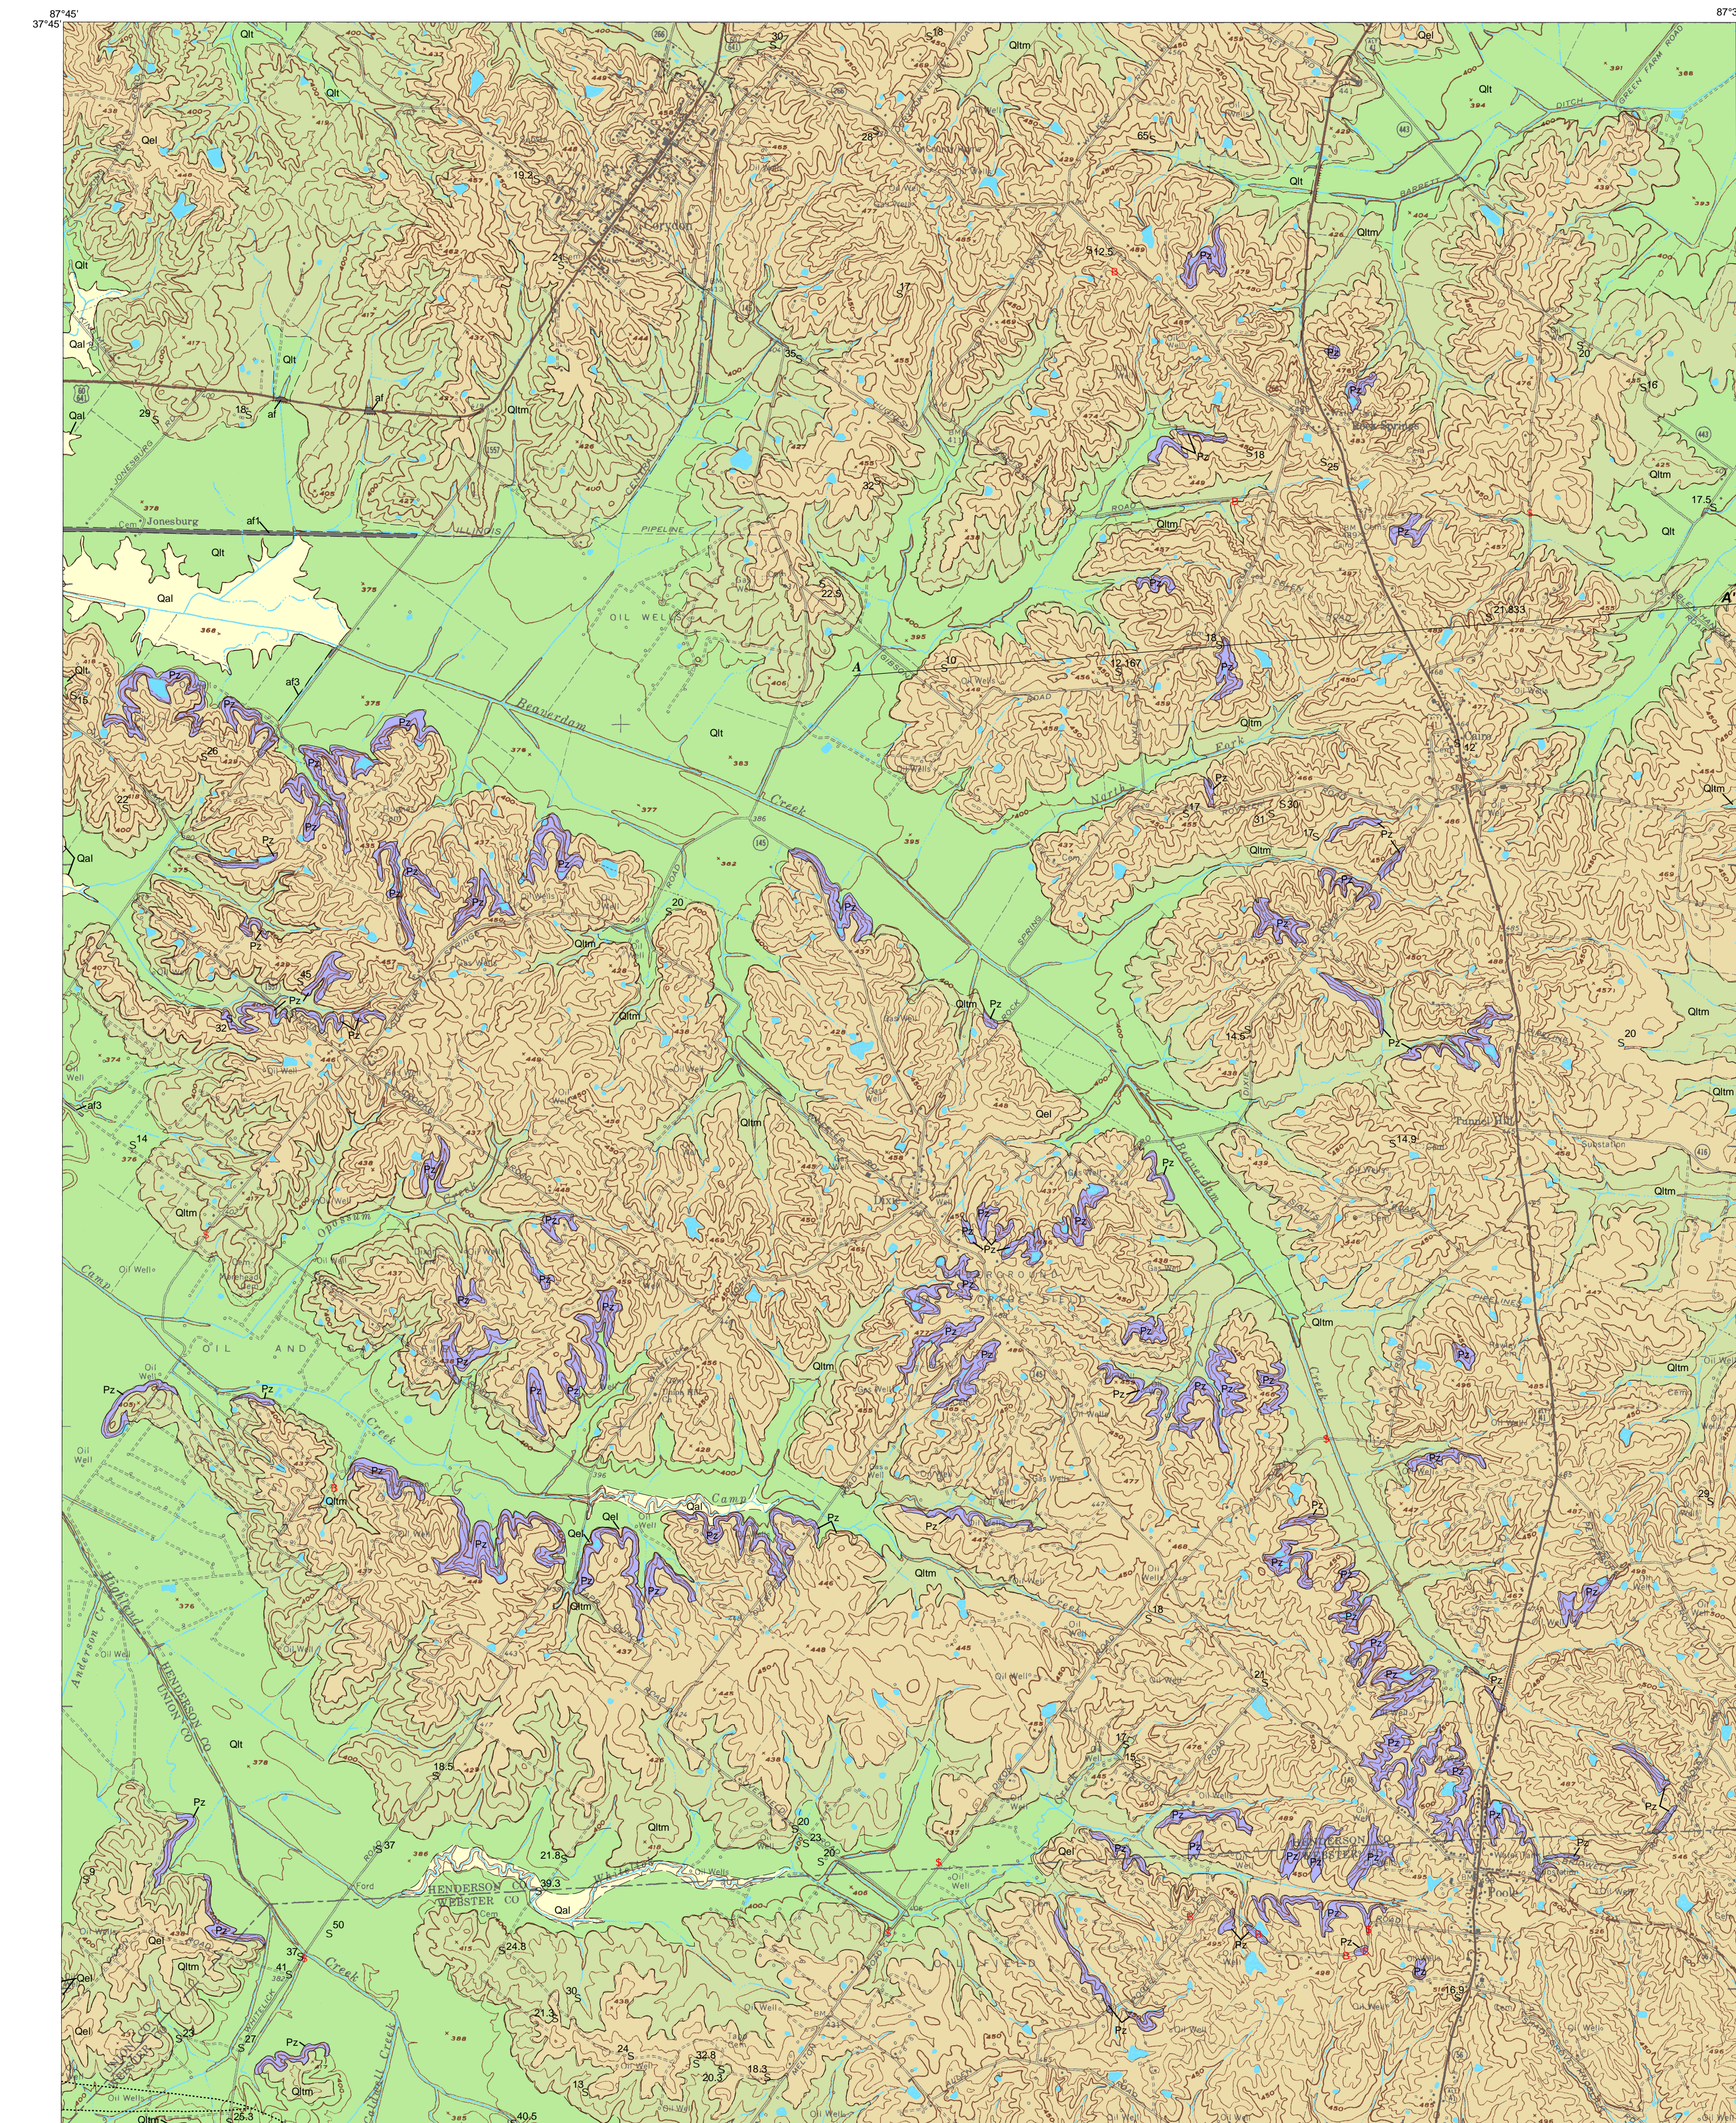
The regional project area is located in the lower Ohio River Valley, and includes the confluence of the Green River with the Ohio River. The landscape of the map area is characterized by low-relief bedrock uplands separated by broad alluvial valleys. Although the area is south of the Pleistocene glacial limit, the Ohio River served as a major outlet for glacial meltwater and entrained sediment during glacial stages. Rapid accumulation of glacial outwash in the main Ohio River Valley and along the mouths of tributaries led to impoundment and extensive deposition of slackwater and lacustrine sediment in the tributary valleys. This lacustrine deposit has a complex and gradational transition with loess mantling adjacent uplands. The loess was primarily derived from the valley-bottom outwash. The uplands are underlain by Pennsylvanian relatively flat-lying, coal-bearing strata.

The Quaternary deposits identified in the map area exhibit a wide range of grain size and geotechnical behaviors. Grain size distribution is one of the primary factors affecting the behavior of soils for geotechnical, hydrogeologic, and agricultural applications. The grain size distribution of unconsolidated sediments is dominantly controlled by the conditions under which the material was deposited. Low energy environments allow the deposition of fine-grained materials. High energy deposits limit deposition to only coarser grained materials. Eolian processes produce very well sorted (poorly graded) materials. Fluvial processes produce moderate sorting; colluvial processes produce poorly sorted deposits.

QGS database, number indicate depth to bedrock in feet
S Landform observation and soil probe
B Landform observation

Flooding is a nearly annual occurrence along the Ohio River. Floods in the late winter or early spring commonly inundate low-lying areas in the floodplain. Larger floods occur roughly every 10 to 20 years (eg. 1913, 1945, 1964, 1997), and cover parts of the low terraces. The maximum flood of record in the valley was in 1937, flooding river towns throughout the valley. Only structures on the highest outwash terraces and the lacustrine terrace (Qit) were spared flood damage. The impact of flooding is reflected in land-use patterns through the area. Older homes and businesses have survived on the lacustrine and high outwash terraces, and on the highest parts of low terraces (Qot1, Qot1a, Qot1g). Trailers and less expensively built homes are constructed on the low terraces. Only barns are found on the high parts of the floodplains (Qalfp). The floodplain and low parts of the low terraces are dominantly left to woodlands or used for row-crop agriculture. Most livestock husbandry in the alluvial valleys has been abandoned and is now restricted to upland areas above the 10- to 20-year flood zone. The low-relief lacustrine terrace is locally very poorly drained.

The map area is proximal to the Wabash Valley Seismic Zone and the New Madrid Seismic Zone. Small earthquakes have been felt in the area relatively frequently. The significant thicknesses of unconsolidated sediment (locally as much as 140 feet in the regional map area) raise concerns about ground motion amplification of seismic waves and potential liquefaction. The variations in lithology and thickness between materials in different map units will likely cause different responses of these materials to seismic shaking.
