Large Landscape Water Conservation Grant Program Completed Project List

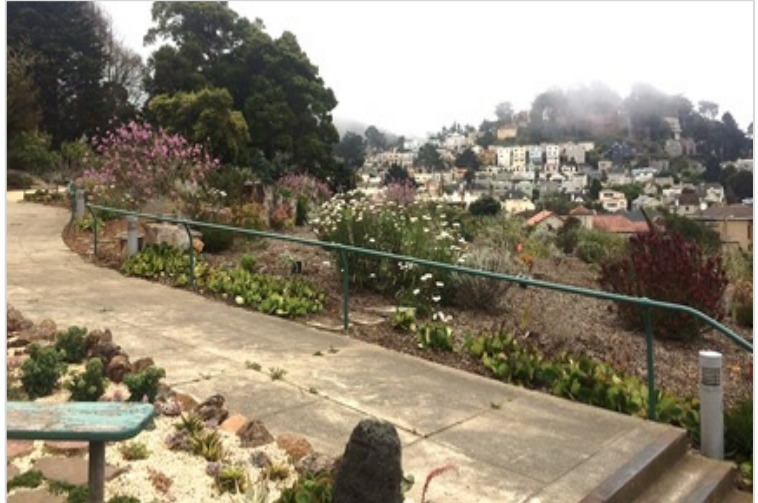
Laguna Honda Hospital

The project replaced turf on the upper hillside of its entryway with California natives and low- water use plant species. In addition to plantings, the irrigation system upgrades included the replacement of high-flow rotors with a more water efficient drip irrigation system. The new landscape includes low-water use groundcovers, shrubs, and trees in a terraced design to help mitigate runoff. ADA pathways were also added for patient use. The project was completed mostly by in-house gardening staff.

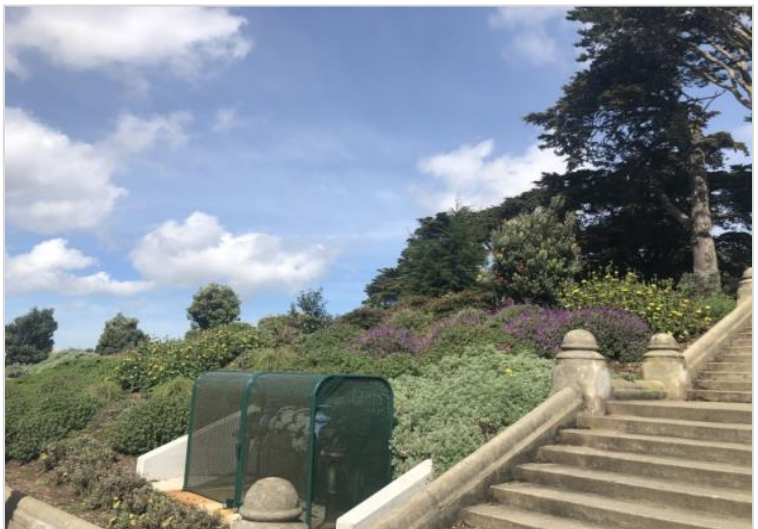
The Alamo Square Park landscape and irrigation system retrofit project replaced irrigation mainlines that were more than 40 years old, removed multiple acres of high water use turf and replaced it with native San Francisco and California trees, shrubs, and plants. Additionally, turf replaced on sloped areas along the eastern, north, and western perimeters was replaced with "no-mow" turf. The new irrigation system utilizes a new mainline and lateral piping with appropriate sprinkler spacing and heads, and a weather-based irrigation controller. The park also secured bond funding separate from the SFPUC grant to install a unisex restroom structure adjacent to the children's playground. More details on the park renovation can be found here: <https://sfrecpark.org/project/alamo-square-water-conservation-2012-bond>.

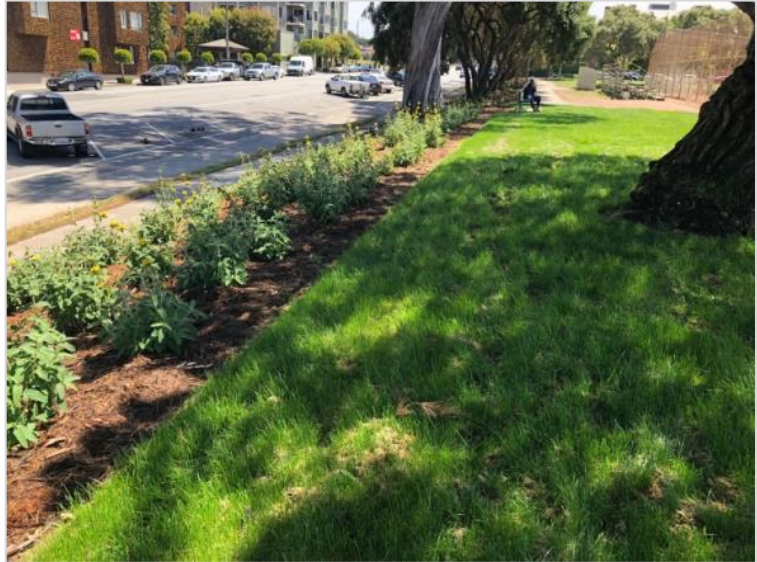
Moscone Playground

The recreation center ball fields at Moscone Recreation Center underwent main line and coupling system replacements; deeply buried irrigation control valves and heads have been replaced to improve sprinkler head-to-head coverage. Landscape improvements include removing portions of turfgrass and replacing the areas with decomposed granite and mulch along with planting street trees in areas where strips of turfgrass have been removed.

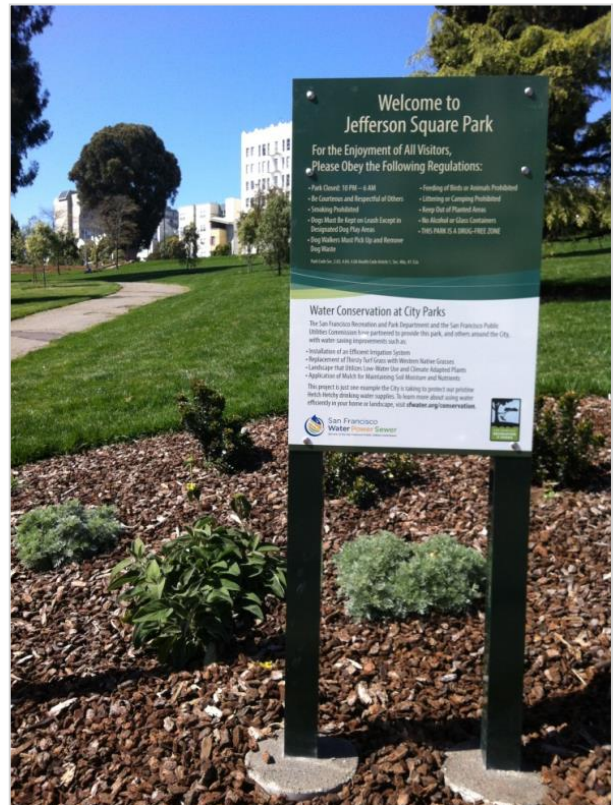
Jefferson Square Park

The project improvements covered by the SFPUC grant included the installation of new irrigation equipment, including a smart controller, flow sensor and master valve. Landscaping improvements included a 30 percent removal of turf, replaced with "no-mow" grass and low water-use shrubs. The total existing irrigation system was replaced to include new irrigation lines and redesigned sprinkler heads for uniform coverage.
