**Alaska - Pacific
River Forecast Center
6930 Sand Lake Road
Anchorage, Alaska 99502-1845
<http://aprfc.arh.noaa.gov>**

**Wind, Rain, Flooding Event across South Central Alaska
October 8-12, 2006**

Prepared by Anchorage Weather Forecast Office and River Forecast Center Staff

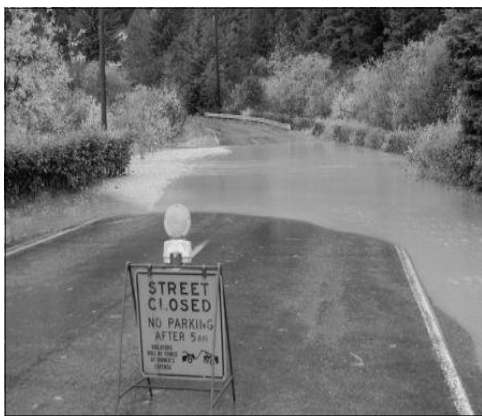
Heavy October rains caused flooding in the city of Seward
Photo courtesy of local resident

Gauged streams in the Seward area crested 1.3 to 2.4 feet above flood stage in the afternoon of October 9th. Eyak River in Cordova crested 3.5 feet above flood stage during the afternoon of October 10th. Significant road damage was incurred on the Richardson Highway south of Tonsina. Other areas affected by the event were mountainous areas of southwest Alaska, and the Susitna River valley.

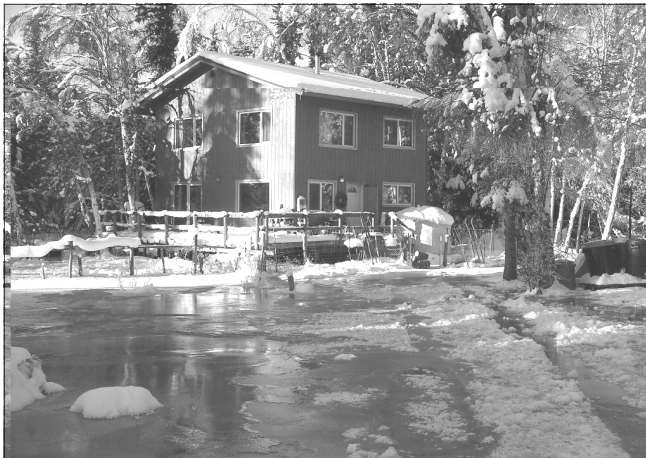
Overflow from Goldstream Creek surrounds a cabin near Fairbanks back in February
Photo taken by Ed Plumb

The cold and dry conditions resulted in considerable overflow icing of creeks and rivers during the winter. There were several reports of overflow inundating private property and causing groundwater levels to rise and dampen some home owners' crawl spaces. The excessive overflow ice has also kept the Department of Transportation busy trying to keep culverts thawed out and water from flowing over roadways. The abundance and thickness of ice on creeks and rivers does have some residents concerned that there may be a higher risk of ice jams during breakup. Fortunately the amount of water in the snowpack is low this year and the amount of runoff into the river systems will be much lower than normal.

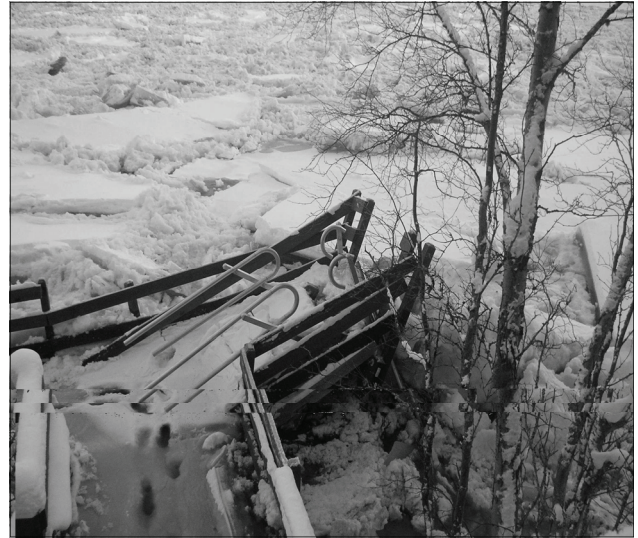
Damaged stairway at the Kenai River Center
Photo courtesy of Kenai Peninsula Borough

water level rise due to the release this winter was sufficient to break up the ice and cause ice jams. The peak water level at the Soldotna gage was 2.6 ft below the 1969 levels, but significant damage was still done to streamside structures such as fishing platforms, docks, and stairways. (The highest stage in 42 years of record at the Soldotna river gage was due to the release of Skilak glacier dammed lake in January of 1969, when the Kenai had an ice cover, and ice jams caused the high stages and significant damage.)

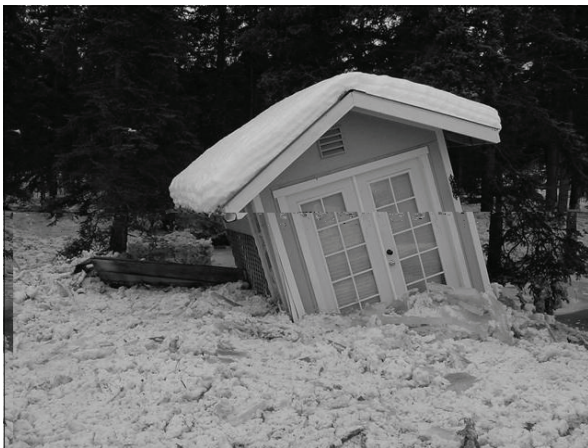
Damage to an outbuilding caused by the release of the Tazlina West glacier dammed lake
Photo courtesy of local resident

residents. The resulting ice breakup caused extensive flooding, with ice reportedly reaching nearly to the underside of the Richardson Highway bridge. Some homes along the river reported water up to the interior electric wall sockets. Besides inundation of an unknown number of homes, numerous cars, snow machines, and outbuildings were damaged or destroyed by ice. There

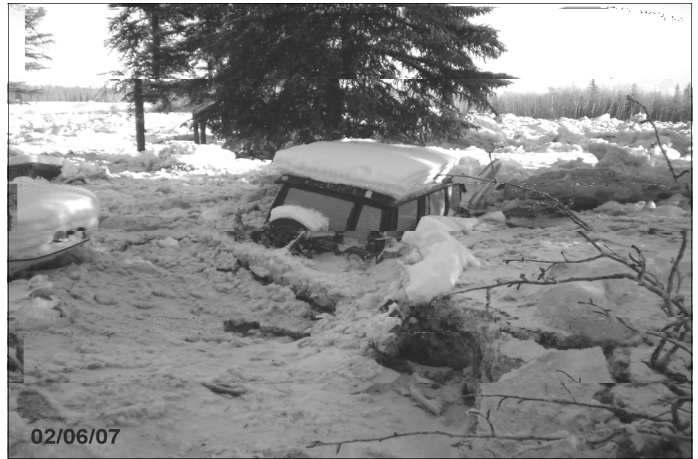
Car surrounded by ice following the release of Tazlina West glacier dammed lake
Photo courtesy of local resident

is insufficient information to know if the ice formed an ice jam downstream of the bridge or if the breakup front continued to move downstream at a rate that caused significant backwater behind the front, but the front moved far enough on Sunday that the river fell below flood stage by Sunday morning between 9:00 and 11:00. Significant amounts of river ice, with pieces up to 3-4 feet thick, remain in the formerly inundated areas.

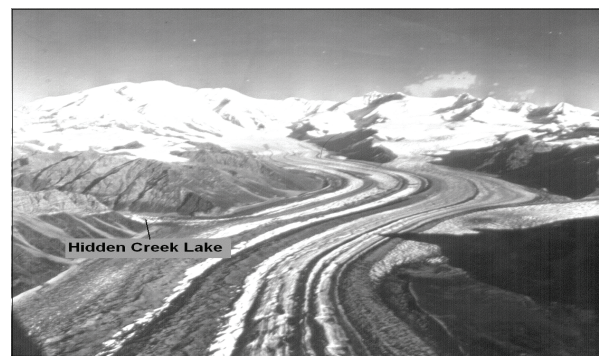
Hidden Creek glacier dammed lake
Photo courtesy of the US Geological Survey

We received a report from our Kennicott River observer that Hidden Creek glacier dammed lake released in late January. This is very unusual for this lake, which released in July of 2006 and regularly releases each summer in late June, July, or early August. Although this is unusual, winter surges of water that may have come from this lake have been documented. A 1971 report by Post and Mayo of the U.S. Geological Survey documented a winter release reported in 1911, as well as a release in March 1968. The 1911 report stated that "a torrent of water rushes down the Kennicott and Nizina Rivers, sometimes flooding the ice all the way to the Copper River." No damage was reported during this winter's event, but there was damage during the lake release last summer. It will be interesting to see if this lake refills in time for its normal summer release this summer.
