COLORADO HEALTHY RIVERS FUNDS PROJECTS

2021 TAX YEAR GRANT CYCLE
FINAL REPORT

Colorado Watershed Assembly

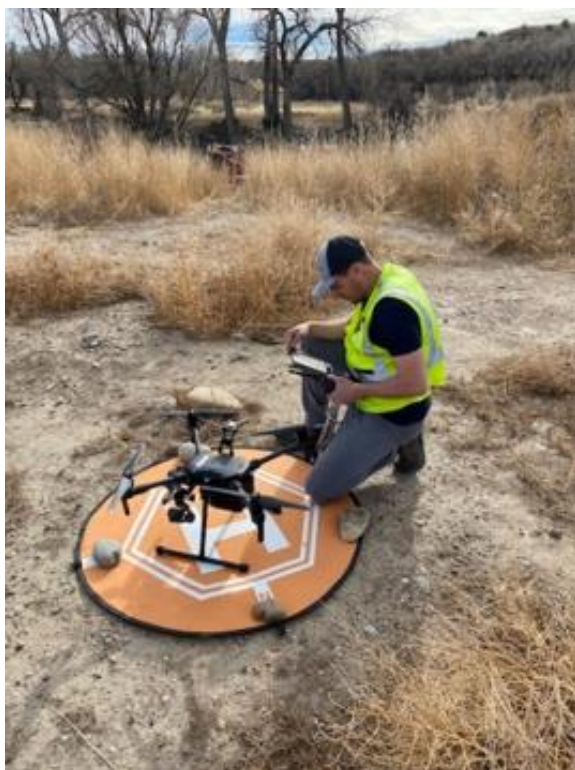
Figure 1 - Luke Javernick of River Science surveying and preparing drone.

Tasks 1 (Land Survey and Certified Elevations) and 2 (Aerial Imagery Acquisition) were scheduled to begin in mid-November as soon as most leaves were off woody vegetation and trees but was delayed two months as it took four months to obtain a Special Use Permit to fly the drone over Bureau of Reclamation property within the project area. Once the Special Use Permit was granted, access within the property was coordinated through Pueblo State Park and the initial surveying and aerial imagery acquisition (1300+ photos) were completed during the week of January 17, 2022.

The surveying and hydraulic modeling of the proposed sites were completed by River Science in late February 2022 and

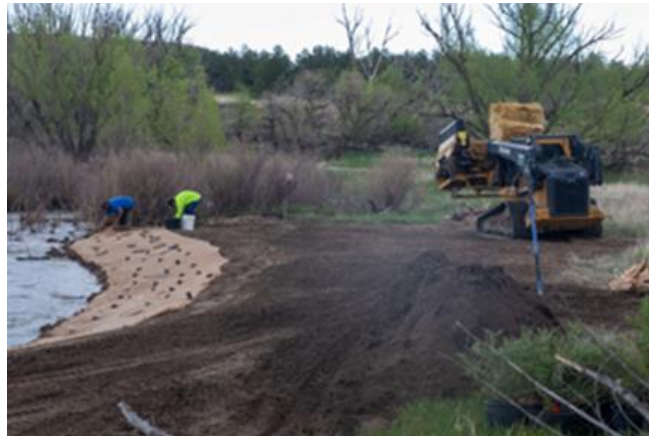
Figure 4 - East Plum Creek bank protections and seeding operation.

The entire grant has been used in restoration activities at East Plum Creek. The incised banks were laid back to a stable angle along a 250-foot stretch of creek corridor. They used a mini excavator and skid steer to pull back and regrade the steep banks and terraces. Various root wads and other woody debris were installed into the creek to create important habitats for invertebrate, fish, and amphibian species. The hummocks of endemic native vegetation were carefully removed along with the existing topsoil and stockpiled during the re-grading portion of the project. The native vegetation has been replanted on the recontoured banks at the stream's edge which will expedite the bank stabilization process.

About an acre of the regraded land was enhanced with compost and then a narrow zone reseeded with a diverse mix of native wetland and riparian plant species and the remaining land was seeded with an upland with a mix of over 25 native plant species. They planted over 2,300 native riparian and wetland plants and 125 upland native shrubs and mulched with wood chips to create desirable wildlife habitat with particular attention to the needs of the Preble's Jumping Mouse.

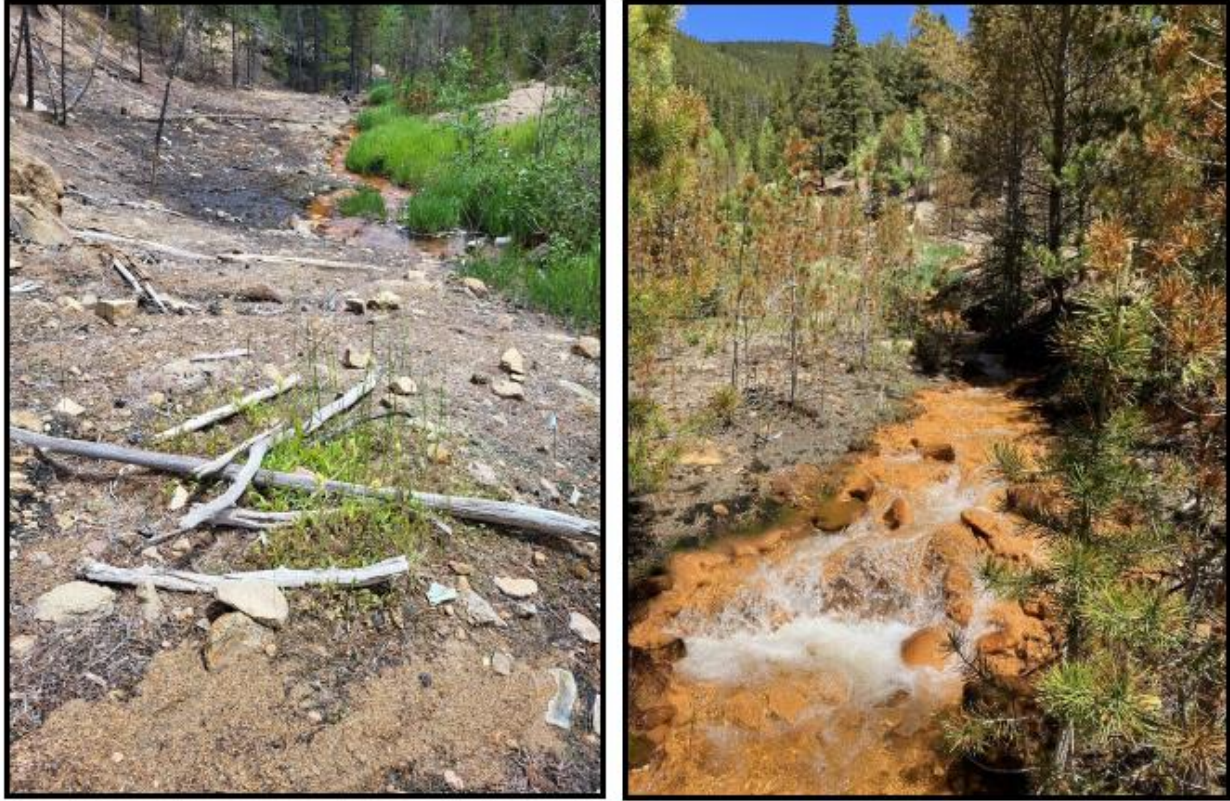
Figure 6 - Site conditions documented at Lion Creek in July/August 2022 (left) and June 2023 (right).

To initiate the design effort, TU, USFS, and WaterVation conducted a project kick-off meeting and site visit in July 2022 to discuss project needs in the field, a site assessment in August 2022 to collect data required to develop the 30% design plans, and review discussions following fieldwork to guide the engineering design approach. The site assessment fieldwork aimed to document existing conditions, evaluate the preferred stream realignment, and collect data required to prepare the 30% design plans.

The field team collected drone-based aerial imagery and, to support the drone topography, geomorphic survey data (e.g., channel cross sections, profile data, and channel pattern) using real-time kinematic (RTK) Global Navigation Satellite System (GNSS) survey equipment. The geomorphic survey data was used to quantify impairments within the project area, determine the potential for restoration, and develop a stream restoration design based on natural channel design criteria. The geomorphic assessment showed that Lion Creek is characterized by step-pool and cascade-pool features, with channel morphology influenced by a flood-dominated system that transports large debris. Natural stability is provided by large cobbles, some boulders, large wood, and densely vegetated floodplain areas. Several headcuts were also observed, which contribute to channel instability and sediment input in the drainage.

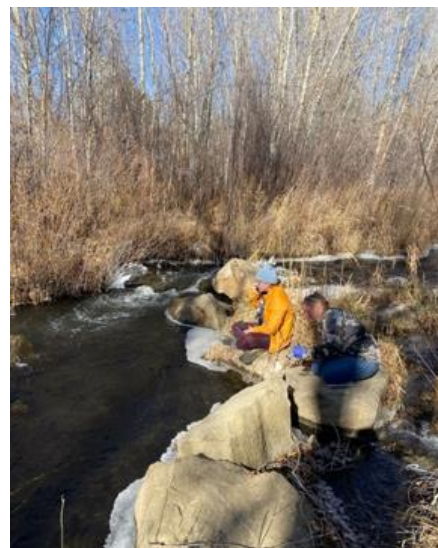
Figure 7 - MCD AmeriCorps VISTA Maggie Sandusky and MCD Watershed Coordinator Sensa Wolcott collecting eDNA samples on the Mancos River.

The Mancos Conservation District purchased a YSI Pro DSS Water Quality Meter and received the meter in November of 2022. MCD also purchased calibration solutions to ensure the meter is calibrated and produces accurate and reliable data. MCD staff collected two sets of data: one fall, low water sample collection and one spring, high water sample collection. The first round of sampling included eDNA samples and water quality measurements at 25 different sites in the Mancos Watershed over the course of two days. 10 of these sites were ponds throughout the watershed, selected in collaboration with Lilly Figueroa, a local high school student who partnered with MCD to analyze eDNA as part of her independent science fair project. The 10 pond site samples were analyzed for amphibian eDNA. 15 additional sites were collected on the Mancos River and its tributaries. These 15 river samples were analyzed for both fish and amphibian eDNA. Samples were sent to Jonah Ventures Lab for analysis. Due to high snowpack and extended runoff in the Mancos River, the second round of sampling occurred later than anticipated. MCD staff were able to sample 14 of the original 15 river sites. These 14 samples were sent to Jonah Ventures lab to be analyzed for fish eDNA.

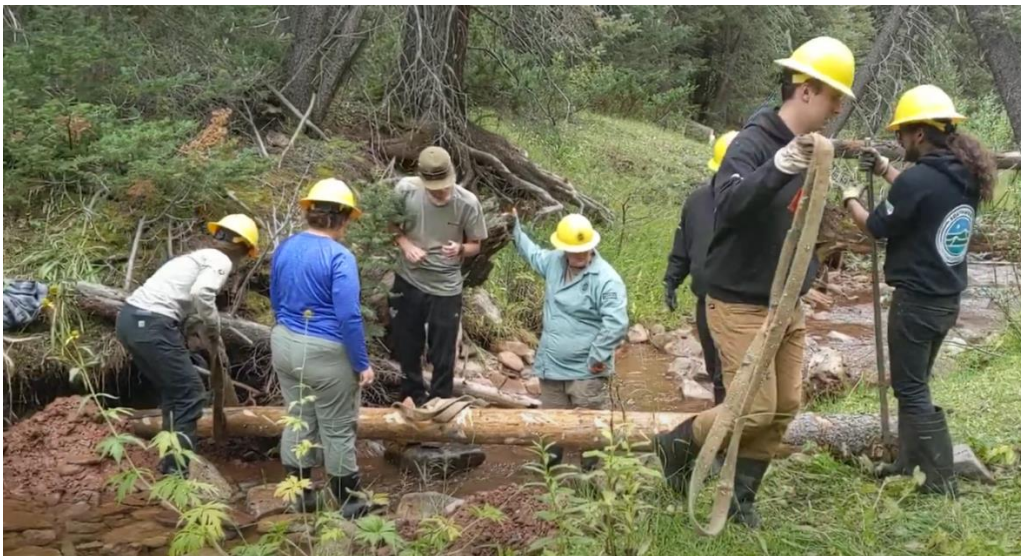
Figure 10 - Installation of the pour-over structures Wildcat Creek Stream-Enhancement Project.

Installing the pour-over structures involves five core steps:
