**Alaska - Pacific  
River Forecast Center  
6930 Sand Lake Road  
Anchorage, Alaska 99502-1845  
<http://aprfc.arh.noaa.gov>**

**Wind, Rain, Flooding Event across South Central Alaska  
October 8-12, 2006**

## Winter Glacier Dammed Lake Releases

### Spring Breakup Outlook for Alaska

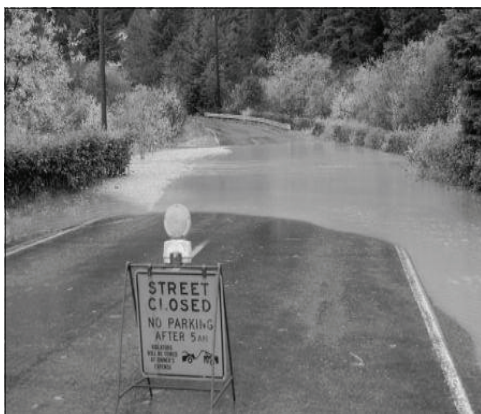
Heavy October rains caused flooding in the city of Seward  
Photo courtesy of local resident

Gauged streams in the Seward area crested 1.3 to 2.4 feet above flood stage in the afternoon of October 9<sup>th</sup>. Eyak River in Cordova crested 3.5 feet above flood stage during the afternoon of October 10<sup>th</sup>. Significant road damage was incurred on the Richardson Highway south of Tonsina. Other areas affected by the event were mountainous areas of southwest Alaska, and the Susitna River valley.

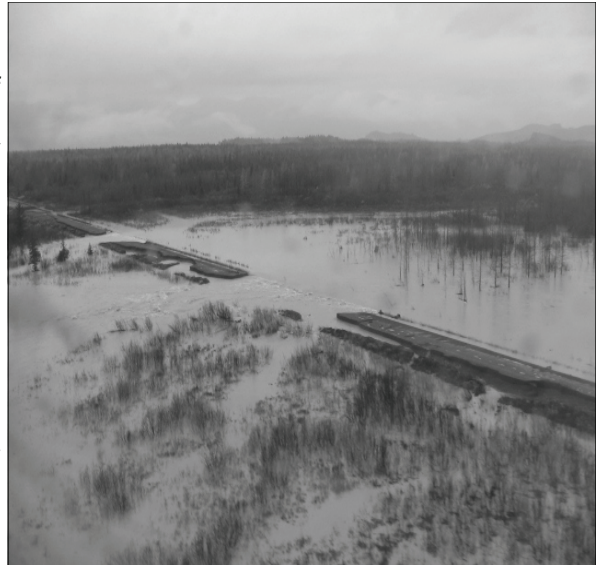
Copper River Hwy washouts near Sheridan River  
Photo courtesy of local resident

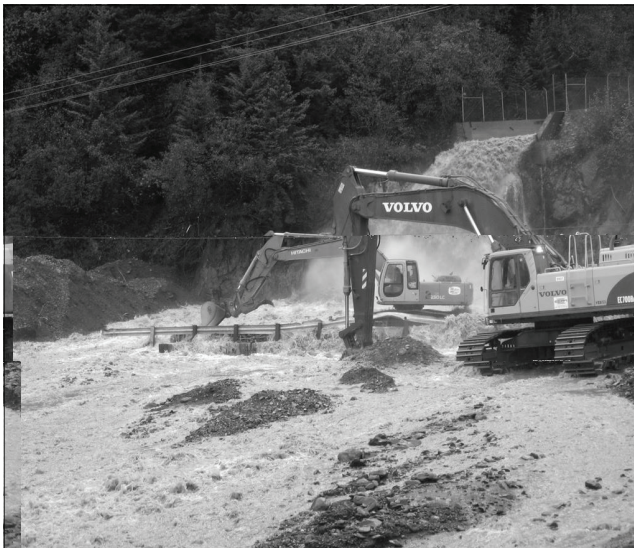
Lowell Point in Seward  
Photo courtesy of local resident

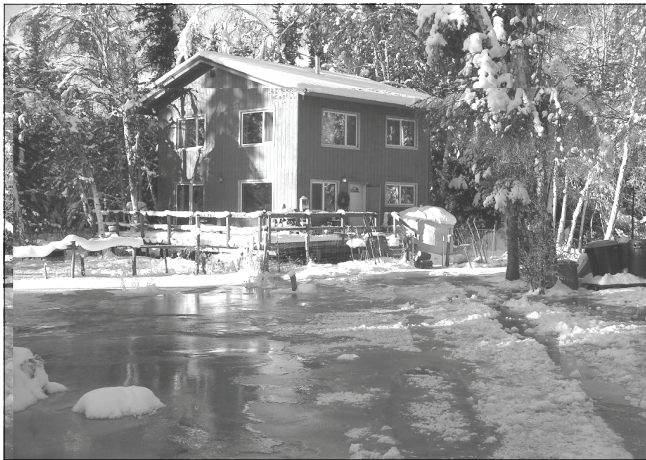
Overflow from Goldstream Creek surrounds a cabin near Fairbanks back in February  
Photo taken by Ed Plumb

The cold and dry conditions resulted in considerable overflow icing of creeks and rivers during the winter. There were several reports of overflow inundating private property and causing groundwater levels to rise and dampen some home owners' crawl spaces. The excessive overflow ice has also kept the Department of Transportation busy trying to keep culverts thawed out and water from flowing over roadways. The abundance and thickness of ice on creeks and rivers does have some residents concerned that there may be a higher risk of ice jams during breakup. Fortunately the amount of water in the snowpack is low this year and the amount of runoff into the river systems will be much lower than normal.

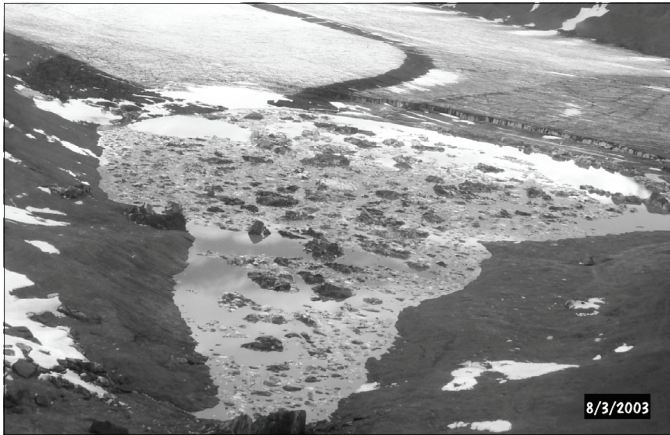
Skilak glacier dammed lake  
Photo courtesy of Lyman Nichols

The Skilak glacier dammed lake in the Kenai River basin was expected to release in the fall of 2006, since its previous release was in October of 2004 and the lake typically has a 2 to 3 year filling cycle. When it did not

release, we expected that it would release earlier than normal, but during open water season, in 2007. In open water conditions, the release of the Skilak glacier dammed lake typically causes a rise of several feet, but usually occurs in the fall when water levels are low, and thus is not a significant flood threat. In mid January an otherwise unexplained rise in river levels was indicated by the stream gages and was confirmed by river observers. The

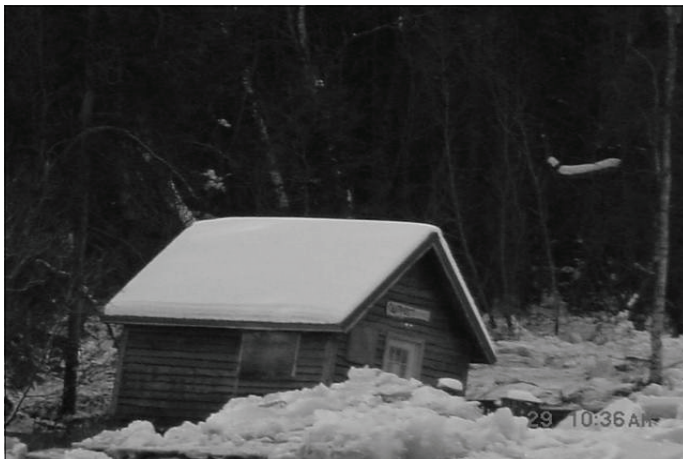
Damaged cabin on the Kenai River  
Photo courtesy of Kenai Peninsula Borough

water level rise due to the release this winter was sufficient to break up the ice and cause ice jams. The peak water level at the Soldotna gage was 2.6 ft below the 1969 levels, but significant damage was still done to streamside structures such as fishing platforms, docks, and stairways. (The highest stage in 42 years of record at the Soldotna river gage was due to the release of Skilak glacier dammed lake in January of 1969, when the Kenai had an ice cover, and ice jams caused the high stages and significant damage.)

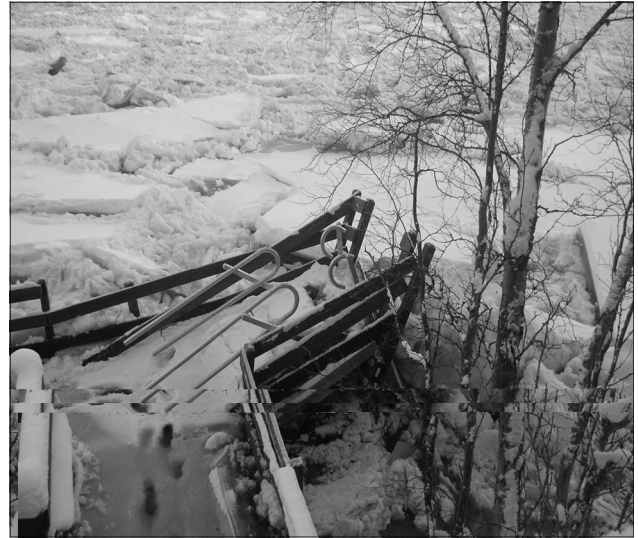
Damaged stairway at the Kenai River Center  
Photo courtesy of Kenai Peninsula Borough

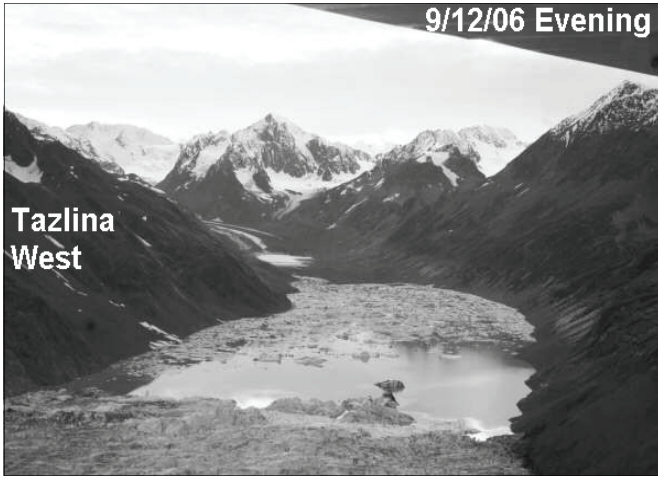
Tazlina West glacier dammed lake  
Photo courtesy of Joe Junker

Nelchina South Lake, dammed by the Nelchina Glacier, released during September of 2006. The other large lake, dammed by the Tazlina Glacier, is called Tazlina West or Tazlione Lake. This lake was reported to be pretty full in September, but did not release before

winter. This lake likely began to release in late January, but without an automated gage on the river, the initial rise in water level on the Tazlina River was not detected. Rising water levels went unnoticed until Saturday February 3<sup>rd</sup>, when the ice breakup front that was caused by the rising water level progressed downstream to the Richardson Highway bridge and residences in the vicinity of the bridge. Water levels were reported to have risen very fast Saturday night, frightening the local

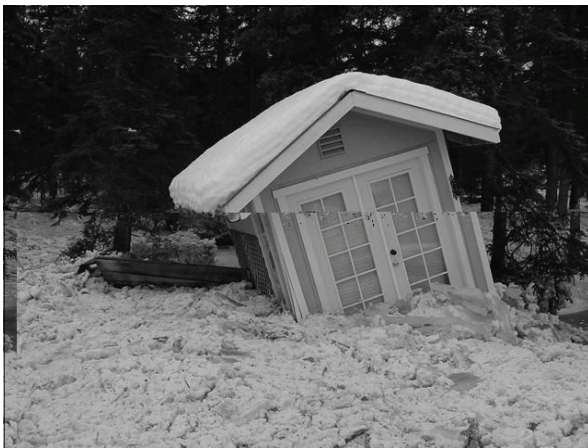
Damage to an outbuilding caused by the release of the Tazlina West glacier dammed lake  
Photo courtesy of local resident

residents. The resulting ice breakup caused extensive flooding, with ice reportedly reaching nearly to the underside of the Richardson Highway bridge. Some homes along the river reported water up to the interior electric wall sockets. Besides inundation of an unknown number of homes, numerous cars, snow machines, and outbuildings were damaged or destroyed by ice. There

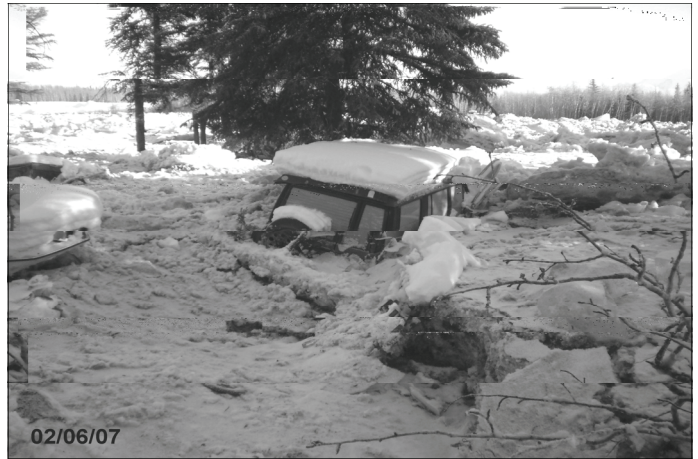
Car surrounded by ice following the release of Tazlina West glacier dammed lake  
Photo courtesy of local resident

is insufficient information to know if the ice formed an ice jam downstream of the bridge or if the breakup front continued to move downstream at a rate that caused significant backwater behind the front, but the front moved far enough on Sunday that the river fell below flood stage by Sunday morning between 9:00 and 11:00. Significant amounts of river ice, with pieces up to 3-4 feet thick, remain in the formerly inundated areas.

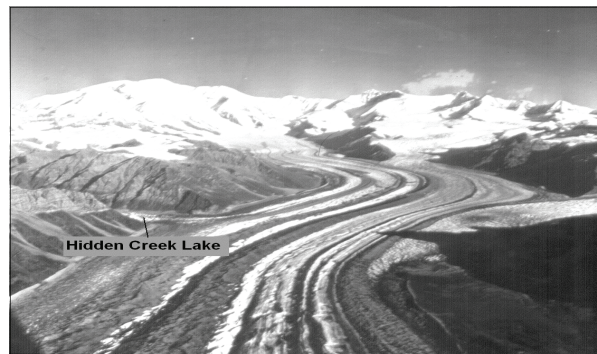
Hidden Creek glacier dammed lake  
Photo courtesy of the US Geological Survey

We received a report from our Kennicott River observer that Hidden Creek glacier dammed lake released in late January. This is very unusual for this lake, which released in July of 2006 and regularly releases each summer in late June, July, or early August. Although this is unusual, winter surges of water that may have come from this lake have been documented. A 1971 report by Post and Mayo of the U.S. Geological Survey documented a winter release reported in 1911, as well as a release in March 1968. The 1911 report stated that "a torrent of water rushes down the Kennicott and Nizina Rivers, sometimes flooding the ice all the way to the Copper River." No damage was reported during this winter's event, but there was damage during the lake release last summer. It will be interesting to see if this lake refills in time for its normal summer release this summer.
