Storm Survey of the Tornado Near Moulton, TX on September 7, 2010

PUBLIC INFORMATION STATEMENT
NATIONAL WEATHER SERVICE AUSTIN/SAN ANTONIO TX
448 PM CDT WED SEP 8 2010

...TORNADO CONFIRMED NEAR MOULTON IN LAVACA COUNTY...

LOCATION...1 MILE SOUTH OF MOULTON IN LAVACA COUNTY
DATE...9/07/2010
ESTIMATED TIME...337 PM
MAXIMUM EF SCALE RATING...EF0
MAXIMUM WIND SPEED...65 MPH
MAXIMUM PATH WIDTH...50 YARDS
PATH LENGTH...0.2 MILES

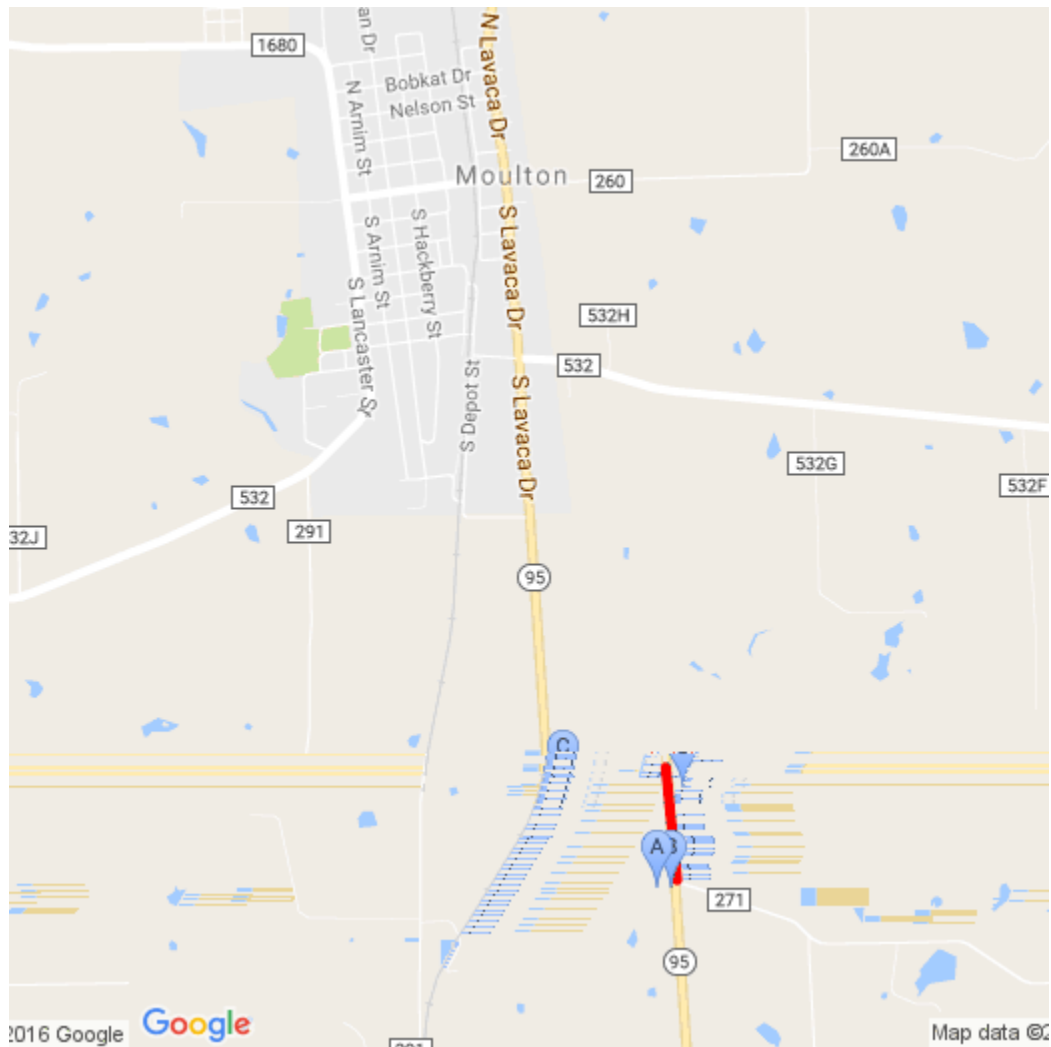
Track...

[A. Site of roof damage](#)

[B. Site of uprooted tree](#)

[C. Site of tornado track in field](#)

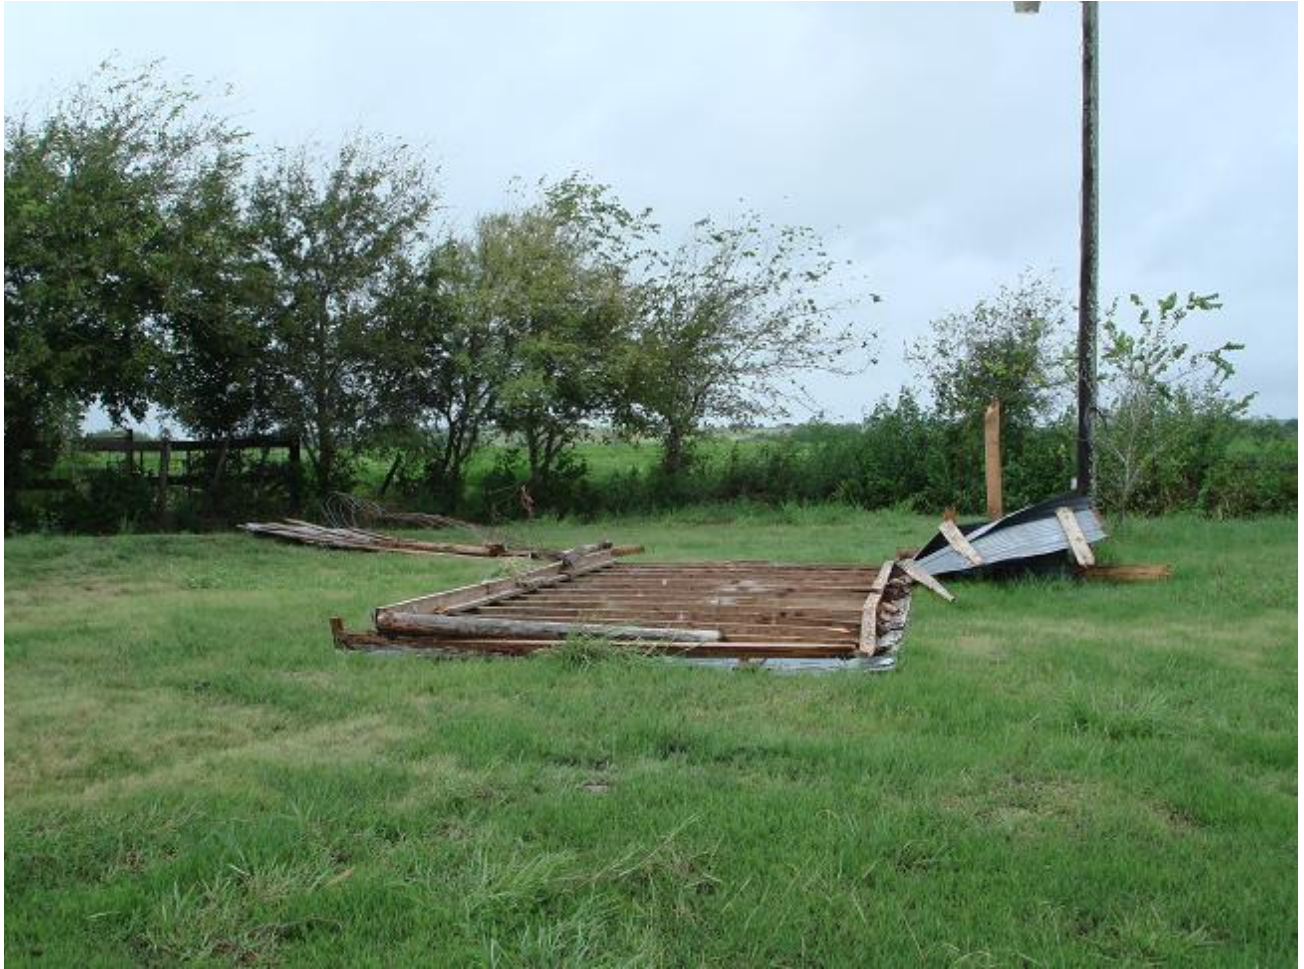
A. Site of Roof Damage

THE TORNADO FORMED ON 09/07/2010 AROUND 337 PM ALONG HIGHWAY 95 APPROXIMATELY 1 MILE SOUTH OF MOULTON IN LAVACA COUNTY. THIS IS VERY NEAR THE INTERSECTION OF HIGHWAY 95 AND COUNTY ROAD 271. A PORTION OF A ROOF WAS BLOWN OFF AN ABANDONED BUILDING WITH A TREE ALSO BEING UPROOTED ON THE PROPERTY. THE TORNADO MOVED NORTH ALONG THE EAST SIDE OF HIGHWAY 95 AND TRAVELED THROUGH A CORN FIELD WHERE THE TRACK WAS CLEARLY VISIBLE. THE TORNADO THEN LIFTED OR WEAKENED JUST SOUTH OF MOULTON AFTER TRAVELING 0.2 MILES. MAXIMUM WIND SPEEDS ARE BEING ESTIMATED AT 65 MPH WITH A MAXIMUM WIDTH OF 50 YARDS. THIS TORNADO IS BEING RATED AS AN EF0 ON THE ENHANCED FUJITA SCALE. NO INJURIES OR DEATHS WERE REPORTED WITH THIS TORNADO.
