## Austin/San Antonio Weather Forecast Office WEATHER EVENT SUMMARY

### 2015 Memorial Day Weekend Flooding

23 – 24 May 2015

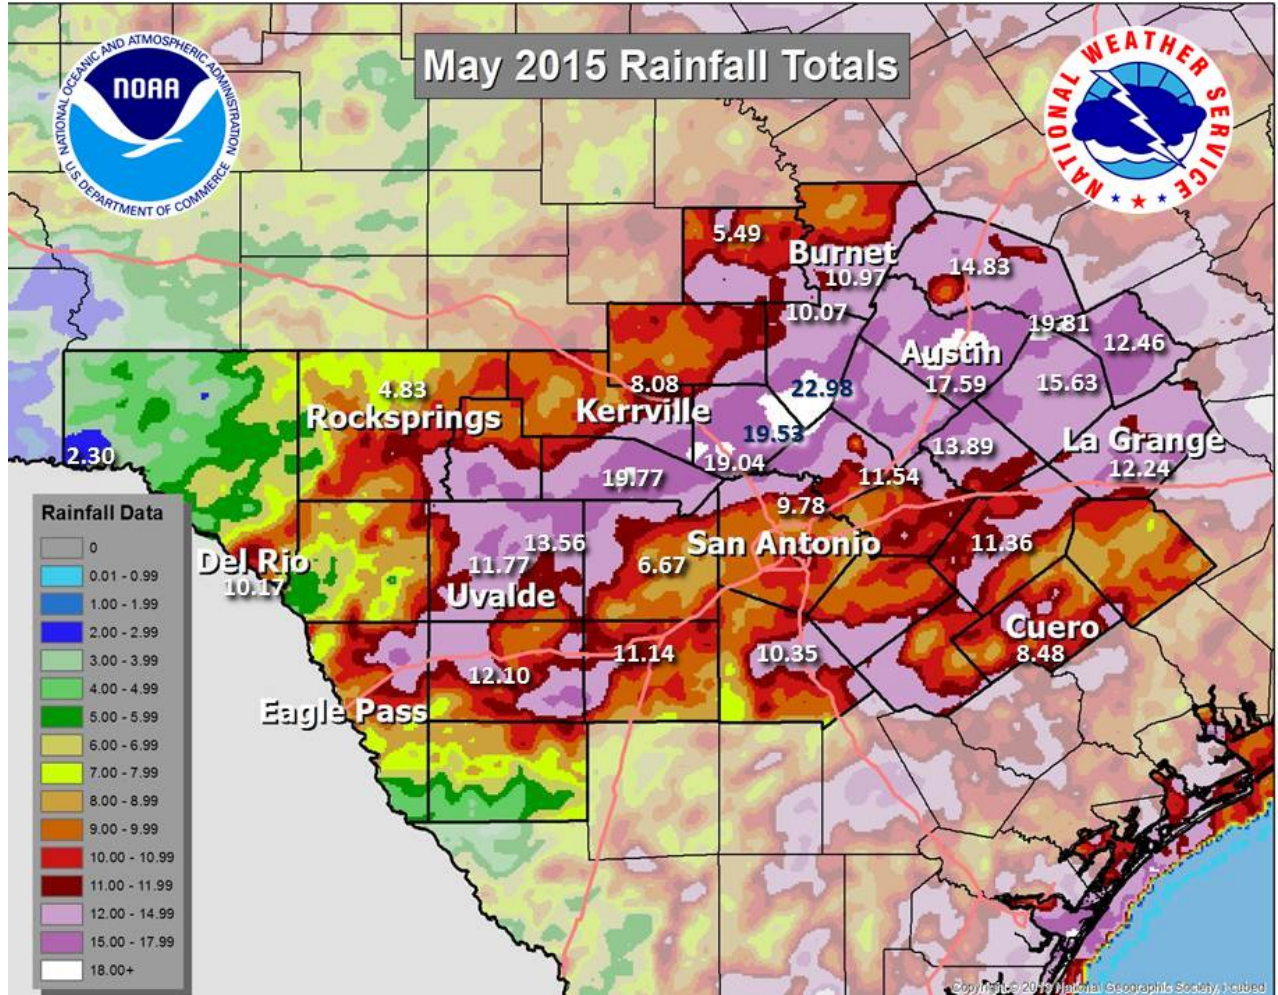
Figure 1: May 2015 rainfall totals.

A persistent weather pattern from the beginning of May began to set the stage for a more concentrated and more impactful flash and river flooding event. May 2015 will go down in history as one of the wettest months across the state of Texas (Figure 1). For the first two to three weeks of the month, most locations across south-central received well-above normal rainfall that saturated the soils. By the time Memorial weekend arrived, much of the region was at least 2-4 inches (100-300%) above normal. These wet antecedent conditions meant that any new rain and especially heavy rain would become run-off directly into rivers, streams, and flash flood prone areas. Ingredients came together during the memorial weekend for several rounds of very heavy rain and severe thunderstorms to develop. Widespread 6-8 inches fell across Bandera, Kerr, Kendall, Blanco and far west portions of Comal and Hays counties with a max of 10 to 13 inches of rain across southern Blanco and extreme NE Kendall counties. Most of this rain fell from Saturday afternoon into the overnight hours of early Sunday morning, leading to a rapid rise in the Blanco and San Marcos Rivers (Figure 2). The Blanco River at Wimberley rose from near 5 feet at 9pm to near 41 feet by 1am. One staggering statistic is that the river rose 5 ft every 15 minutes from 10:45pm to 11:45pm. This equates to a 20ft rise along the river within a one hour time frame. The river gauge hydrograph for Wimberley can be seen in Figure 3 below depicting this rapid rise. Numerous high water rescues occurred throughout the late evening and morning hours along the banks of the Blanco and eventually the San Marcos Rivers.

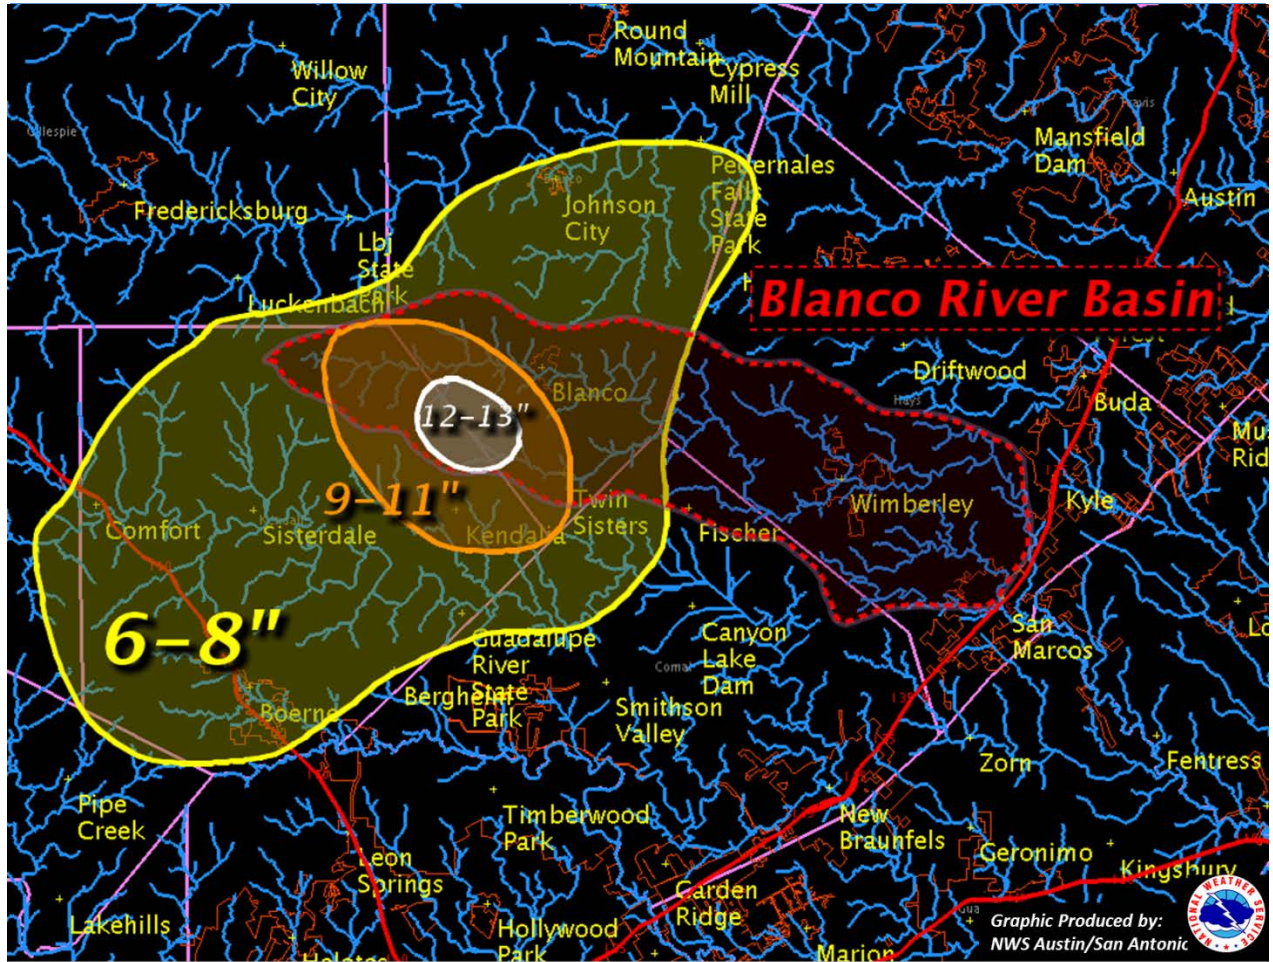
**Figure 2:** Widespread 6-8 inches of rainfall with local 9 to 11 inches and a maximum of 12-13 inches fell in the head waters of the Blanco River Basin over 4-6 hours.

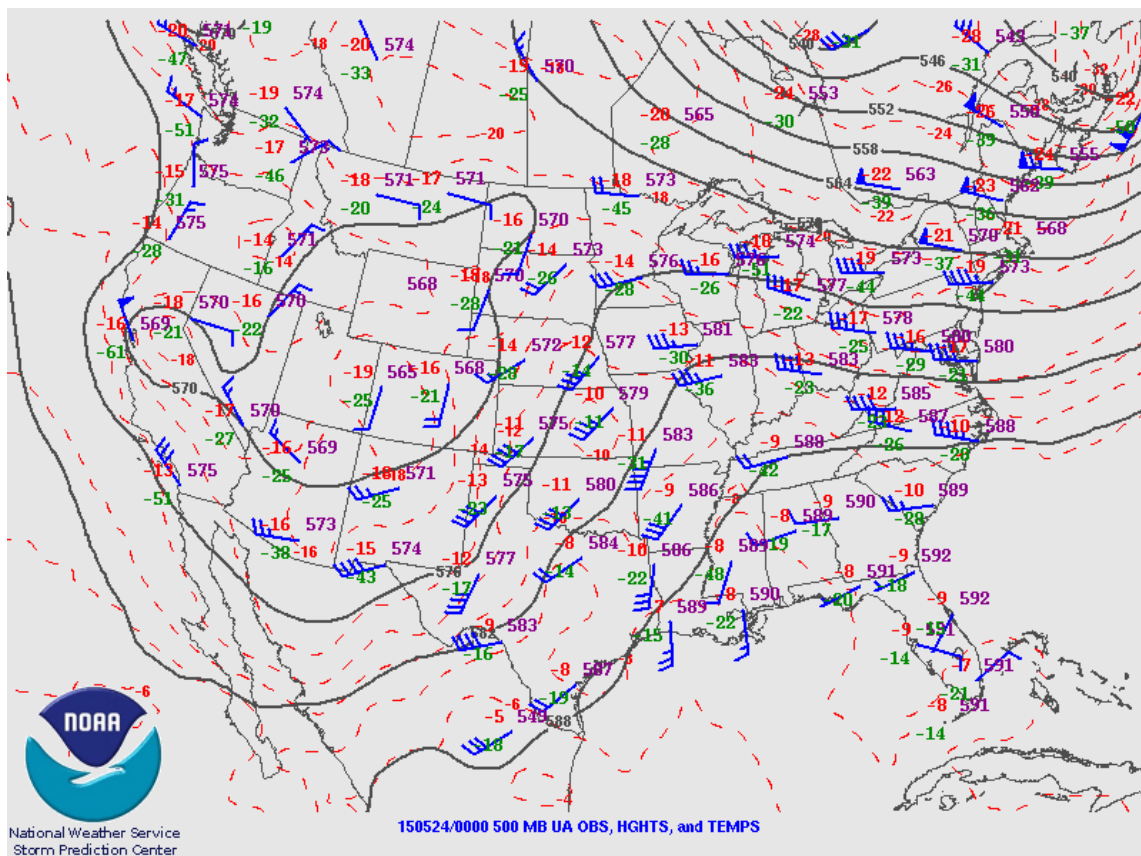
**Figure 4:** 500 mb chart for 5/24 at 00z (May 23 7pm). Mid-level Atmospheric pattern on May 23rd at 7pm. Note the little ripples in the lines over Texas. These ripples can indicate enhanced areas of lift and when combined with cyclonically-curved winds, can result in supportive environment for longer lived storms.

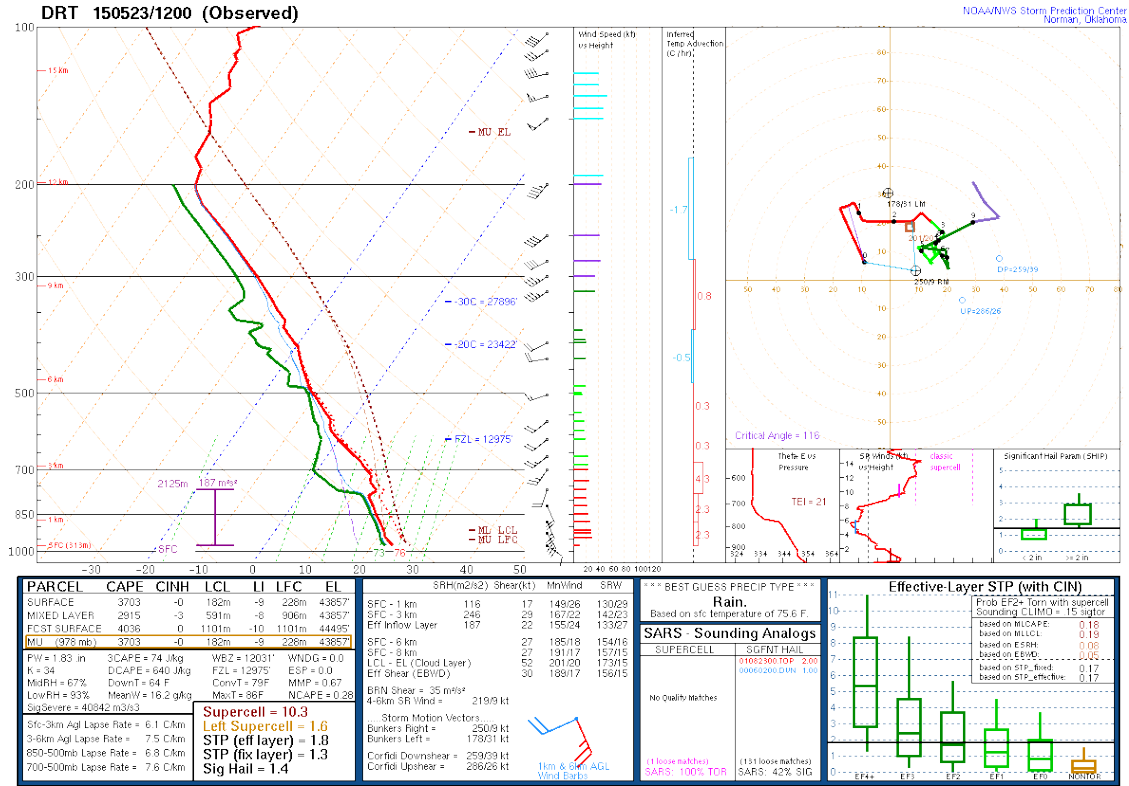
**Figure 5:** SPC Sounding chart from KDRT 05/23 12Z. Note the PW value of 1.83" taken from the weather balloon sampling in Del Rio, Texas from Saturday morning. CAPE values were already high that morning ahead of developing storms and indicated more storms would be likely that afternoon. This instability in combination with modest shear values allowed for organized storms to develop.

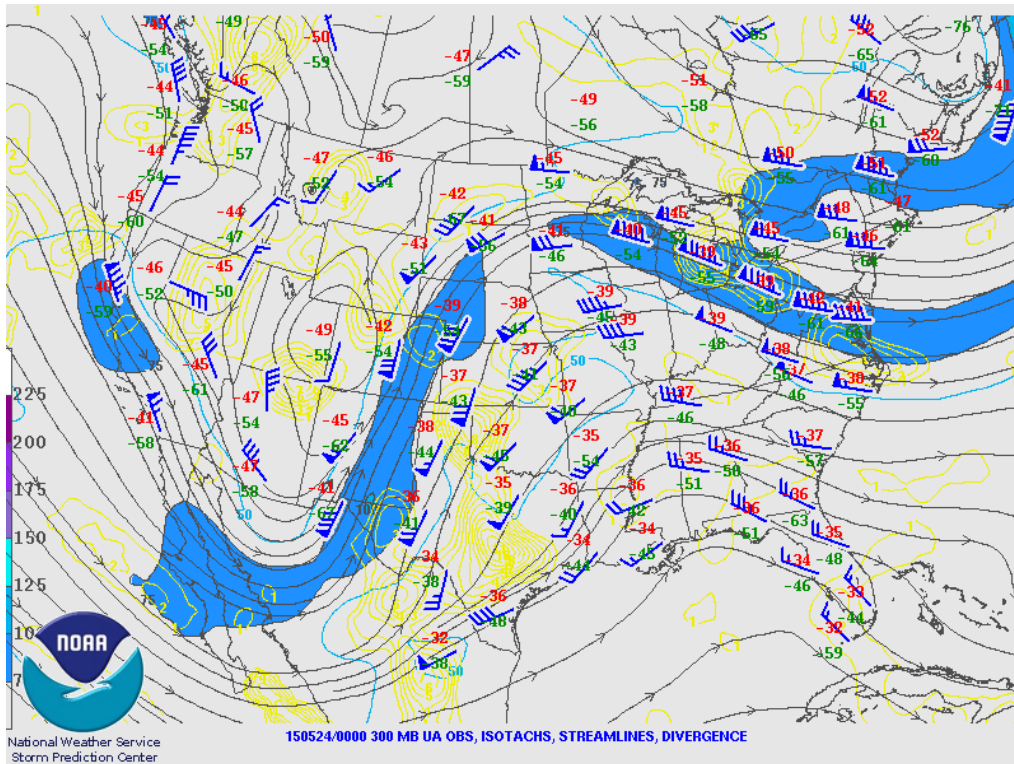
**Figure 6:** 300mb winds and divergence outlined in yellow. Note the sharp air flow direction change across northern Mexico with a potent long wave trough. This strong diffluence allowed for strong horizontal divergence that supported stronger and long-lived updrafts that tapped into the ample moisture in place over Texas. Note the high contouring of yellow outlines across south central Texas.

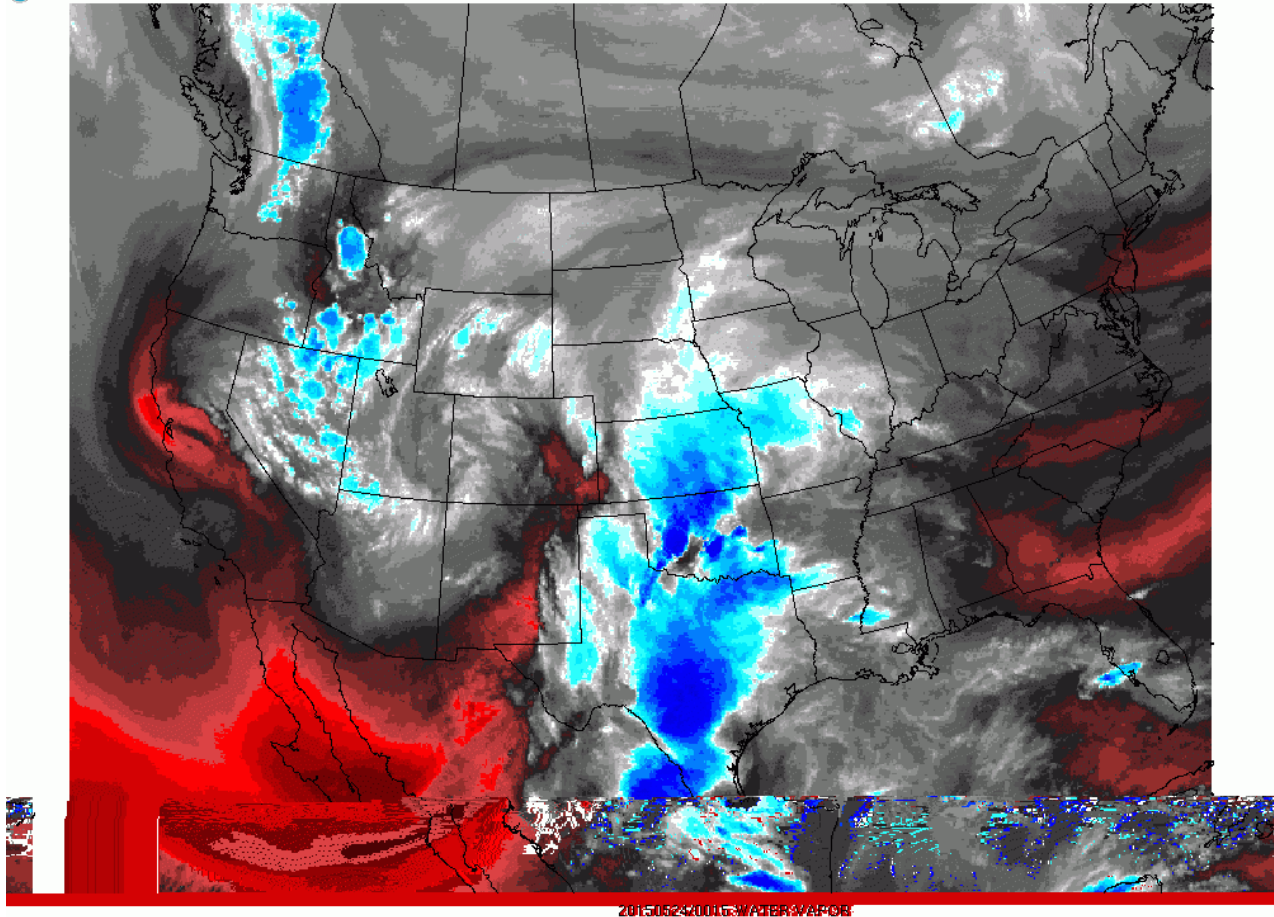
**Figure 7:** Water Vapor Image for 7:15pm on Saturday, May 23rd. Note the significant thunderstorm activity over south-central Texas that is producing heavy rainfall.

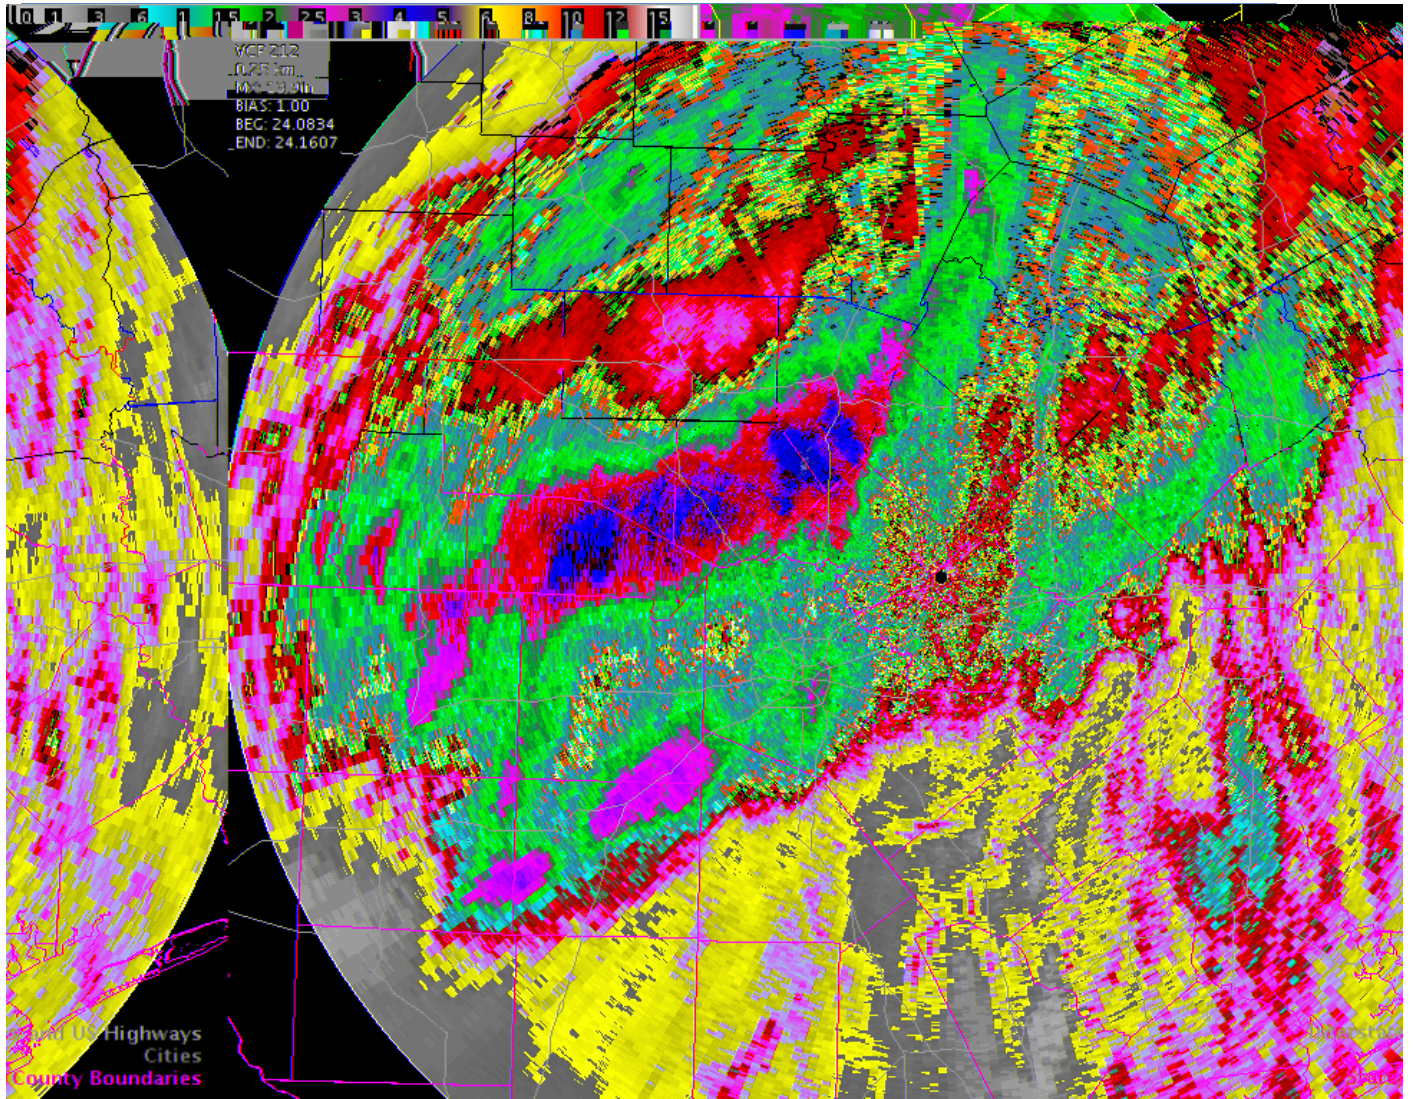
**Figure 13:** Dual-Polarization Radar Storm total Rainfall Estimates. Note the 9-11 inches with Max nearing 13" in the dark red to White area along the Blanco/Kendall County Line

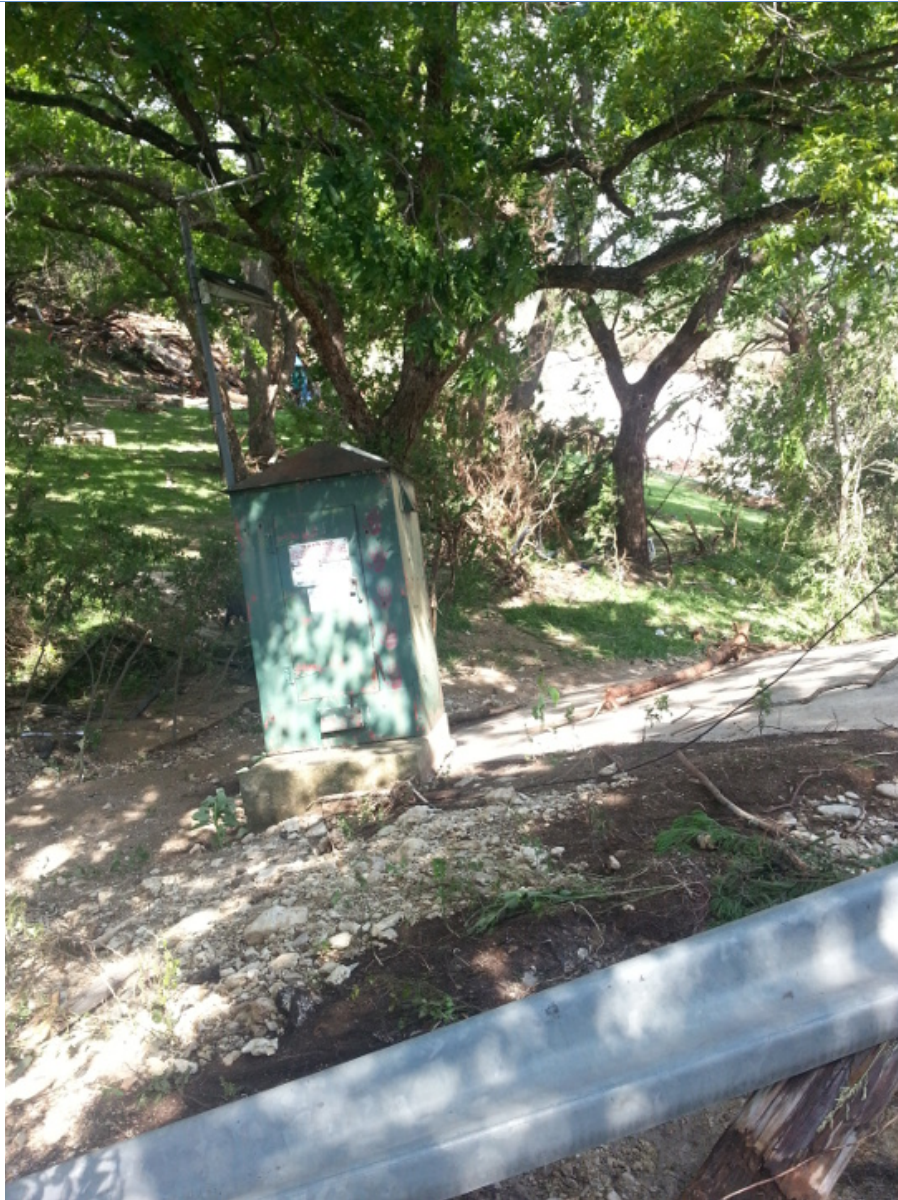
**USGS Gage Housing at Ranch Road 12 Bridge (Blanco River at Wimberley, TX) on May 24, 2015.**

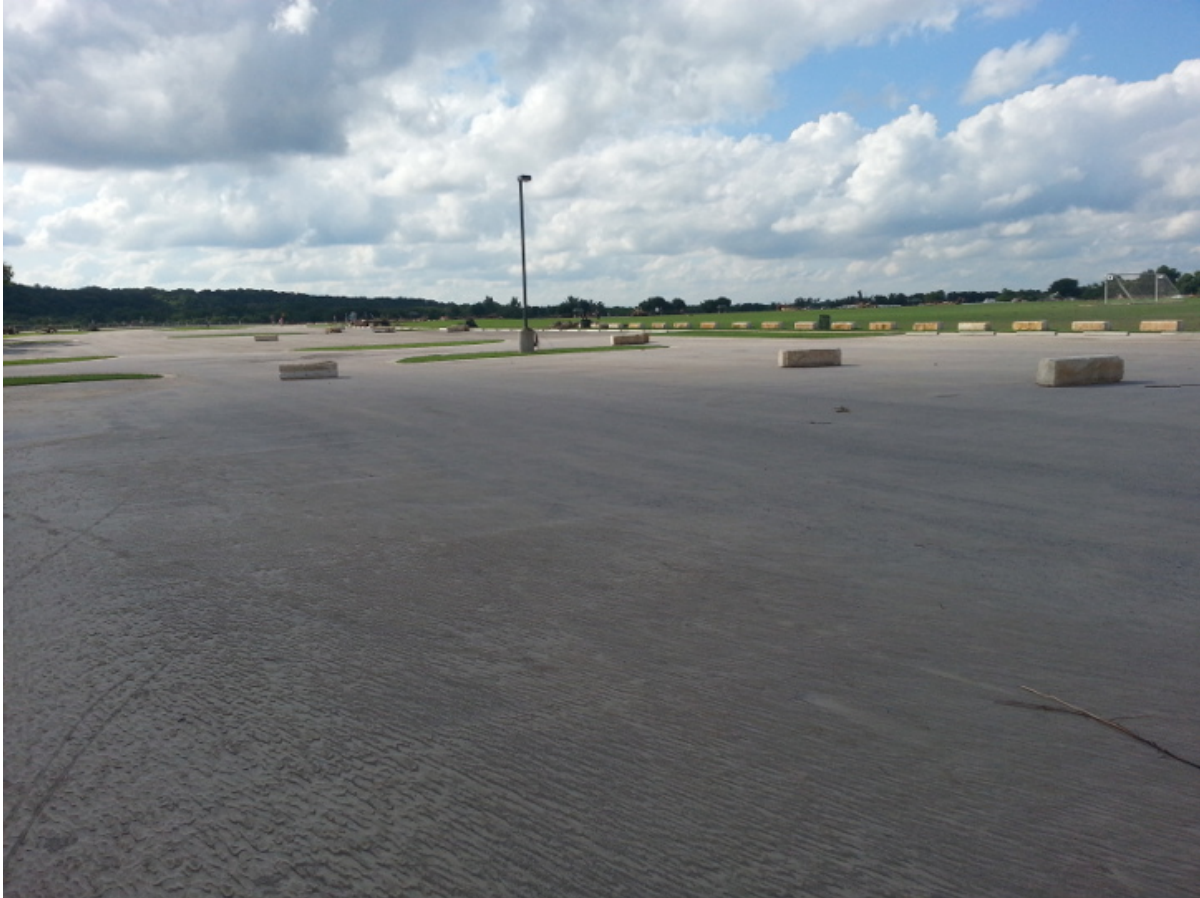
Stone boulders pushed across a parking lot at Five Mile Dam Parks Complex in San Marcos, TX on May 24, 2015.

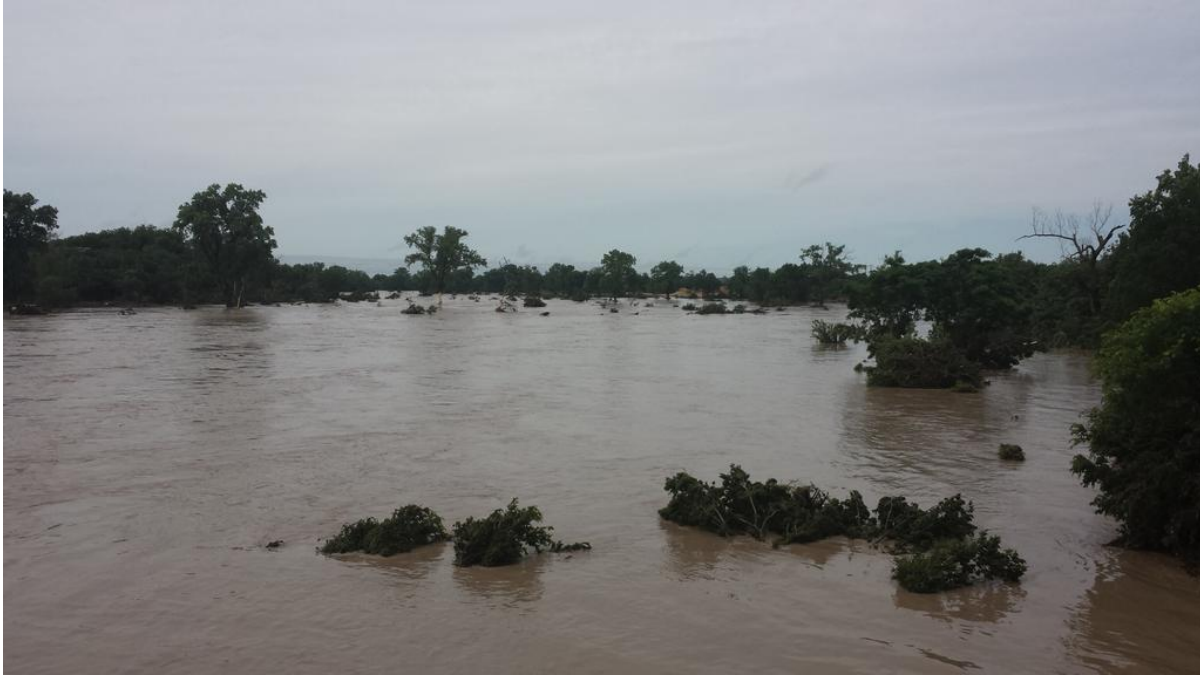
**(From Figure 3b) The Blanco River near San Marcos at 9:45am 5/24/2015. Photo taken from HWY 80 Bridge. The BSMT2 gauge is located 30 feet to the left of this photo. The river reported a level of 32.59 feet at this time, over 10 feet below its crest height of 43.08 feet 4.5 hours earlier.**

**Figure 3b:** Hydrograph for San Marcos River near San Marcos, TX. Note the similar rapid rise of river levels compared to the Wimberley gauge (Figure 3a). The heavy rains falling upstream created a river surge downstream into the city of San Marcos. The initial flash flood warning for this area was issued at 11:24PM and an upgrade to a Flash Flood Emergency was issued for San Marcos at 1:25am. The river surge arrived in San Marcos just before 3:00am. Several upstream warnings were issued prior this time. The river crested at 43.08 feet at 5:15am on the 24th. The significant impacts due to this river warranted a re-issuance of the Flash Flood Emergency at 8:47am when the river had already receded to 36.78 feet. An NWS employee that lives nearby this gauge took a picture of the river from the viewpoint of the gauge at 9:45am (see below).

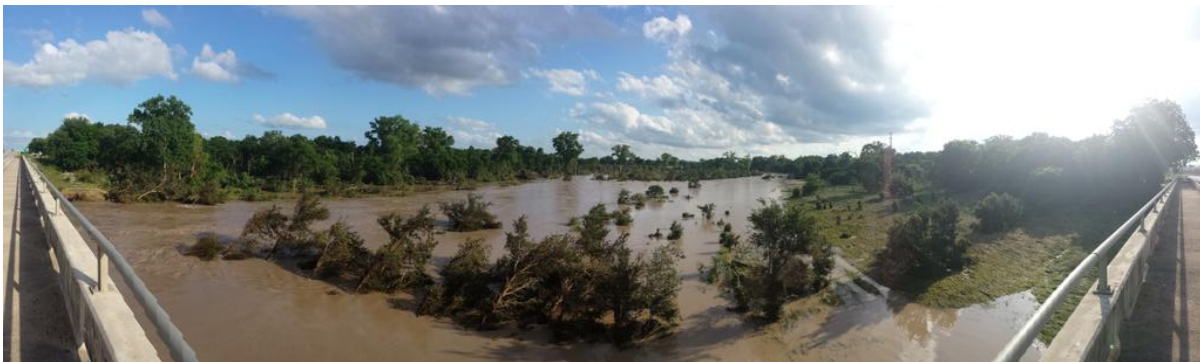
**The Blanco River near San Marcos at 6:29am 5/24/2015, almost 7 hours after the image above. River level was 21.88 feet at this time, almost 11 feet lower than above. The gauge is located on the left side of the photo where the tree line meets the bridge. You can see the trees are less submerged compared to the above photo.**
