Austin/San Antonio Weather Forecast Office WEATHER EVENT SUMMARY

February 2017 Severe Weather Outbreak

19 - 20 February 2017

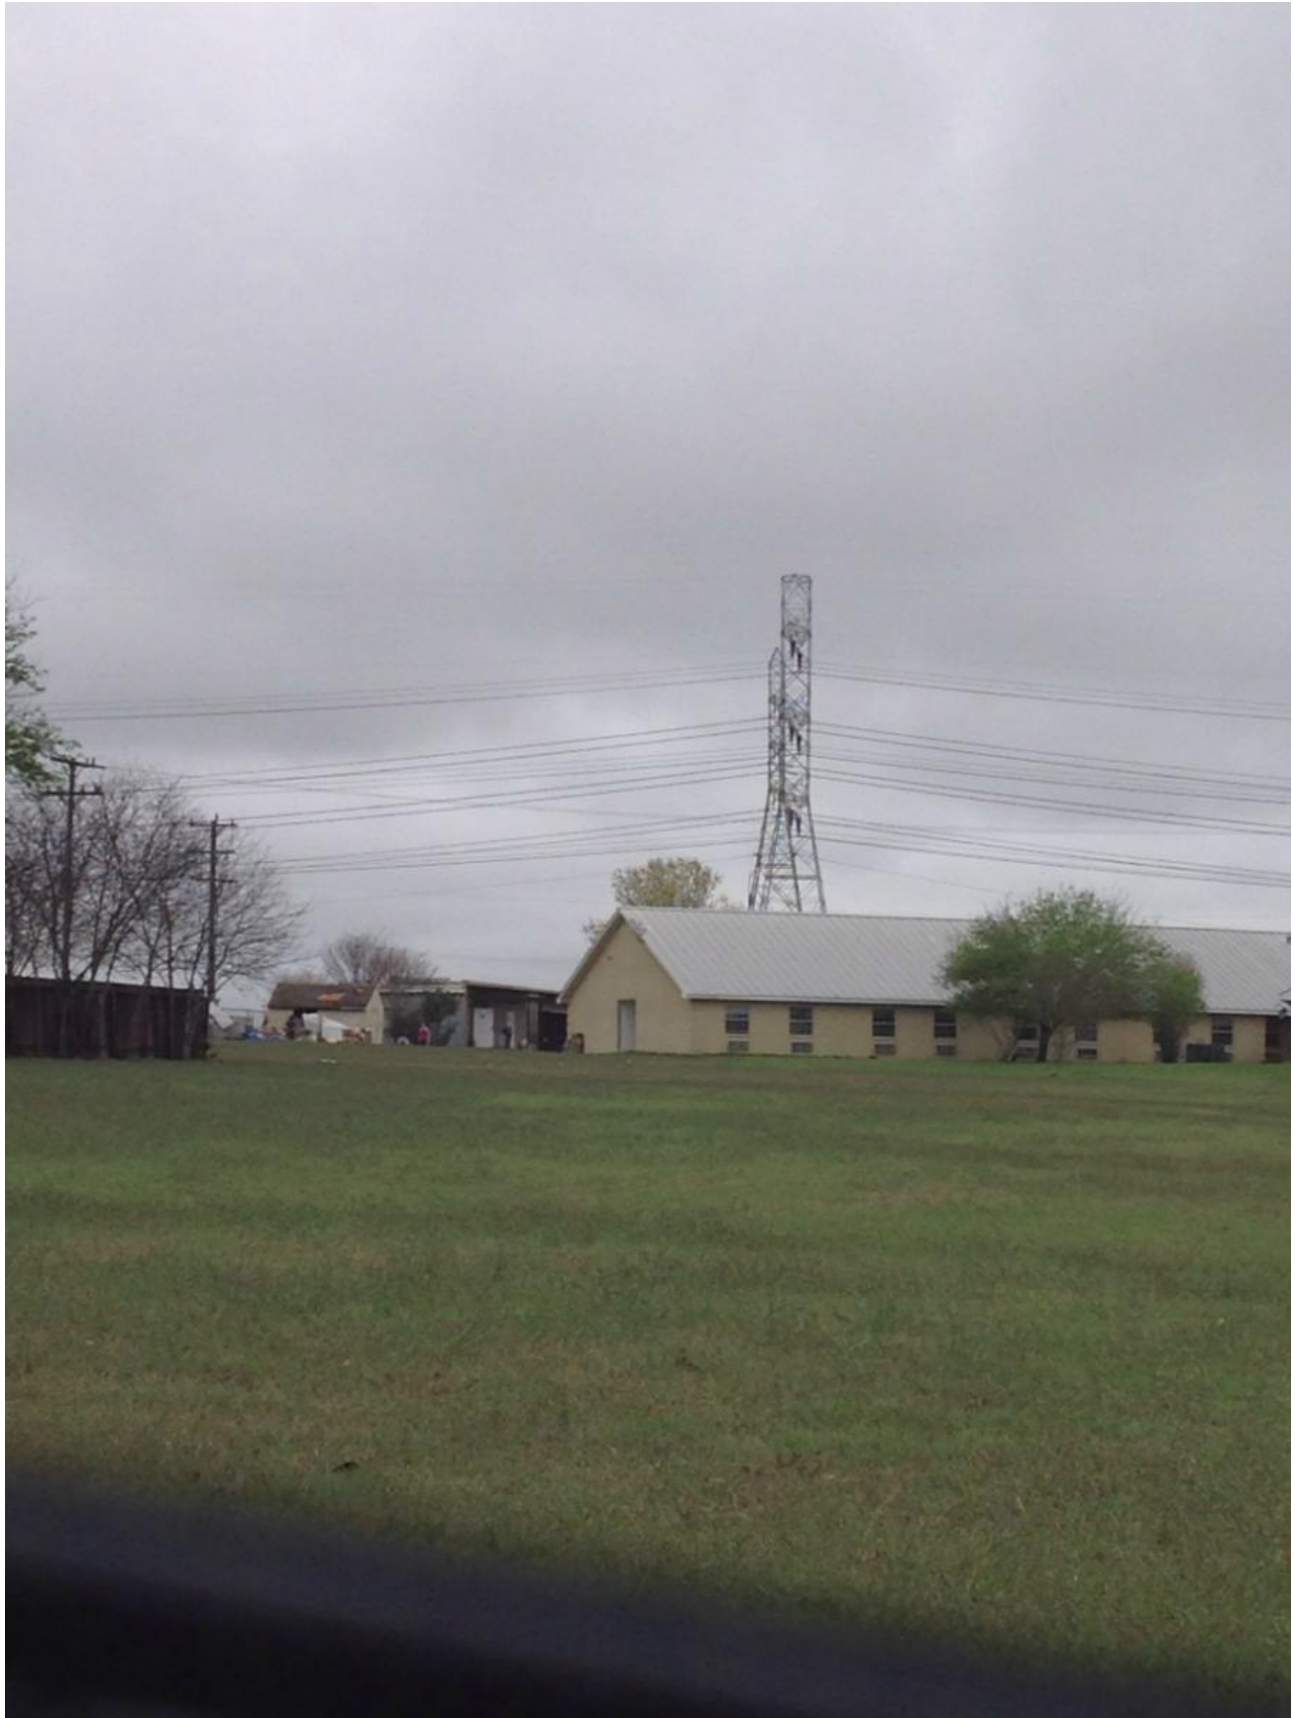
Survey Summary: A tornado formed near the intersection of Walzem Road and New World Drive. This tornado produced EF0 damage as it traveled to the northeast before lifting near the intersection of Crestway Road and Oconnor Road. There was primarily damage to trees and minor damage to roofs and carports.

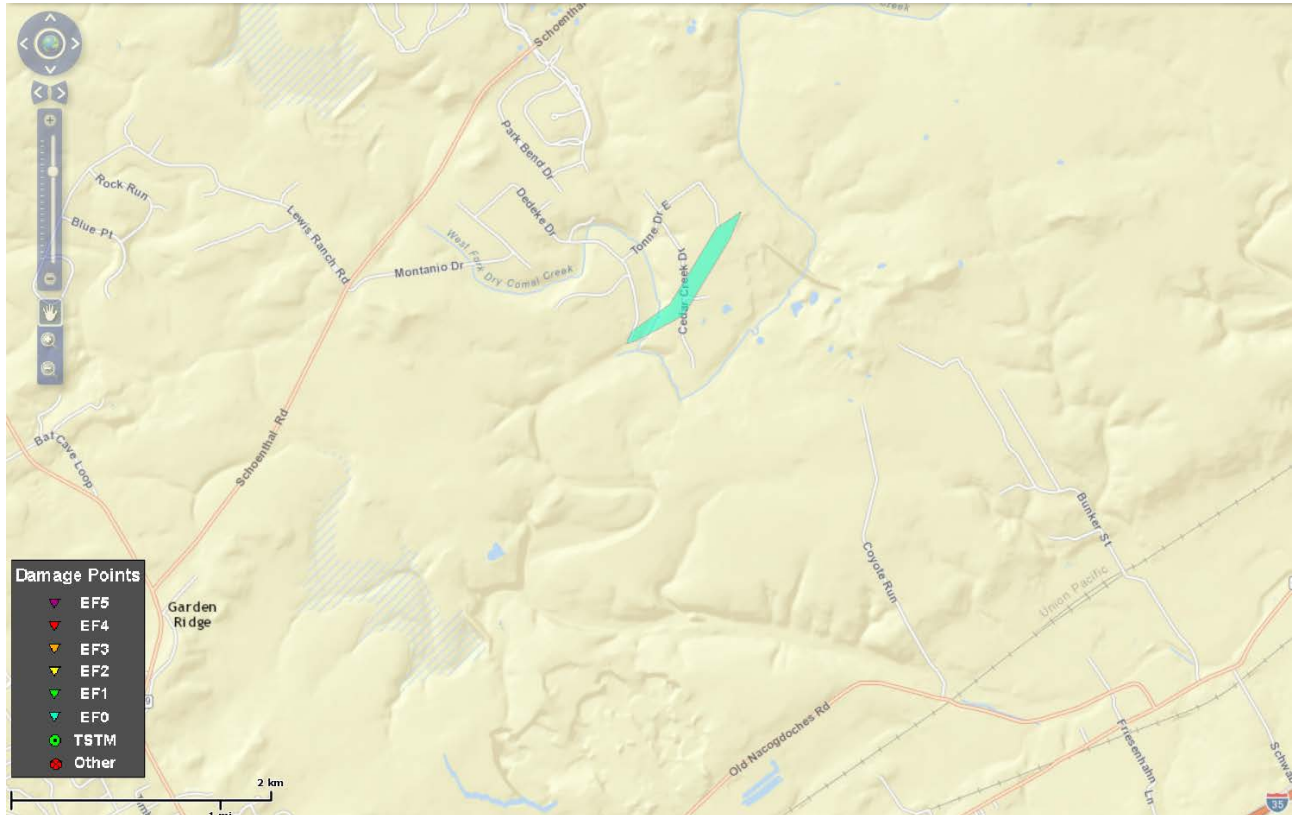
Schoenthal Ranch (Comal County)

A tornado initially occurred at the end of Dedeke Drive near the Dry Comal reek. This tornado primarily produced minor tree damage as it traveled northeast before lifting northeast of Tonne Drive East.

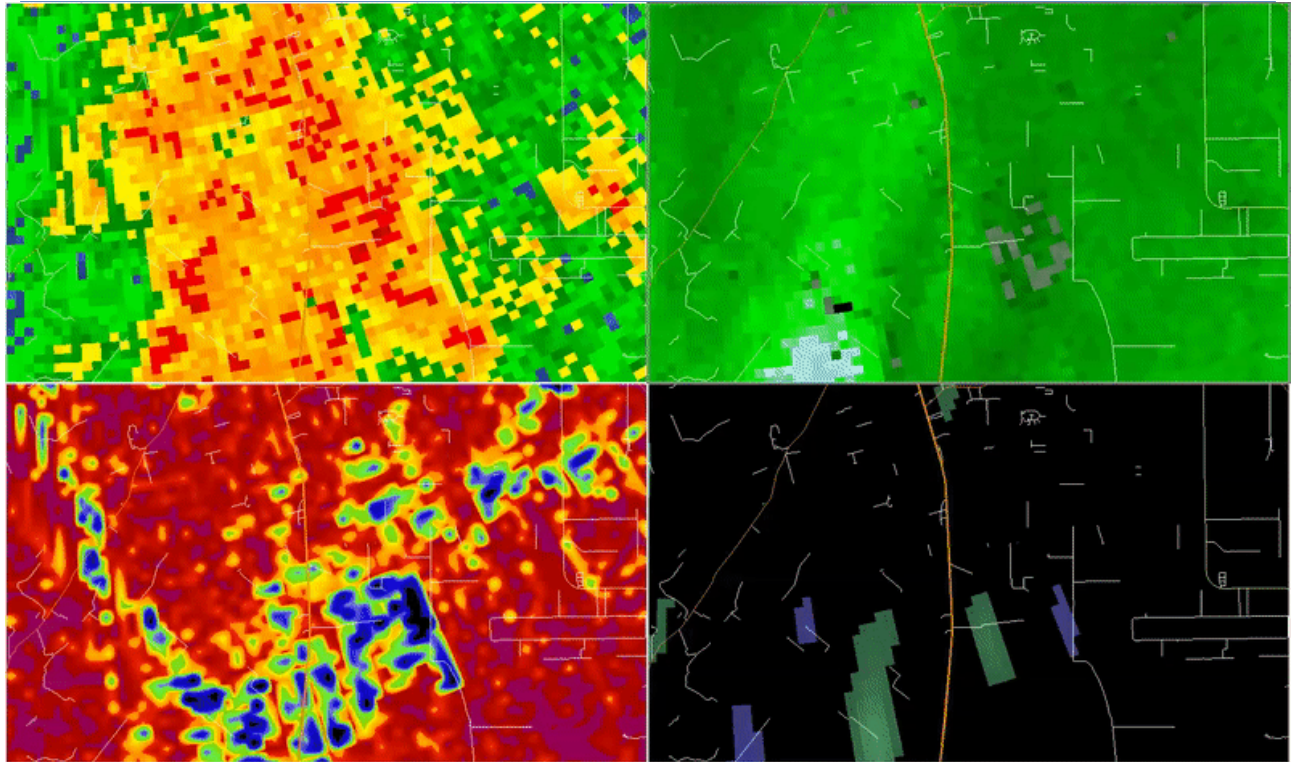
Seguin Tornado (Guadalupe County)

This short-lived tornado occurred about 7 miles south of Seguin along Highway 123. This tornado caused several recreational vehicles to overturn, and caused damage to several sheds and outbuildings.

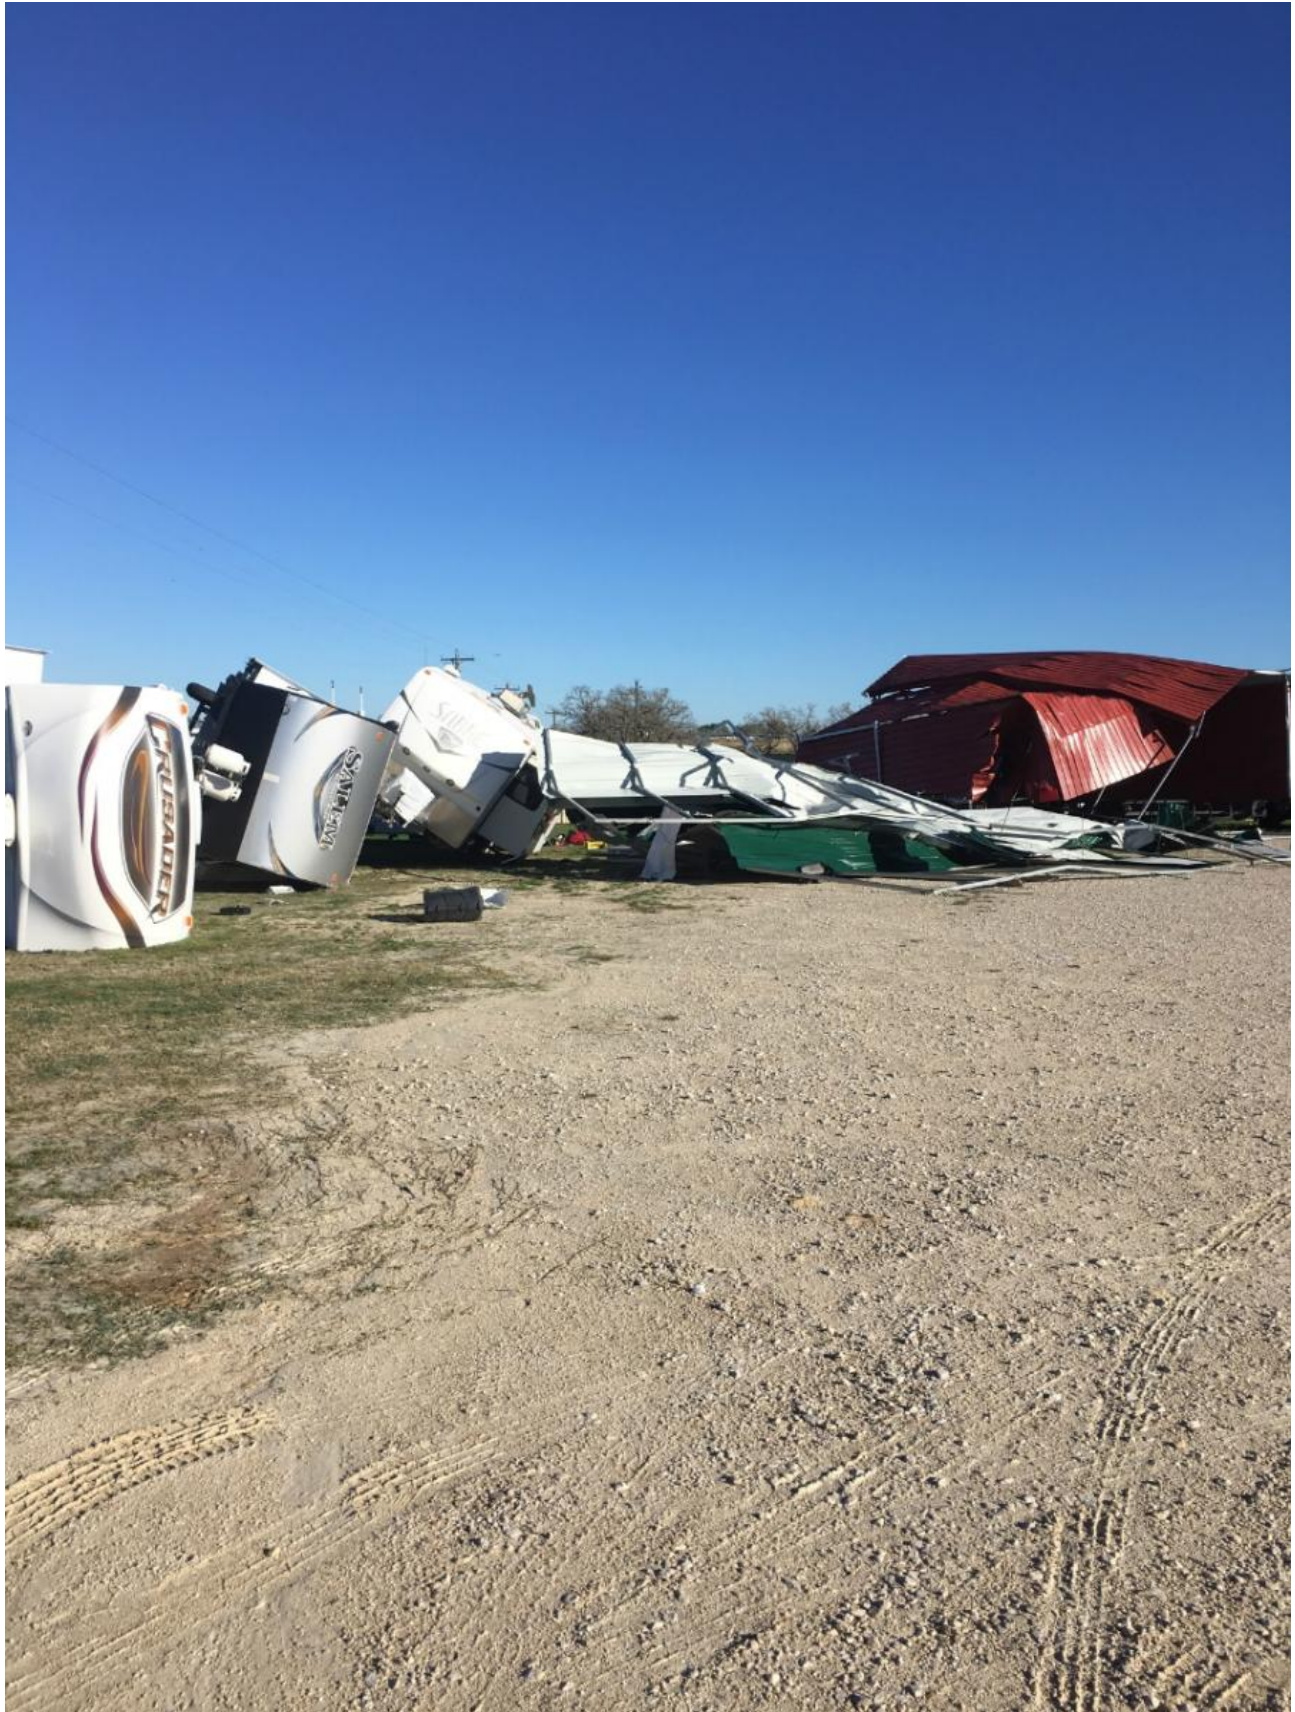
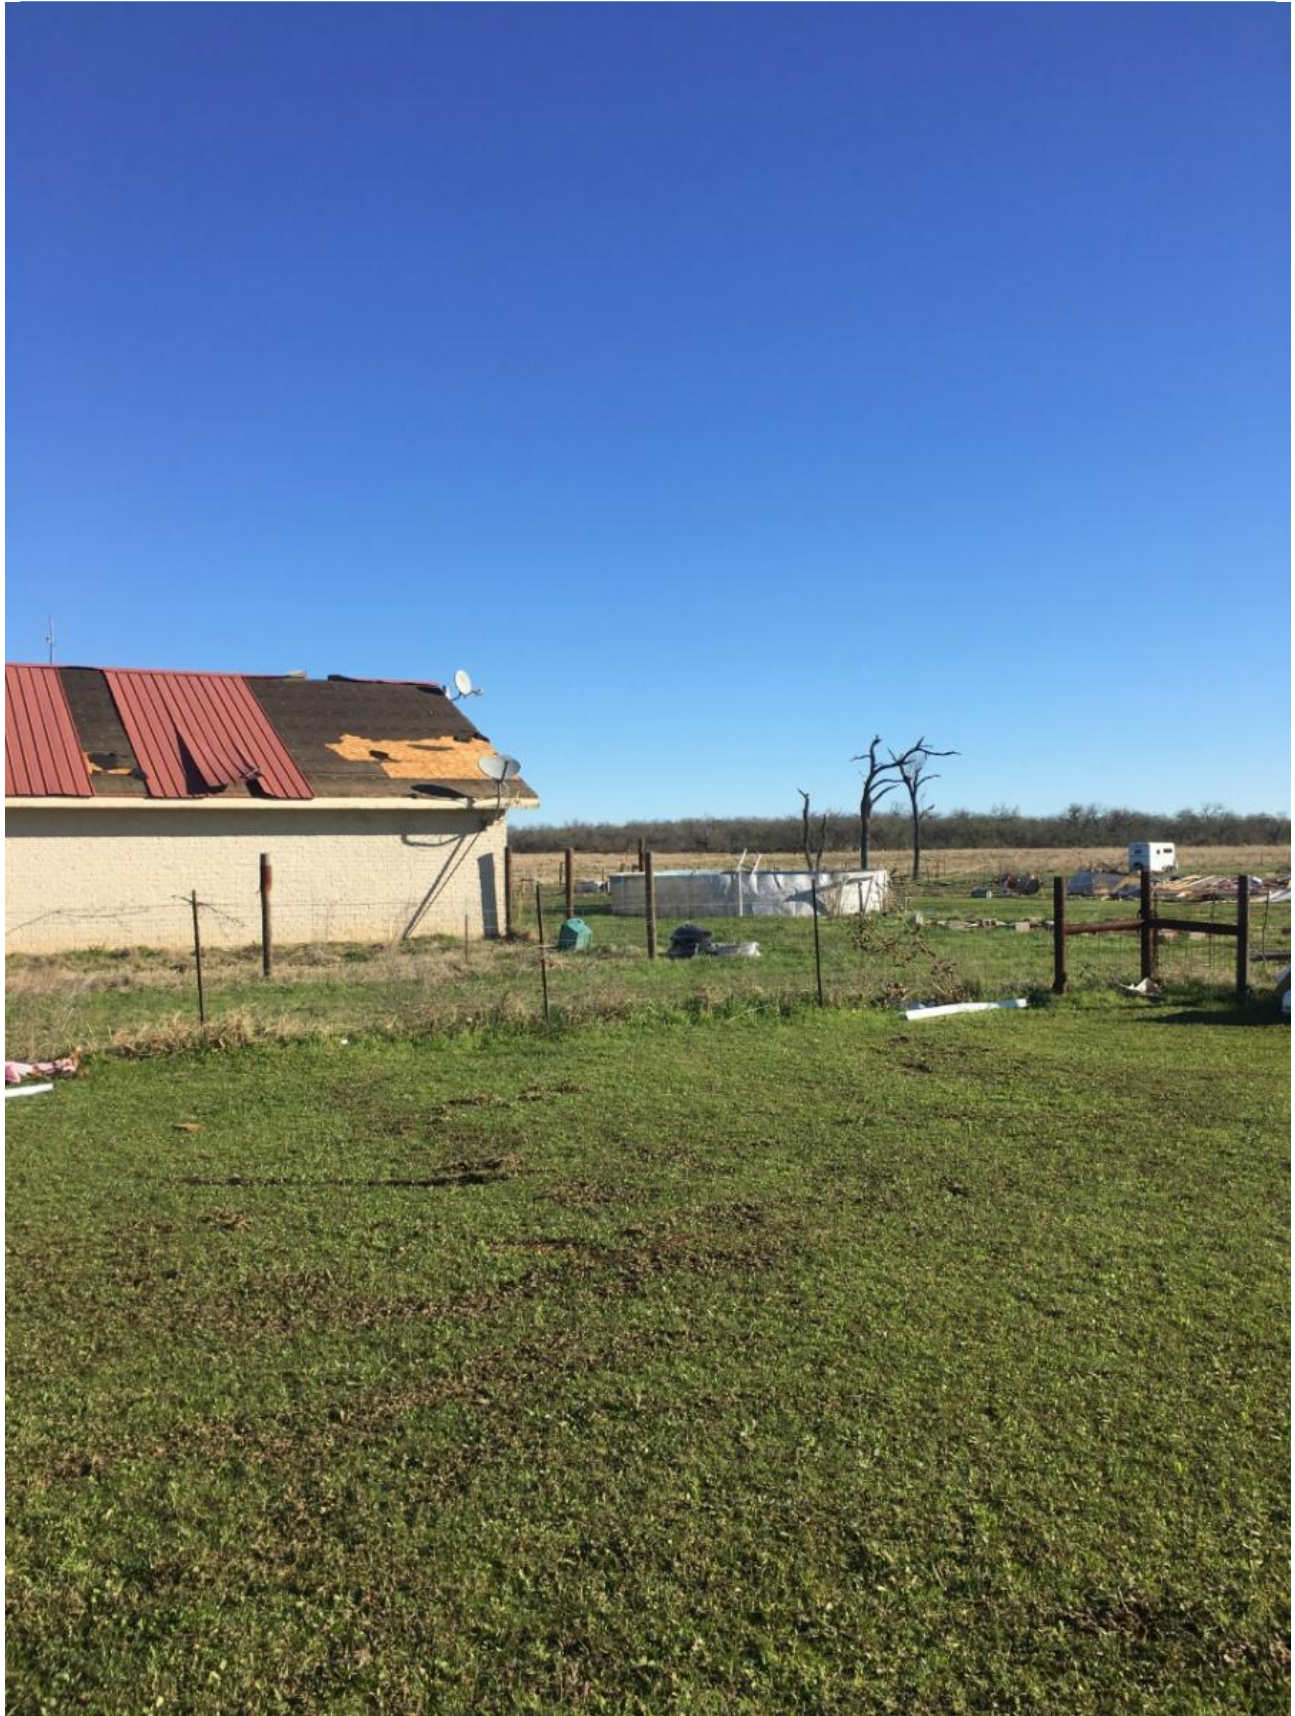
Survey_Summary: This short-lived tornado occurred about 7 miles south of Seguin along Highway 123. This tornado caused several recreational vehicles to overturn, and caused damage to several sheds and outbuildings.

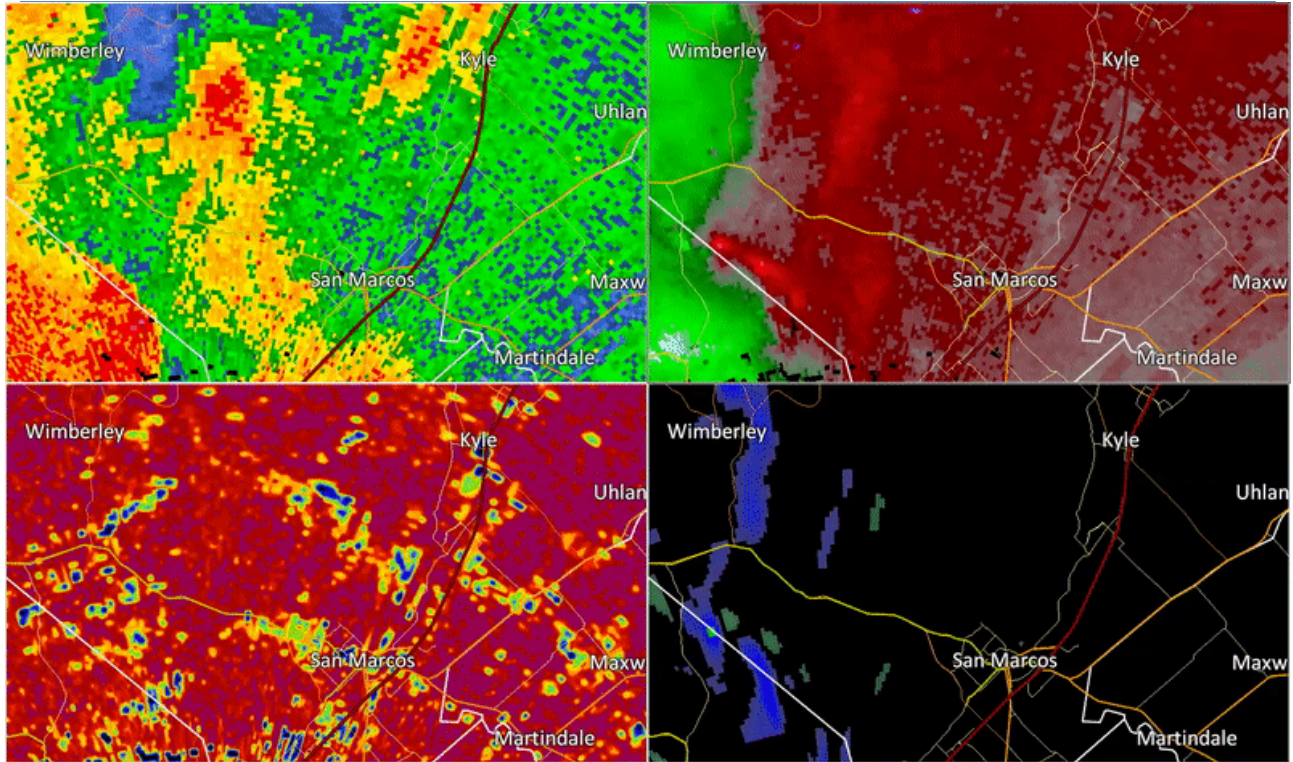
San Marcos (Hays County)

The survey team concluded that a tornado began at the intersection of Ranch Road 12 and Hugo Road where some trees were noted as snapped and a small business had considerable structural damage. The tornado traveled northeast and likely traversed a large area of land that was inaccessible until reaching Hilliard Road and a neighborhood along Thousand Oaks Loop where a wide area of considerable tree damage, including a tree uprooted and fallen onto a vehicle, was found. The tornado path crossed the Blanco River before ending near the Kyle Cemetery on Old Stagecoach Road. At this point, damage became much less significant and sporadic moving east toward I-35.

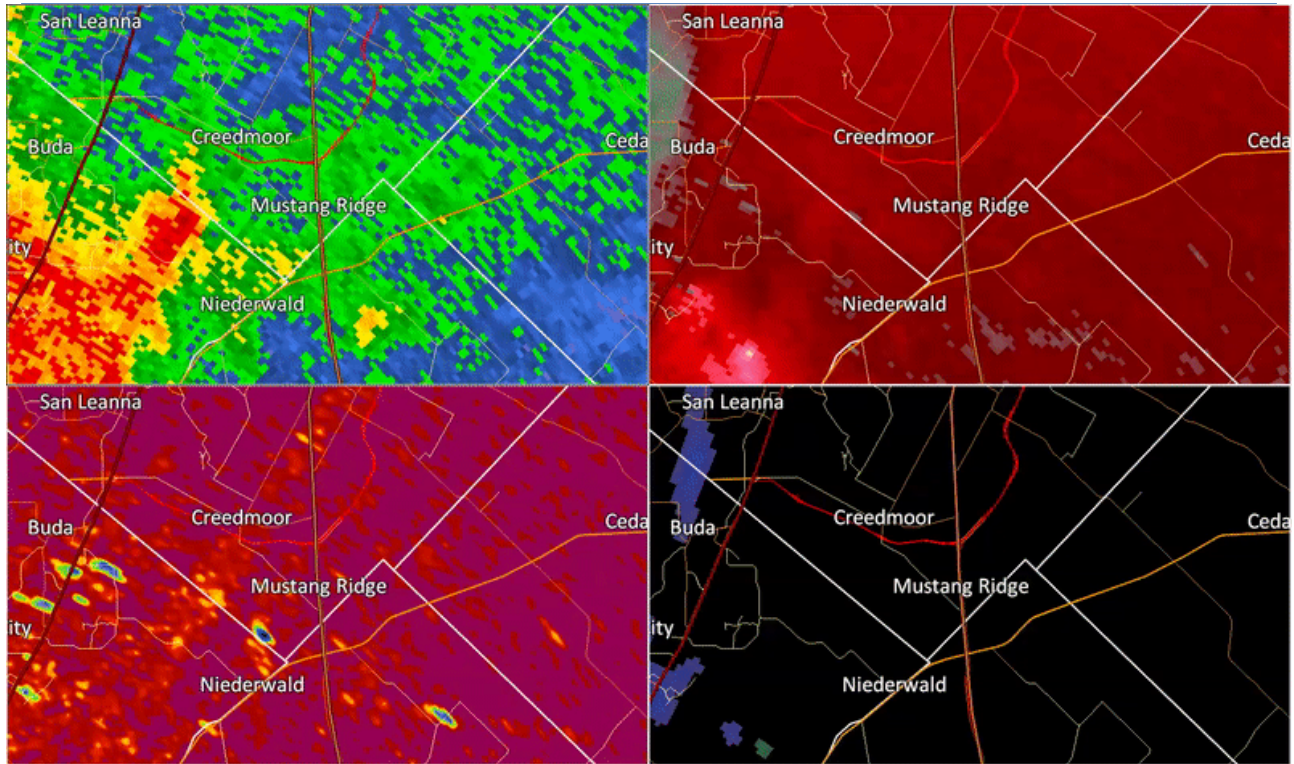
Niederwald/Mustang Ridge Tornado (Hays/Travis County)									
#	Rating	Max Winds	Time	Start	End	Length	Width	Fatalities	Injuries
7	EF0	85 MPH	2348-2351	30.0361/- 97.7415	30.0613/- 97.7046	3.0 mi	100 yds	0	0

The survey team concluded that many damage areas across central Hays County were due to straight line winds, but a new tornado indeed developed northwest of Niederwald. Damage in this area included a destroyed aluminum barn structure, car port damage, and a few trees with large limbs snapped. As the tornado moved northeast into the Mustang Ridge area, multiple mobile homes had significant roof damage consistent with EF-0 speeds. The tornado likely lifted as it approached SH 130 as damage east of SH 130 was found to be caused by straight line winds.

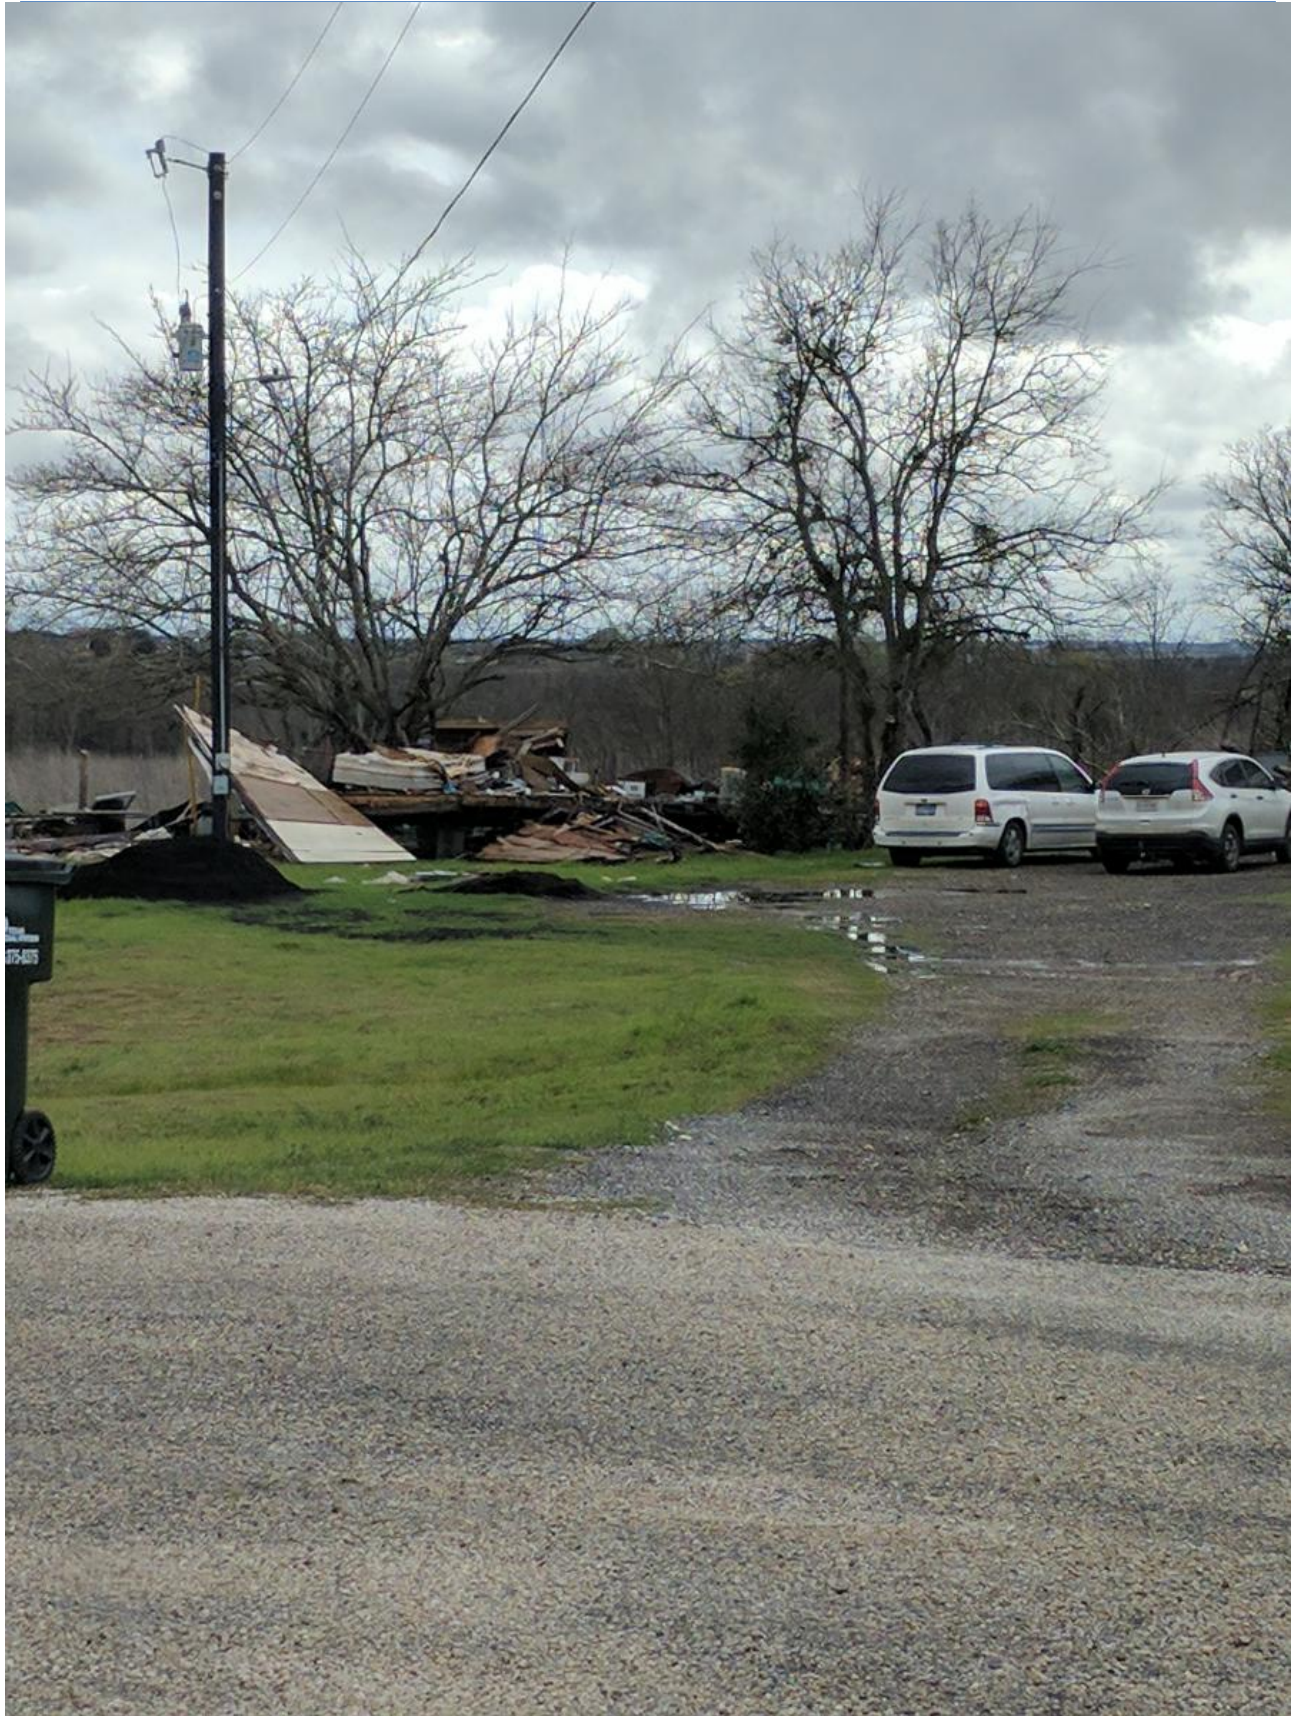
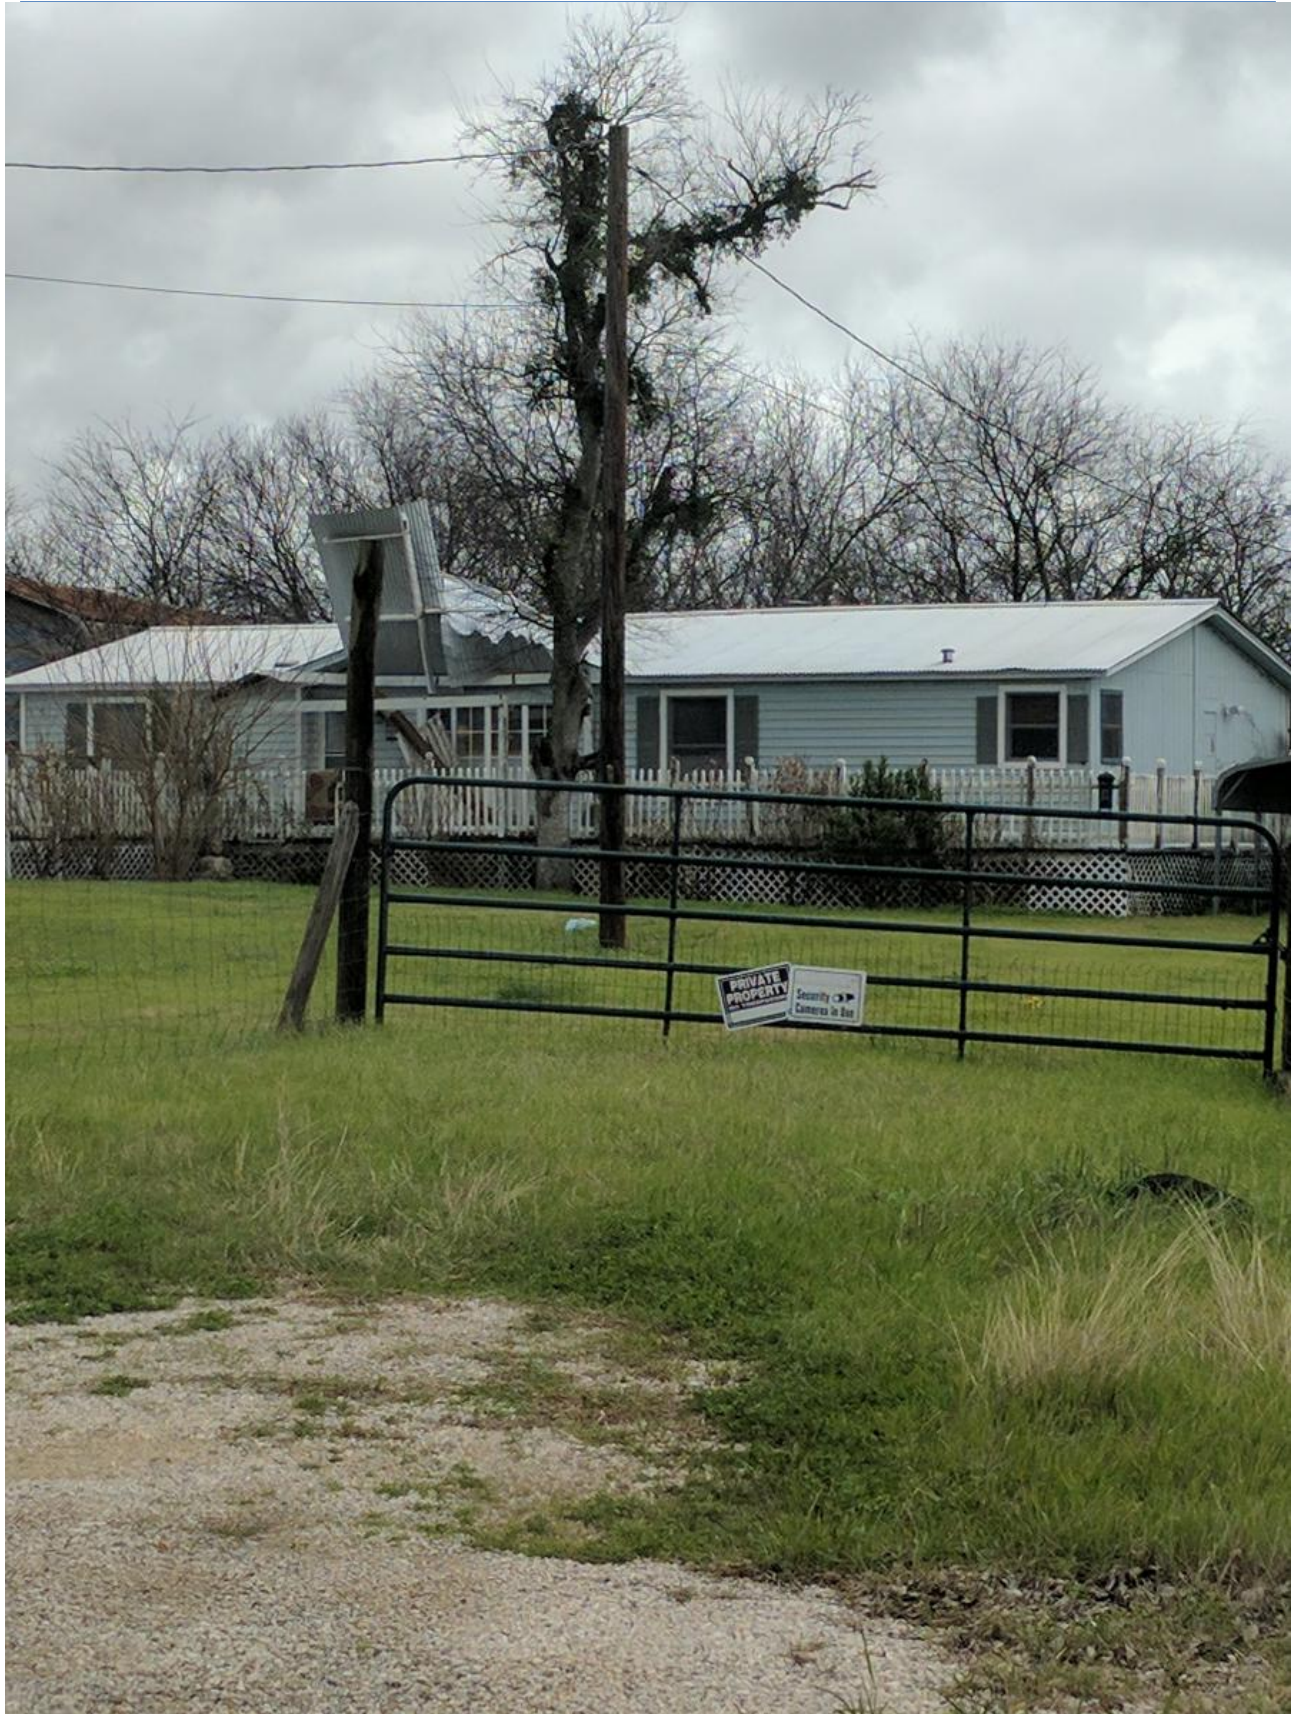
Survey_Summary: The survey team concluded that many damage areas across central Hays county were due to straight line winds, but a new tornado indeed developed northwest of Niederwald. Damage in this area included a destroyed aluminum barn structure, car port damage, and a few trees with large limbs snapped. As the tornado moved northeast into the Mustang Ridge area, multiple mobile homes had significant roof damage consistent with EF-0 speeds. The tornado likely lifted as it approached SH 130 as damage east of SH 130 was found to be caused by straight line winds.

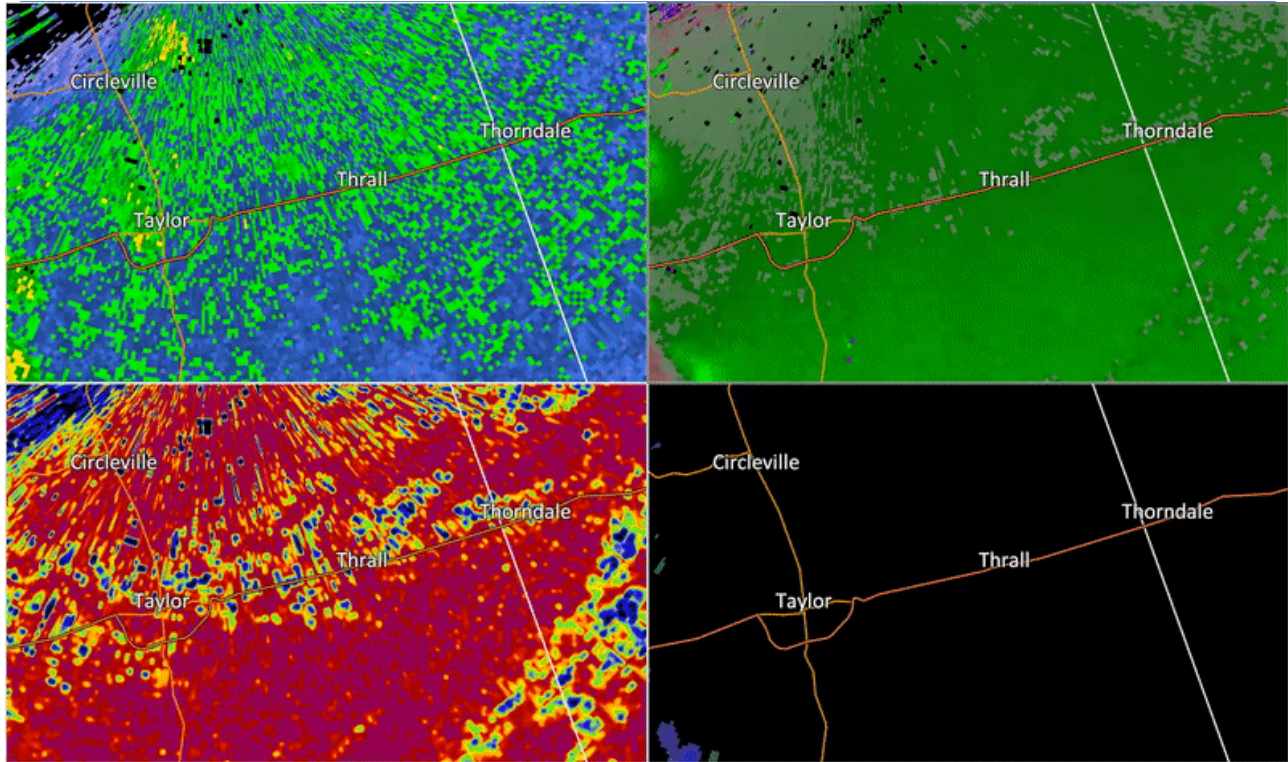
Thrall / Noack (Williamson County)

This tornado was the northern one of a pair on near parallel tracks a few miles south of U.S. Highway 79. Damage was sporadic...but concentrated when it occurred. The most significant damage was to a metal building system home...at least five other single family homes...and 12 railroad cars blown off the tracks east of Thrall. The train cars may have also been affected by strong straight-line winds.

This tornado was the southern one of a pair on near parallel tracks a few miles south of U.S. Highway 79. Damage was sporadic...but concentrated when it occurred. The most significant damage was to a 3-bin grain storage facility...where the bins were completely destroyed and swept from their foundations. Additional damage occurred to an extension of Christ Lutheran Church of Noack on FM 112...where the walls were bolted to the foundation.
