Austin/San Antonio Weather Forecast Office WEATHER EVENT SUMMARY

February 2017 Severe Weather Outbreak

19 - 20 February 2017

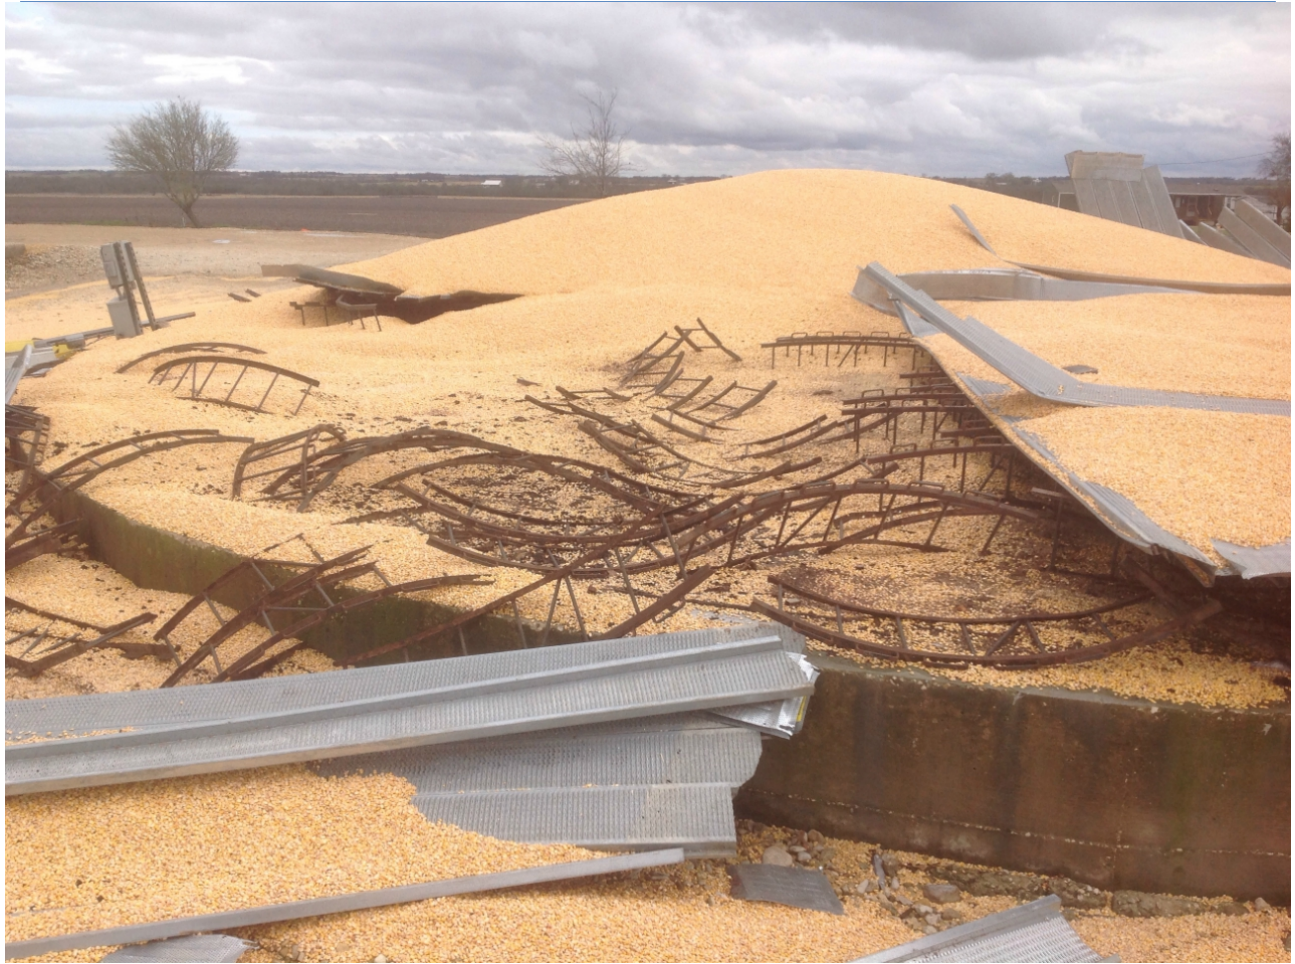
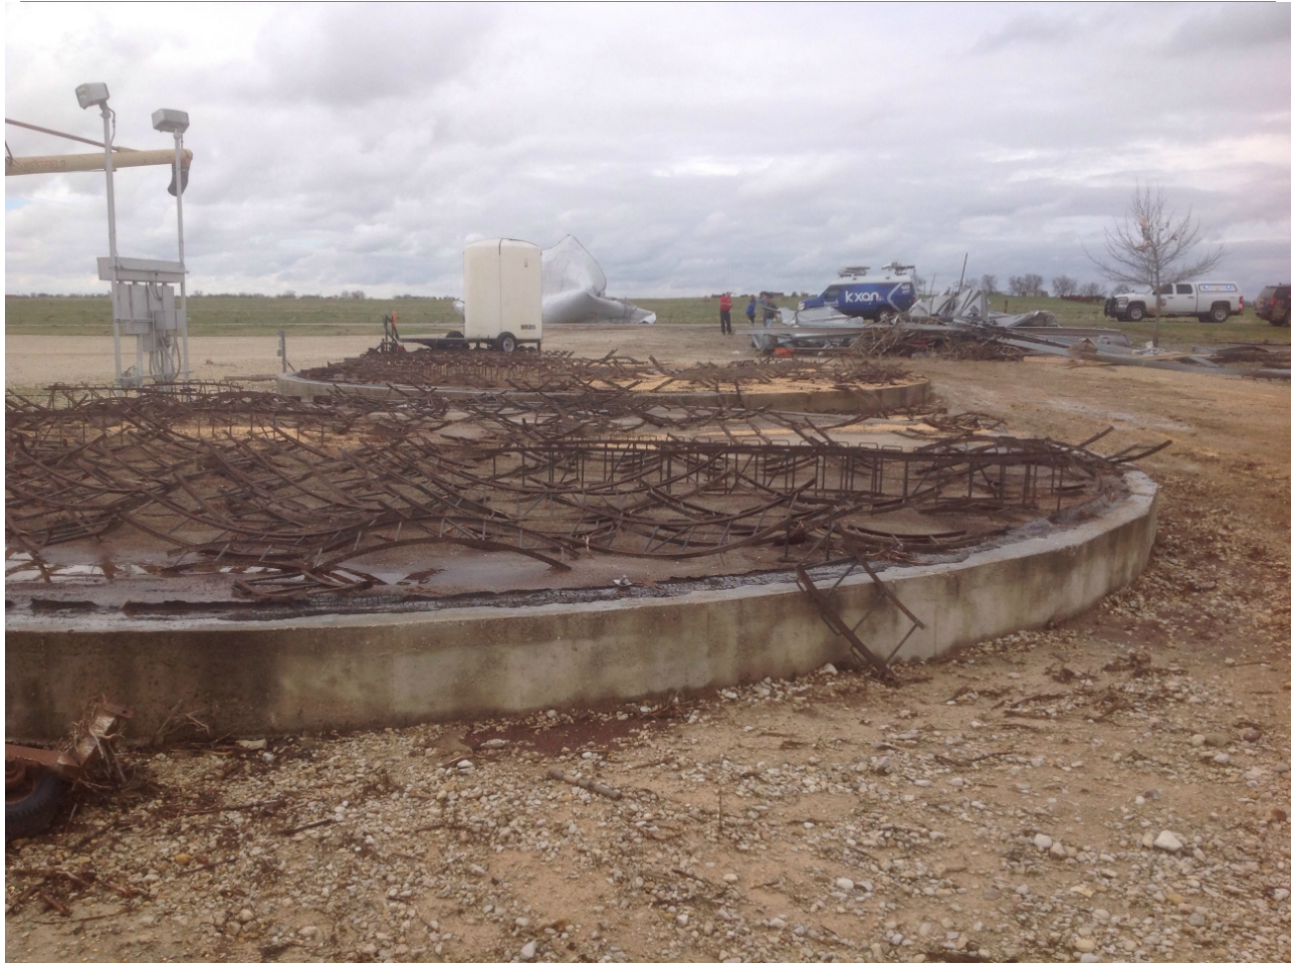
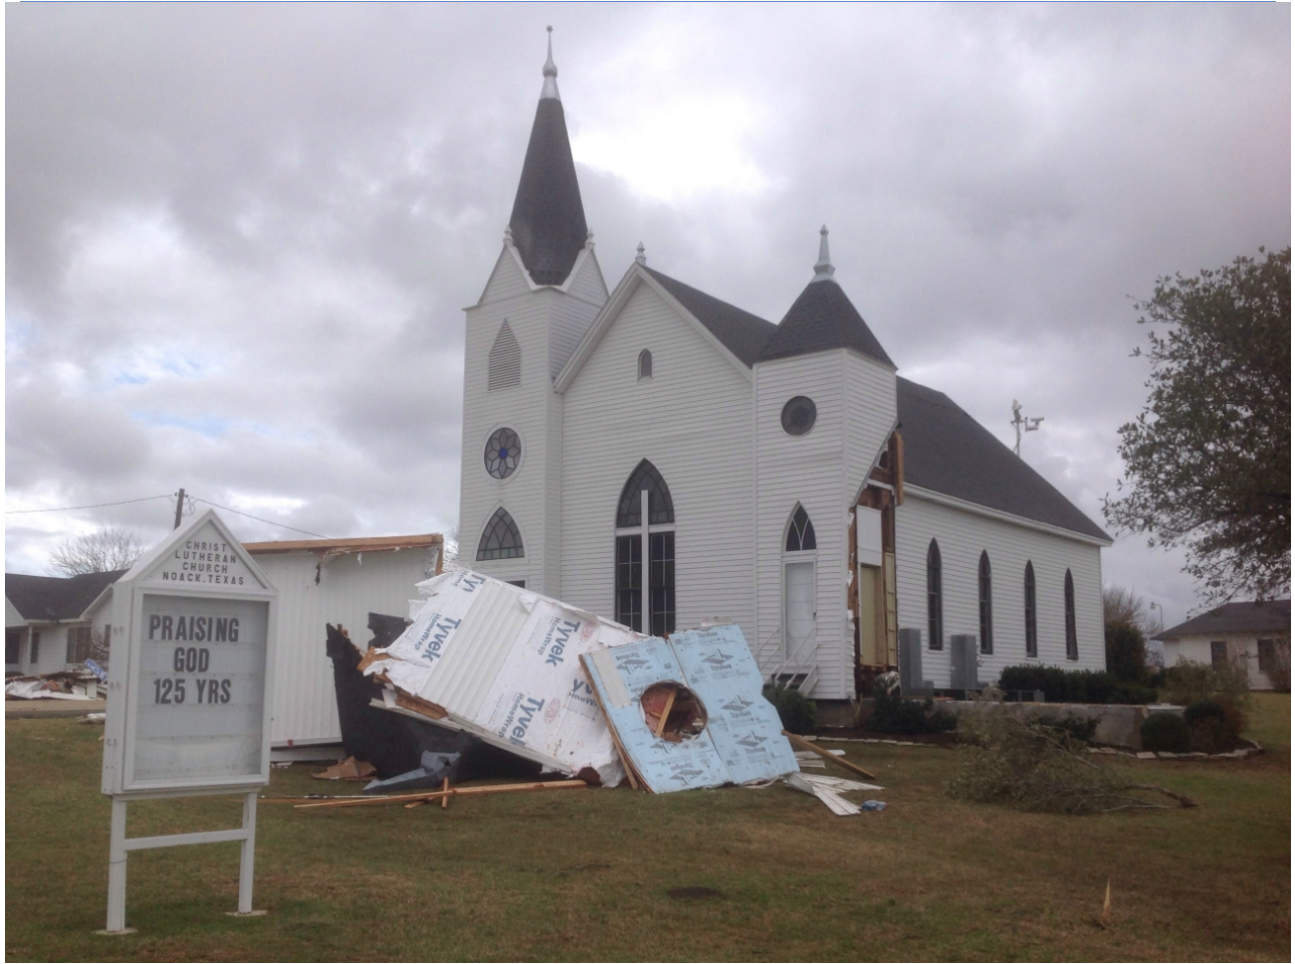
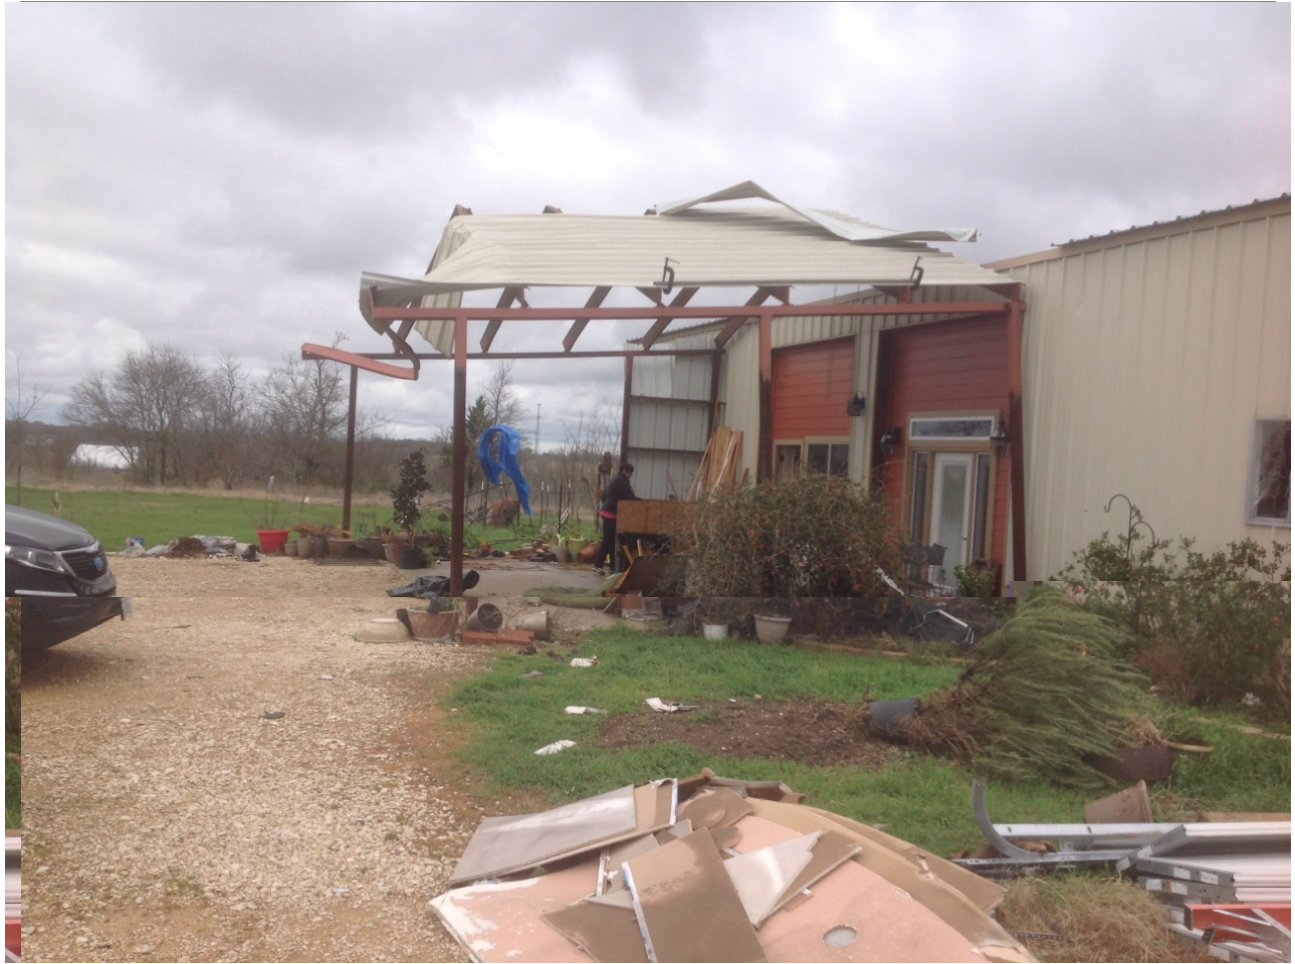
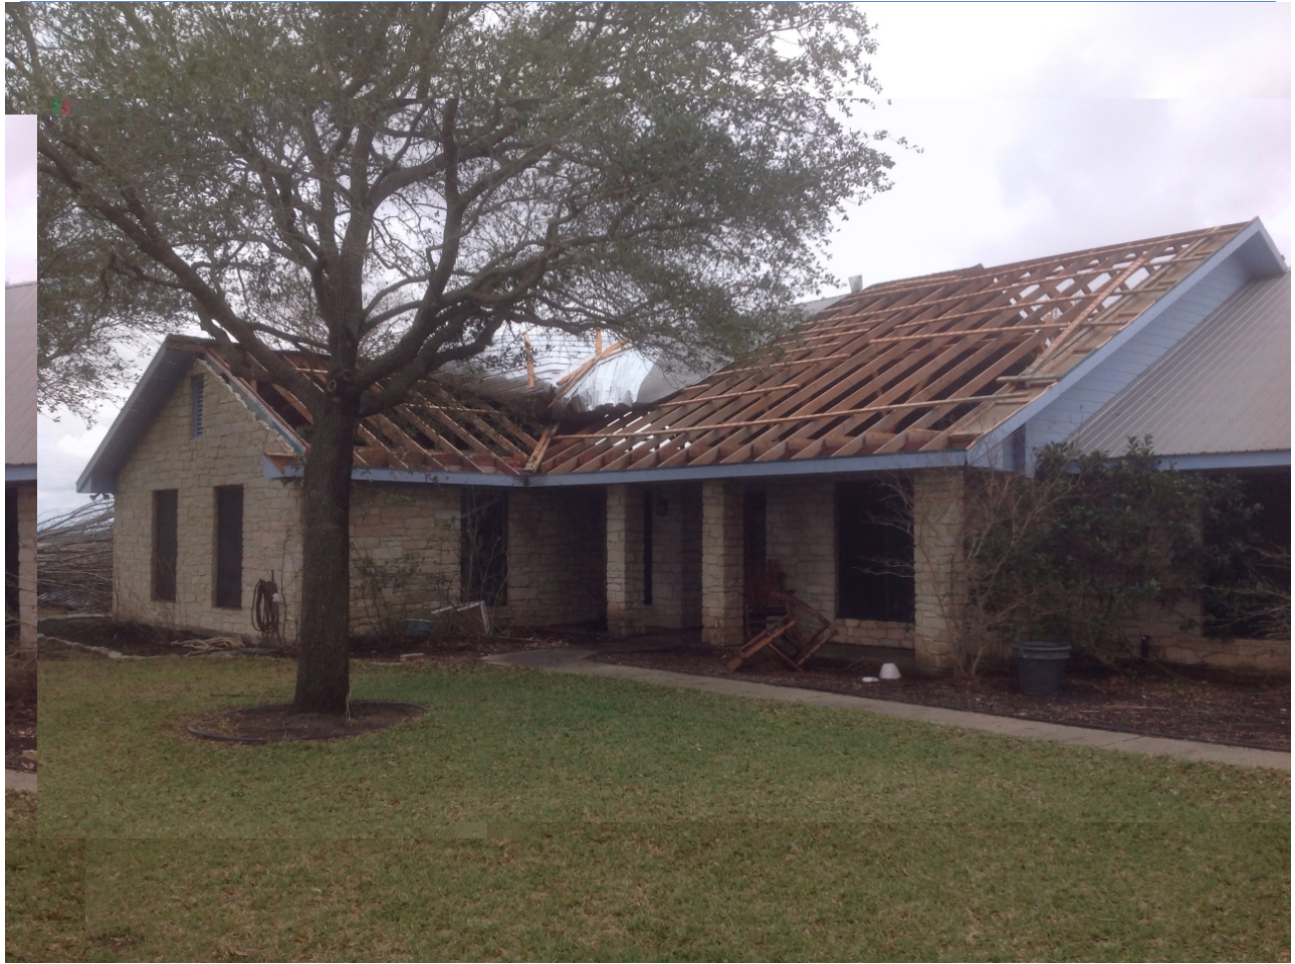
Survey_Summary: This tornado was the northern one of a pair on near parallel tracks a few miles south of U.S. Highway 79. Damage was sporadic...but concentrated when it occurred. The most significant damage was to a metal building system home...at least five other single family homes...and 12 railroad cars blown off the tracks east of Thrall. The train cars may have also been affected by strong straight-line winds.

Survey_Summary: This tornado was the southern one of a pair on near parallel tracks a few miles south of U.S. Highway 79. Damage was sporadic...but concentrated when it occurred. The most significant damage was to a 3-bin grain storage facility...where the bins were completely destroyed and swept from their foundations. Additional damage occurred to an extension of Christ Lutheran Church of Noack on FM 112...where the walls were bolted to the foundation.
