# **June 6-7, 2020 Tornadoes in Orange, Volusia & Lake Counties**

## **Including Straight-Line Wind Damage in Lake and Volusia Counties**

### **Event Summary**

...NWS Damage Survey For 06/06/20 Orlando Ferncreek Tornado and  
Daytona Flea Market Wind Events...

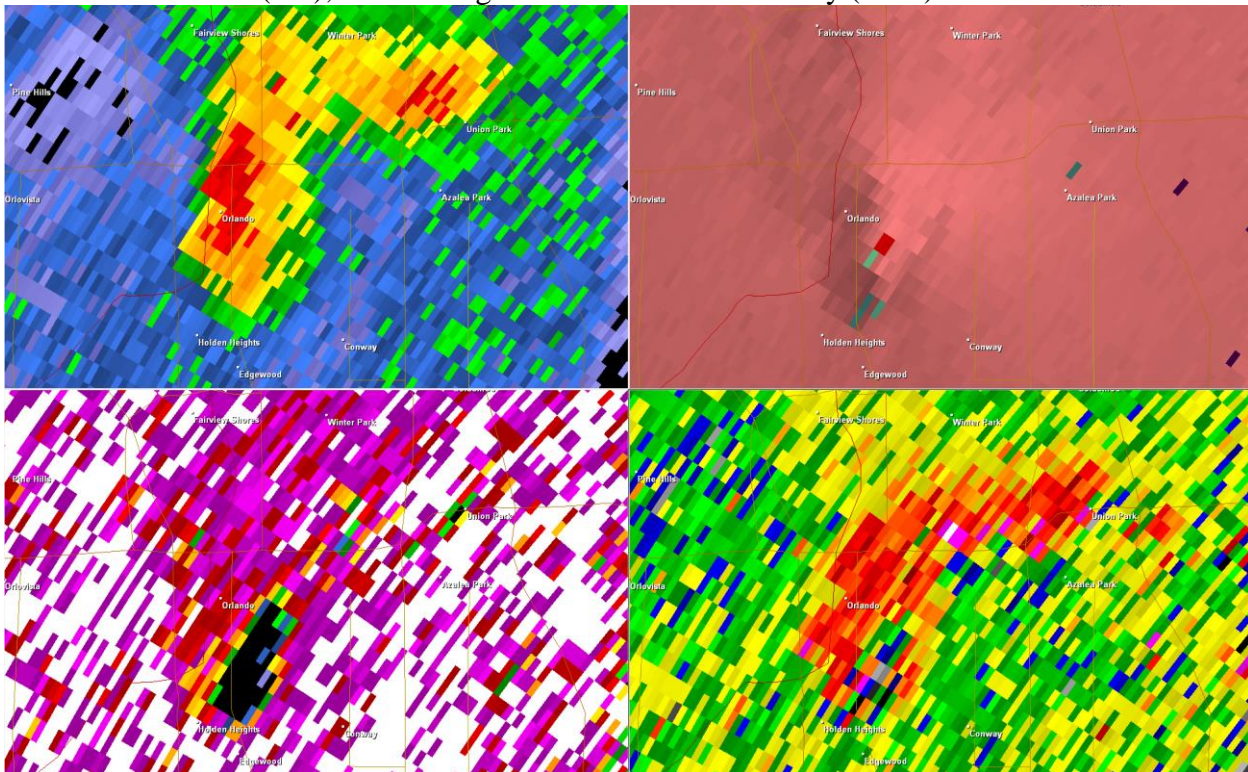
- Top Left: Reflectivity; Top Right: Storm-Relative Velocity; Bottom Left is Correlation Coefficient (CC); Bottom Right: Differential Reflectivity (ZDR)

Tornado Debris Signature seen on the Melbourne radar at 7:26 PM (June 6, 2020). At this point the tornado had been ongoing for several minutes, and the radar likely captured the uplift of debris as the tornado moved over Ferncreek Avenue.

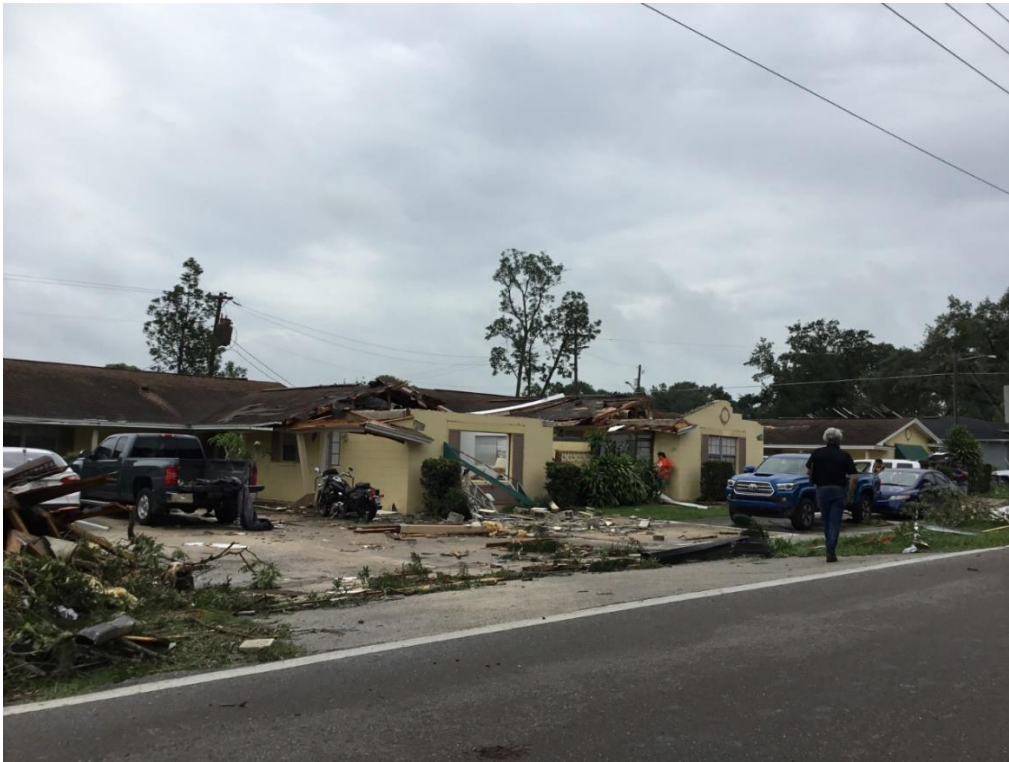
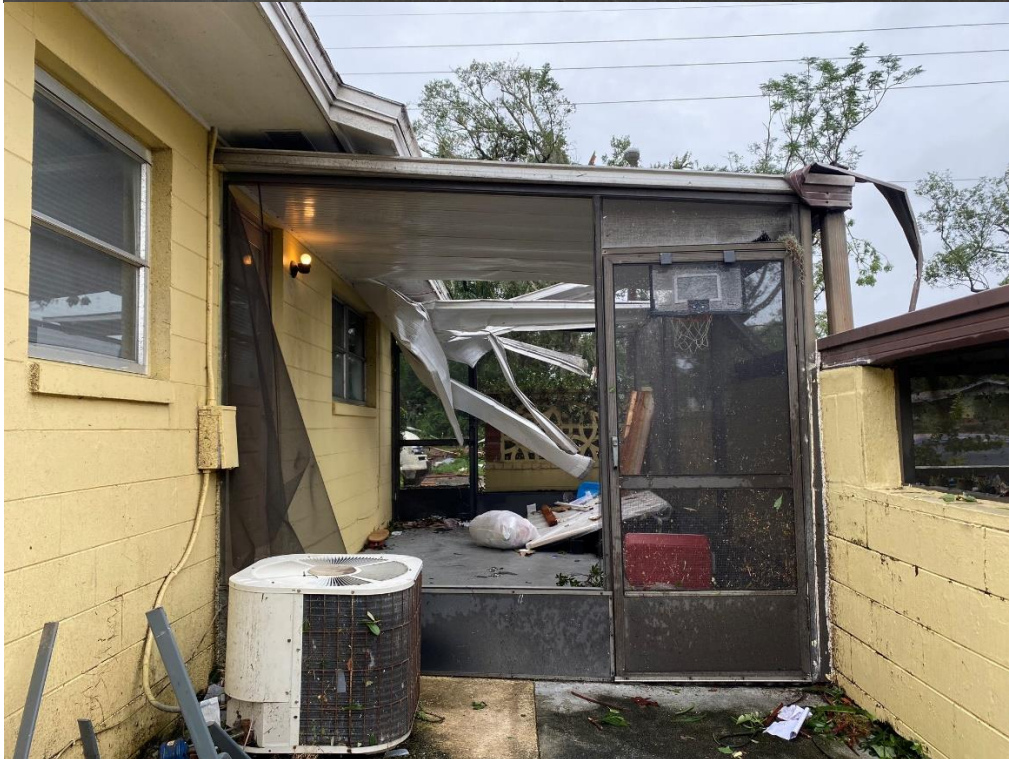
Worst damage at the Lake Margaret Village Apartments (both pictures)  
(peak winds estimated 100-105 mph, EF-1)

The tornado reached peak intensity of EF-1 in the vicinity of Ferncreek Avenue, Lake Margaret Drive and Carmia Drive (estimated peak winds 100-105 mph). Several one story apartment buildings lost significant portions of their roofs.

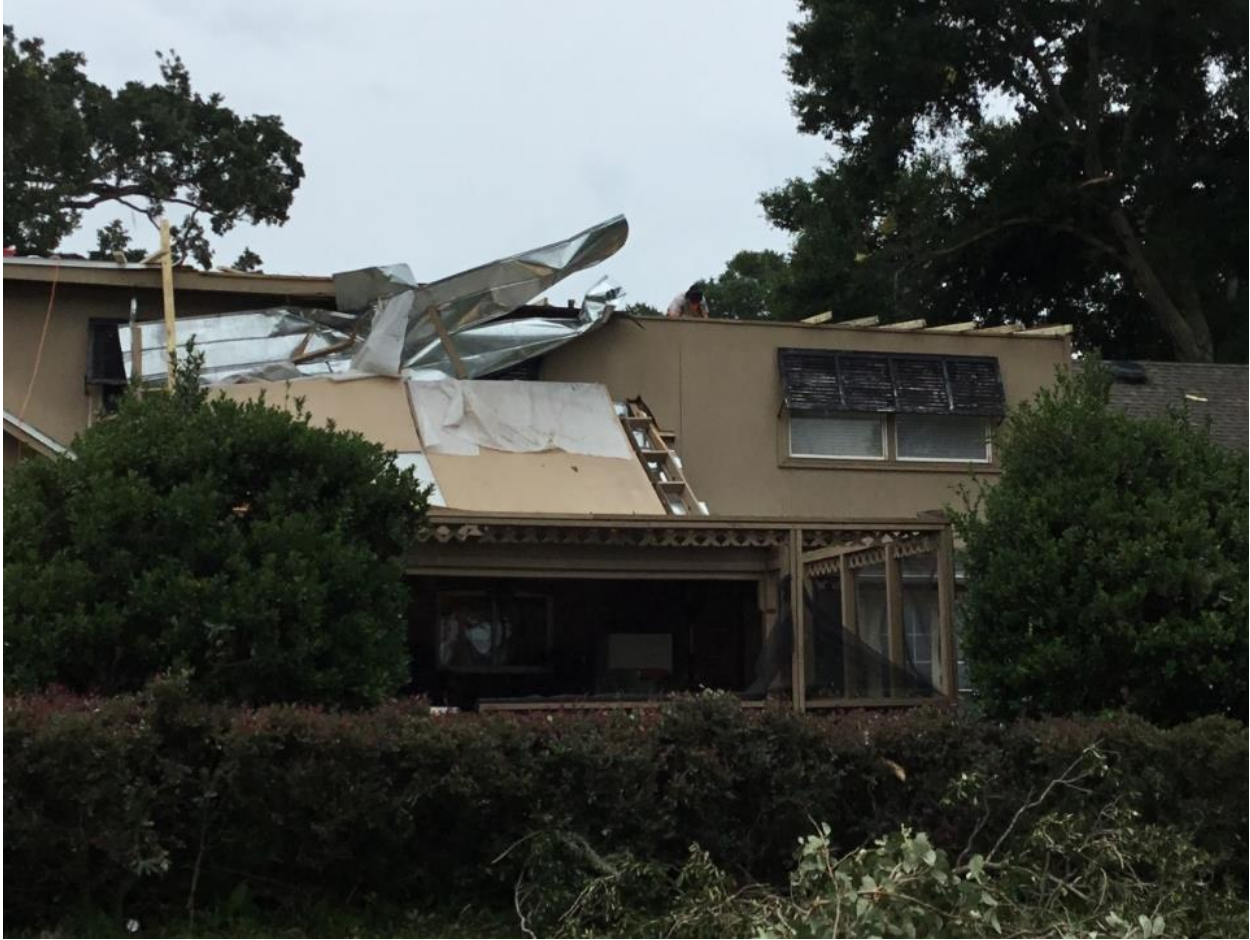
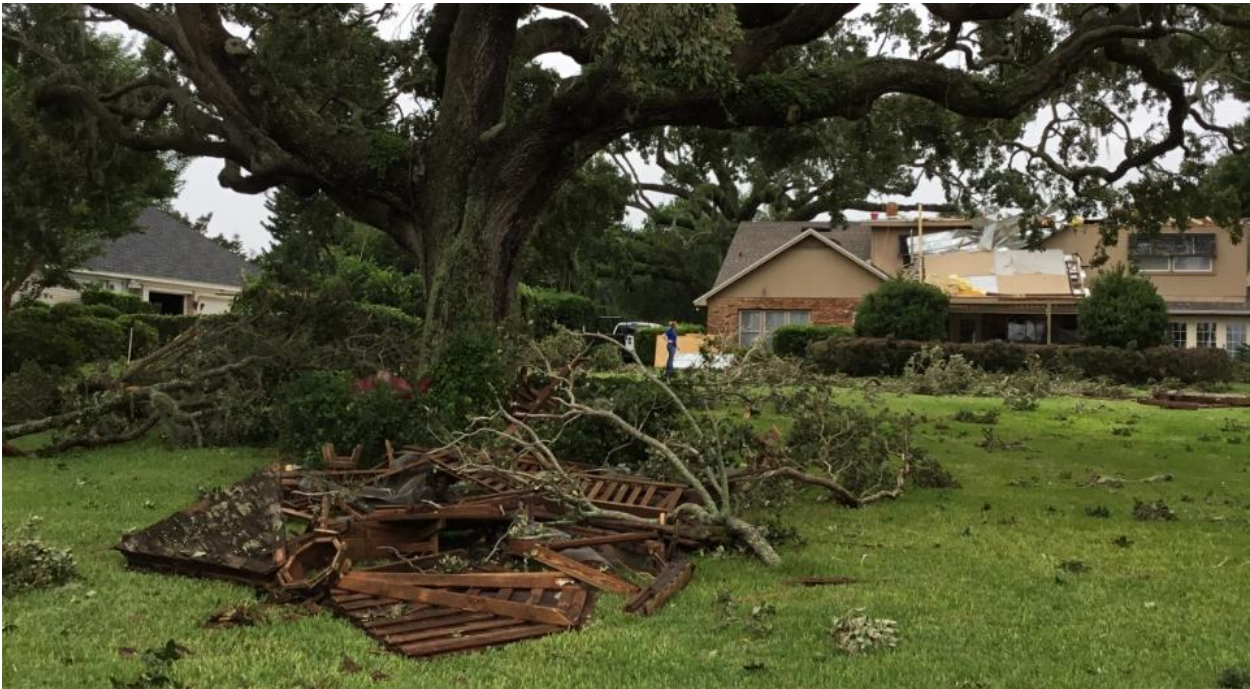
Damage to a home along Hoffner Avenue (peak winds estimated 85-90 mph, EF-1)

Damage was continuous along a 5.1 mile swath with a width of 350-500 yards. As the tornado came onshore at Hoffner Avenue it briefly attained EF-1 intensity (peak winds estimated at 85-90 mph) resulting in severe damage to the roof of a lakefront home and numerous large trees toppled. Damage along much of the remainder of the path was rated EF-0 (winds estimated 65-85 mph).
