Service Assessment

The Central Texas Tornadoes of May 27, 1997

**The Central Texas Tornadoes of
May 27, 1997**

April 1998

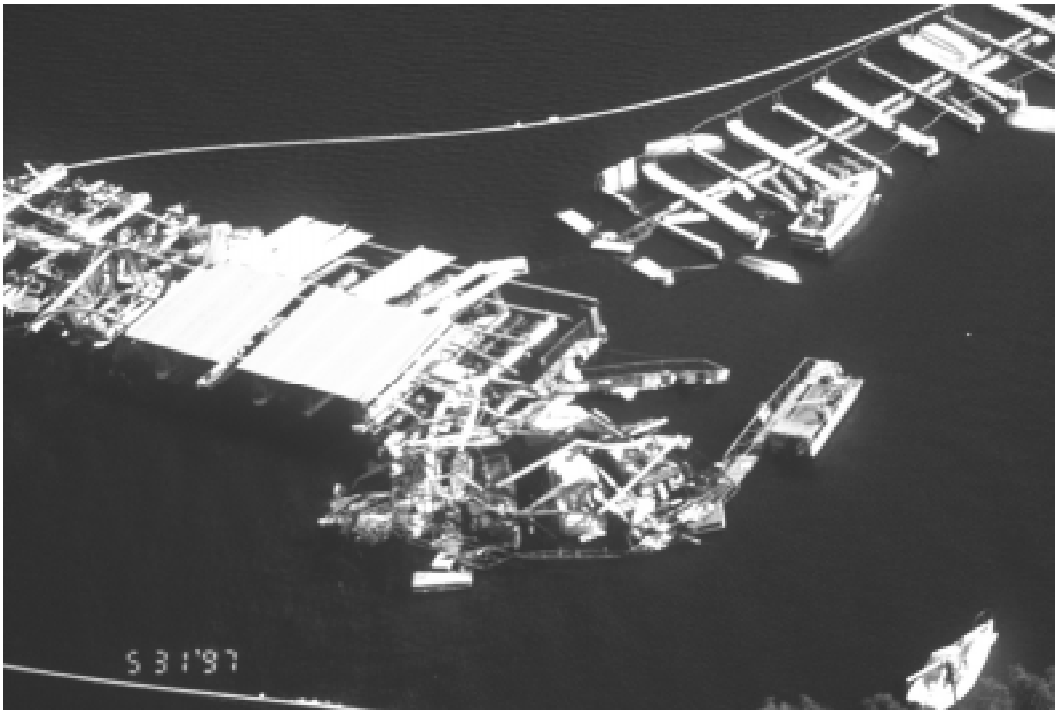
Aerial view of damage to boats at Belton Lake from the Belton tornado. Photograph by L. Phan, NIST.

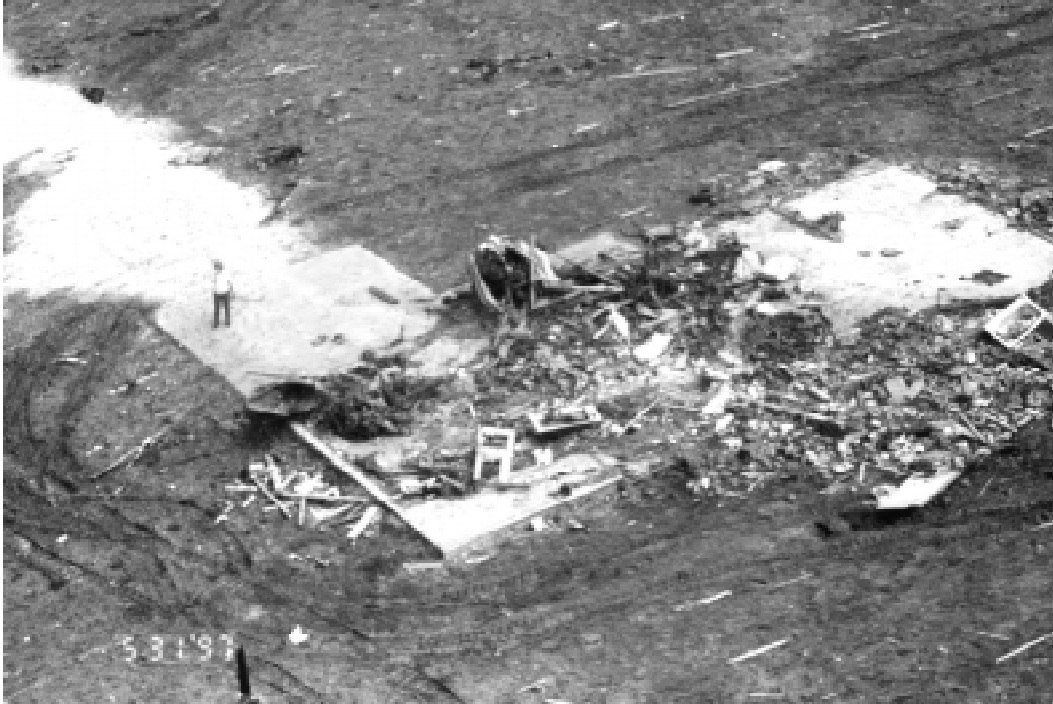
Close-up aerial view of the remains of a home in the Double Creek Estates subdivision of Jarrell. Photograph by L. Phan, NIST.

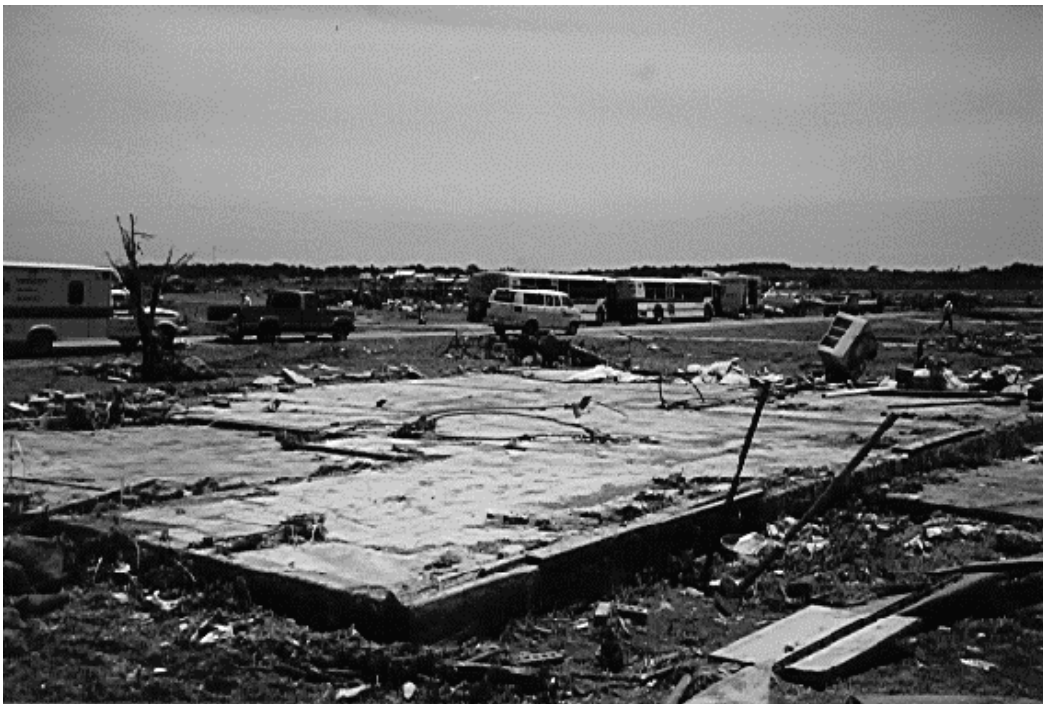
Close-up view of a home foundation in the Double Creek Estates subdivision of Jarrell. Note the plumbing pulled out of the concrete in the center of the picture. Photograph by NWSFO Austin/San Antonio.

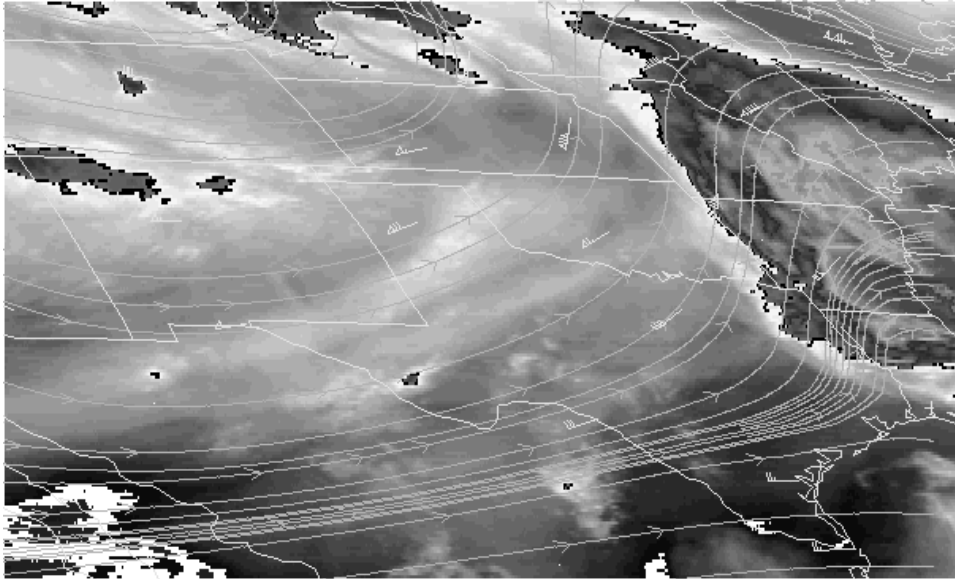
Figure 1. Eight kilometer resolution 6.7 μm image from GOES-9 displayed at the 4 km scale. The image was taken at 1200 UTC on May 27, 1997. The 200 mb winds and streamlines are plotted on the image.

The 6.7 micrometer (μm) channel on GOES senses emission from upper-level water vapor and high cloud; because of this, 6.7 μm imagery is very useful for revealing upper-level flow patterns and for analysis of mesoscale features within the larger scale flow. As might be expected, animated 6.7 μm channel imagery very nicely revealed upper-level flow at the 300-200 mb level (Figure 1).

When Figure 1 is viewed as part of an animated image sequence, the circulation around the upper-level low in Nebraska and the location and movement of the upper-level trough and jet stream are all well defined. Both 6.7 and 10.7 μm imagery show the development of a large MCS over Arkansas and eastern Oklahoma during the night (Figure 2).
