Tornado Hits Tampa Bay Golf and Country Club

101 Homes Damaged by the Tornado

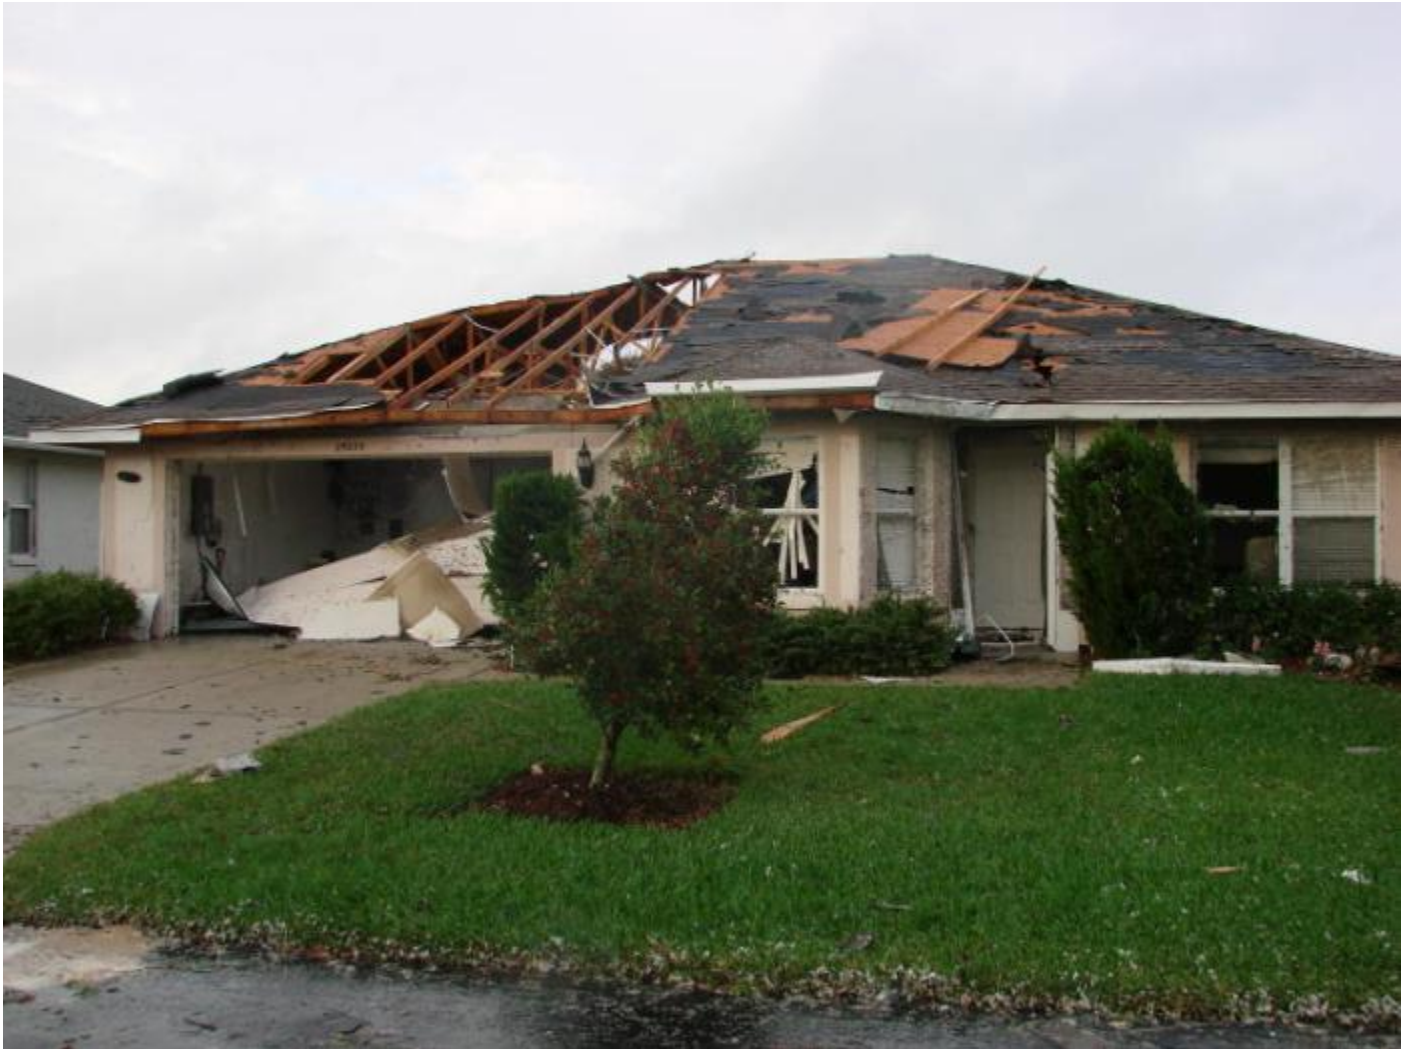
Photograph of F2 damage to home in the
Tampa Bay Golf and Country Club

The tornado first touched down a short distance southwest of the Clubhouse, then moved north for about one mile ending just south of State Road 52 (Figure 2). It produced damage all along its path, most of which was rated as F0/F1 on the Fujita Scale. However, damage rated as F2 occurred on the 29000 block of Caddyshack Lane. A visiting family was in one of these houses when the tornado ripped through. Miraculously no one was seriously hurt with only a few cuts on their faces and feet.

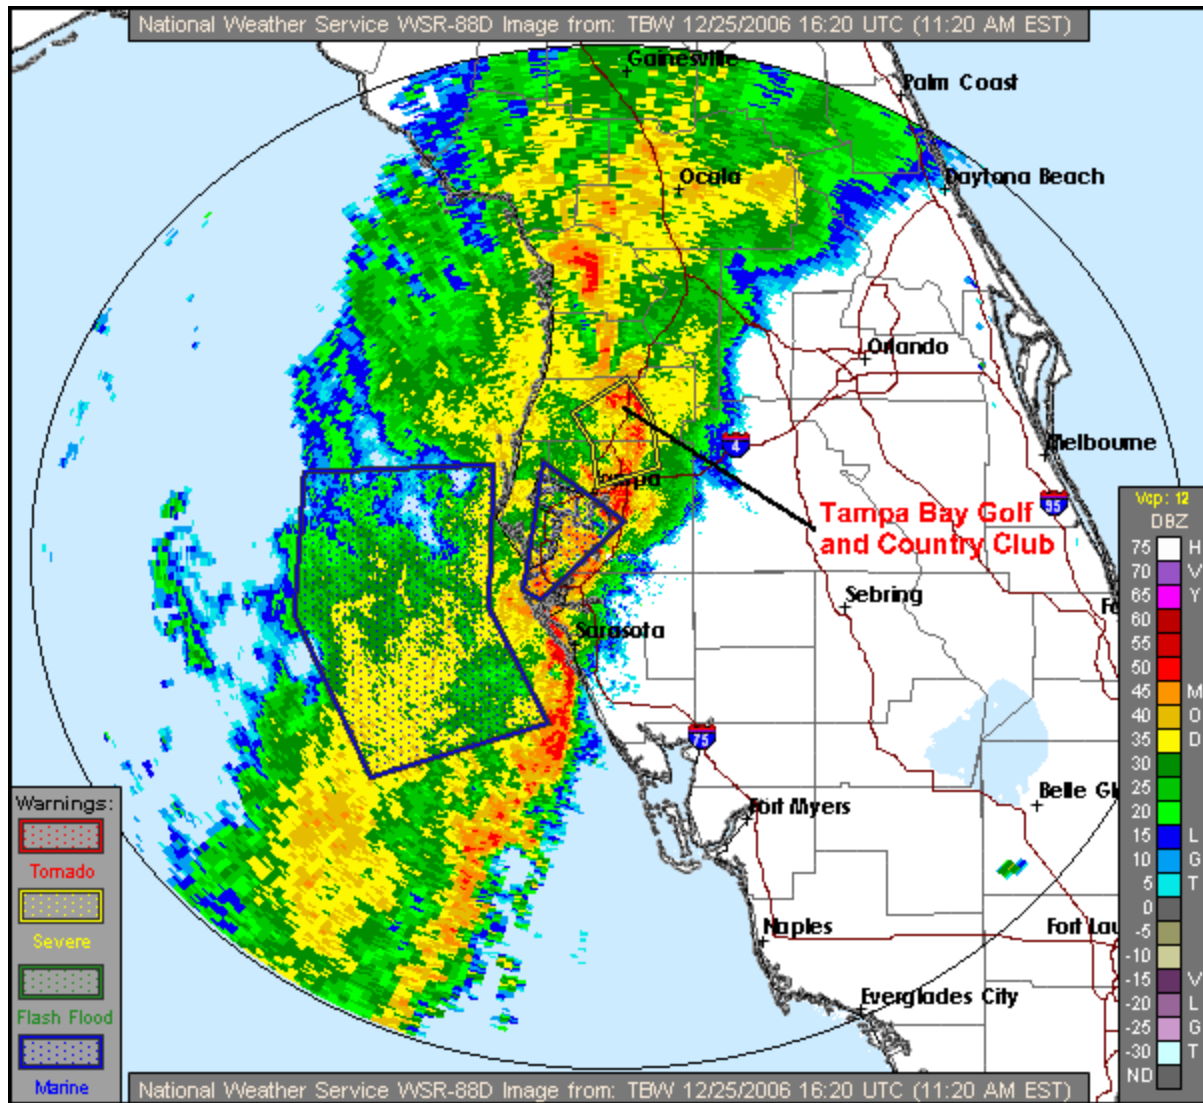
Figure 1. Base reflectivity image, 11:20 AM EST, December 25, 2006.

A small F2 tornado, about 100 yards wide with winds up to 125 mph, rapidly developed within a line of thunderstorms (Figure 1) at around 11:20 AM EST December 25, 2006. This line of thunderstorms was out ahead of a cold front (Figure 3) that was moving across the eastern Gulf of Mexico.

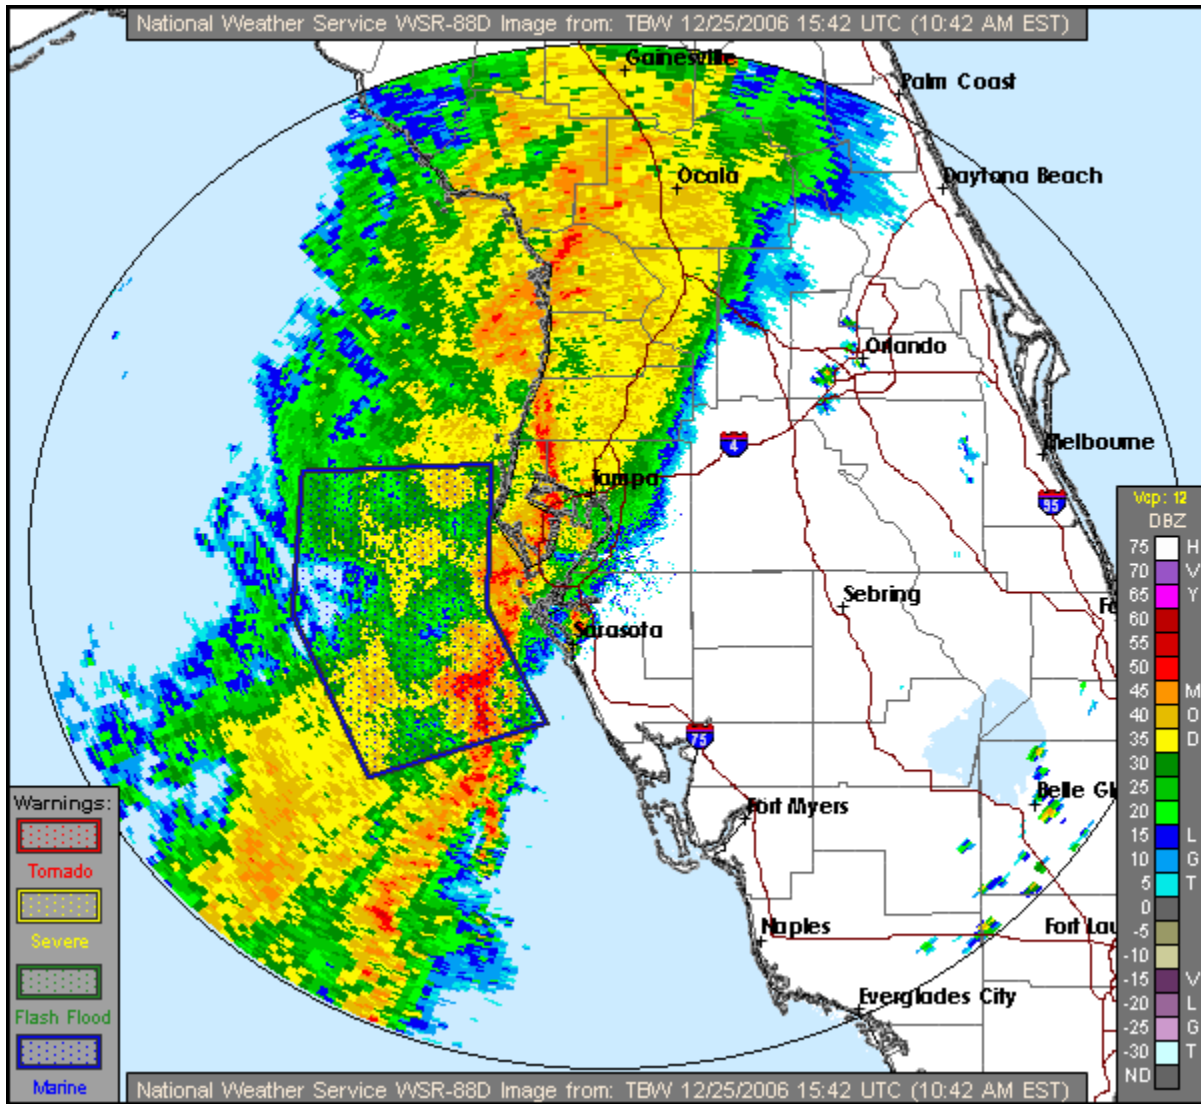
Base reflectivity loop

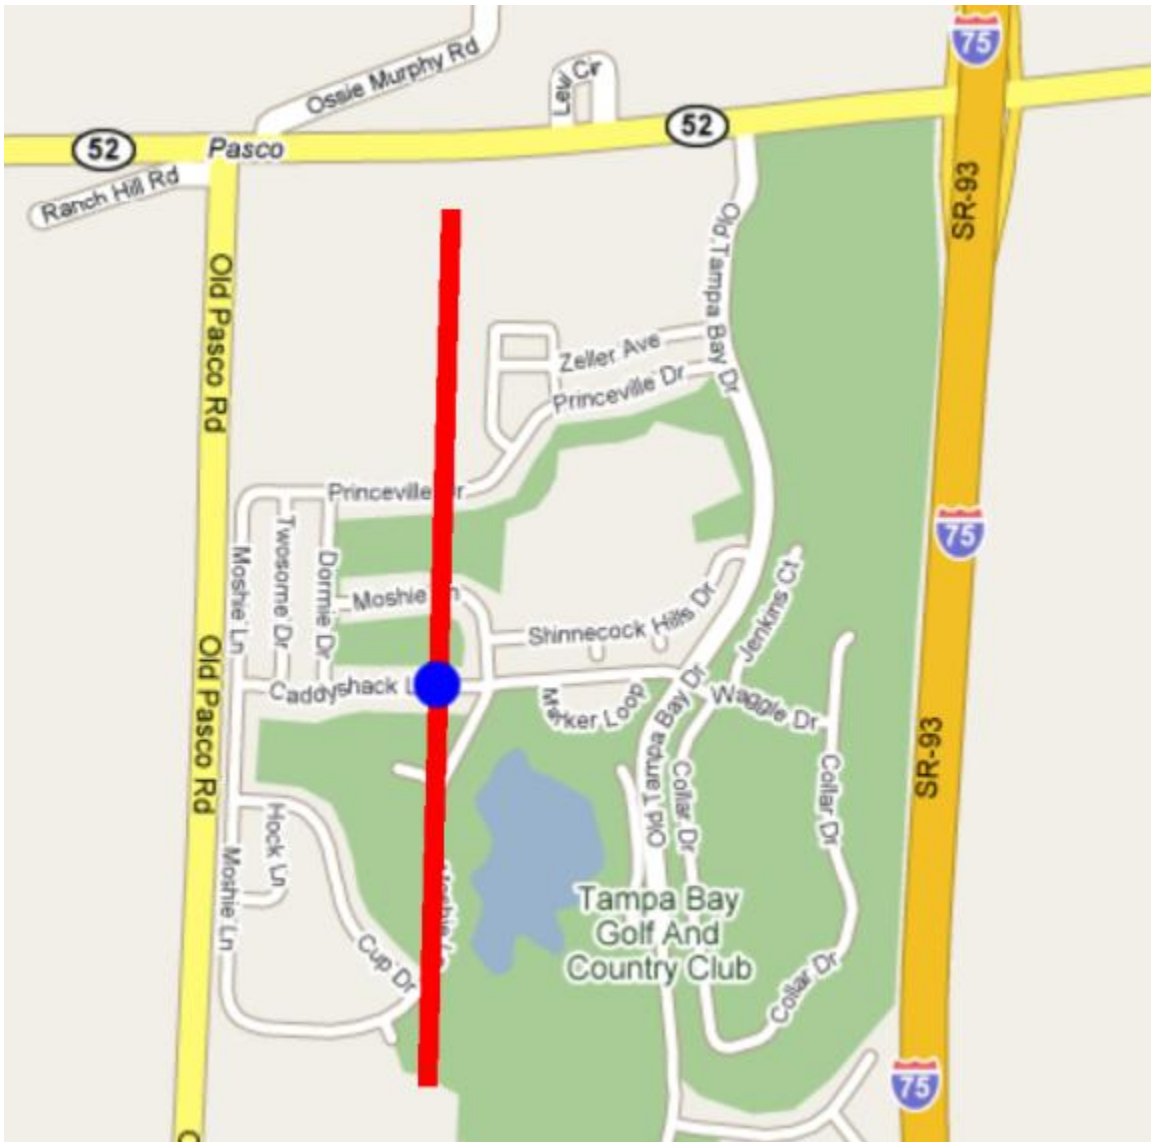
Figure 2. Track of tornado (red line) overlaid on zoomed in map of central Pasco County. Blue circle indicates location with F2 damage.

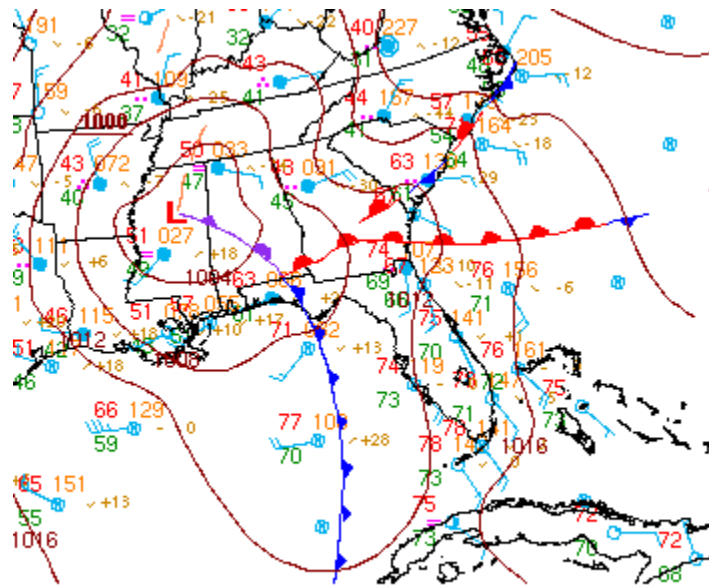
Figure 3. Surface Analysis, 7:00 AM EST December 25, 2006
