Type of Event: EF0 Tornado, winds estimated 80-85mph

Date of Event: 5/12/09

Location: 2606 – 2612 Smithtown Dr., Lakeland, FL

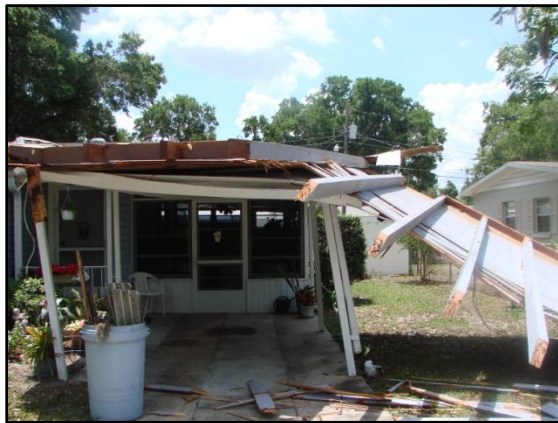
A piece of the dislodged carport rests on a structure

Winds with the tornado were estimated to be between 80-85 mph. This rating was based on the construction quality of the dislodged carport which consisted of older wood and straight nails. In addition, the shallow root structure of the fallen tree would have been susceptible to winds of this magnitude.

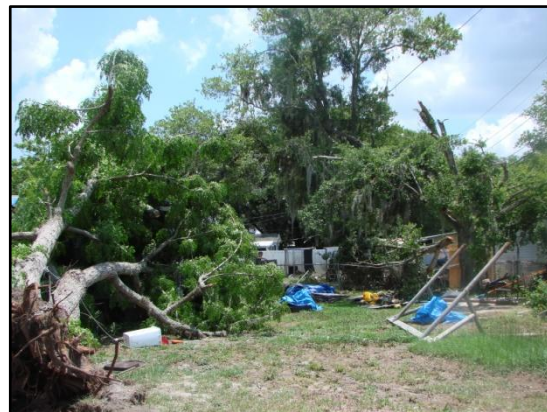
Looking down the approximate tornado path

Damage in the area consisted of many downed tree branches ranging in diameter from 2 to 6+ inches, an uprooted tree, and a torn apart wooden carport. Several areas of collateral damage also occurred due to flying debris, including broken windows, heavily damaged fences, and areas of roof and carport damage. Pieces of the torn-apart carport were thrown 40-50 yards, between two trees, before landing on separate ends of another residence. The total damage path length was around 80yds, with a total width of 15-20yds.
