"Recognition" as a Component of Emergency Response¹

John F. Weaver
NOAA/NESDIS/RAMM
CIRA/Colorado State University
Ft. Collins, Colorado 80523

Paper presented at the International
Technical Rescue Symposium
held Nov 5 - 7, 1999
Fort Collins, Colorado

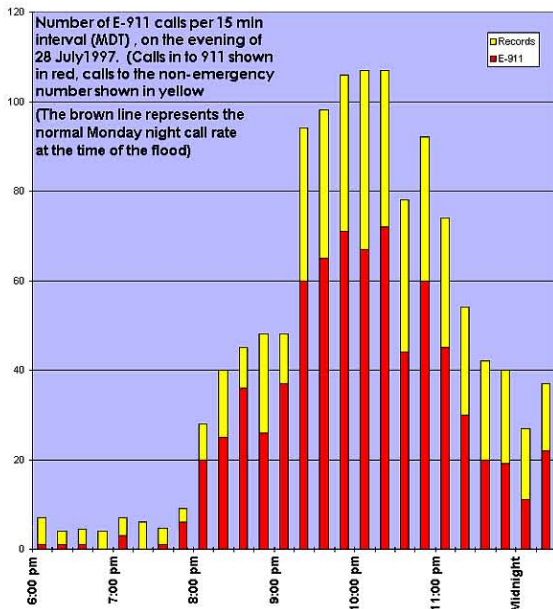
Figure 4. Incoming 9-1-1 (dark) and police (light) phone calls in 15-min increments. Times in Mountain Daylight (24-hr clock).

E-911 activity really began to liven up about this time. The total call volume (9-1-1 plus non-emergency police lines) increased sharply, going from just 9 calls in the fifteen minutes between 7:45 and 8:00, to 28 in the next 15-min. period. Several calls concerned the PV&L canal overflowing into houses. What wasn't known at the time was that a major backup in the canal's flow was occurring just north of Spring Creek where three-foot-deep runoff swept across a ten-to-twelve acre open space. It was running *across the top of the PV&L canal* in a place where the canal ran west for several hundred yards, and in a direction *opposite to that of the underlying flow*.

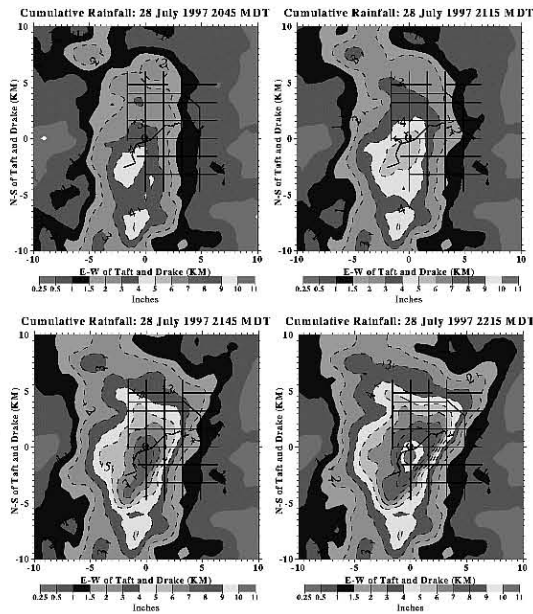
Figure 6. Rainfall accumulation in 1/2 hr increments beginning at 8:45 p.m. MDT on 28 July 1997. 10.5" fell near Taft Hill and Drake.

The total rainfall in southwest Fort Collins for the six hour period from 5:00 through 11:00 p.m. was 10.5 inches. In eastern and northern Fort Collins, residents looked out their windows at what for them would be an inch or two rainfall, and went to bed where they enjoyed a peaceful night's sleep.

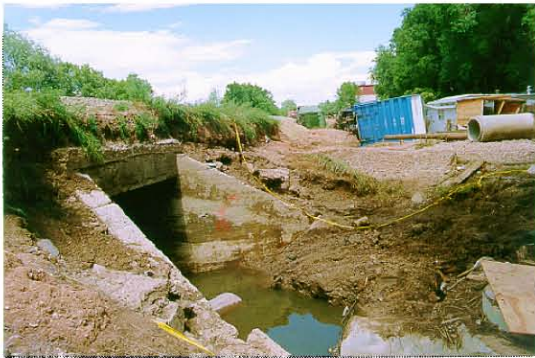
The first sign of the final phase of the disaster came when several people to the east of the railroad tracks noticed that Spring Creek was running exceptionally high between the railroad bed and College Avenue – the main north-south street through the city. Nearby houses were starting to flood. Calls from this area began to filter into the overworked dispatch center. Only one engine was available in reserve, and it headed down College at 10:44 p.m. While it was still on its way, and while most rescuers worked furiously in a three-to-four sq. mi. area to the west, severe turbulence and enormous water pressure caused the 12' x 14' culvert under the railroad bed to fail catastrophically.

Figure 7. Failed culvert, 9:00 a.m. on the morning of 29 July 1997. Compacted dirt had all been washed away, and the 80 ft. long, 36 in. diameter pipe broken into pieces.

A few minutes after the culvert failed, the deepening water (which continued to rise despite the sudden release of 3,300 cfs through the culvert) overtopped the railroad bed. Unfortunately, a freight train had started across this section of tracks between the two events. The combined flow from the culvert and the overtopping surged into two trailer parks situated next to the tracks on the east. Several witnesses who'd driven through the parks just twenty minutes before report having seen only rain dampened roads, and

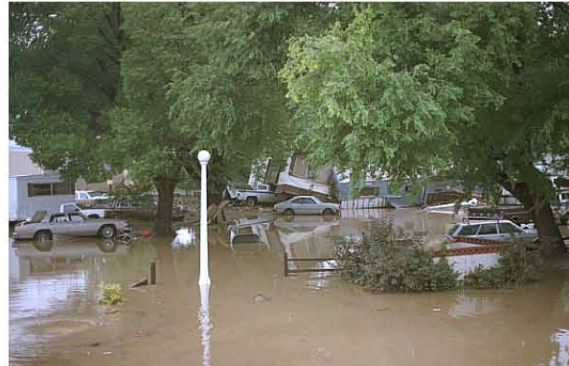
normal activity. By 11:00 p.m., eight-foot-deep raging waters were floating trailers, and sweeping victims into the twelve-foot-deep Spring Creek channel. Broken gas lines had ignited three mobile homes which burned fiercely in the middle of the flood waters. The passing train was derailed, and a nearby store exploded. Sixty-two people were in the process of being injured and five ladies had already drowned.

Figure 8. Entrance to the Johnson Mobile Home Park, 1799 S. College Ave. at about 8:30 a.m. on the morning of 29 July 1997.
