Thunder Bay Reef Habitat Restoration

Lake Huron, Michigan

Project Summary:

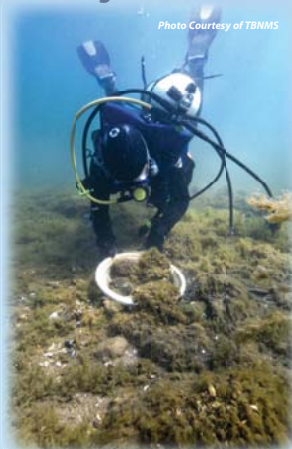
Egg bags being buried amongst rock to measure the number of lake trout and white fish eggs being deposited

Mapping efforts have determined suitable locations for placement of reef material. Coordination efforts with Thunder Bay National Marine Sanctuary and Underwater Preserve will ensure no historic artifacts are impacted. Preconstruction monitoring of egg and fry survival on existing spawning habitat has begun.
