***May 12, 2008 Sichuan, China  
Earthquake Reconnaissance***

Zhenming Wang  
Kentucky Geological Survey  
228 MMRB

KGS Brown Bag Seminar  
July 10, 2008

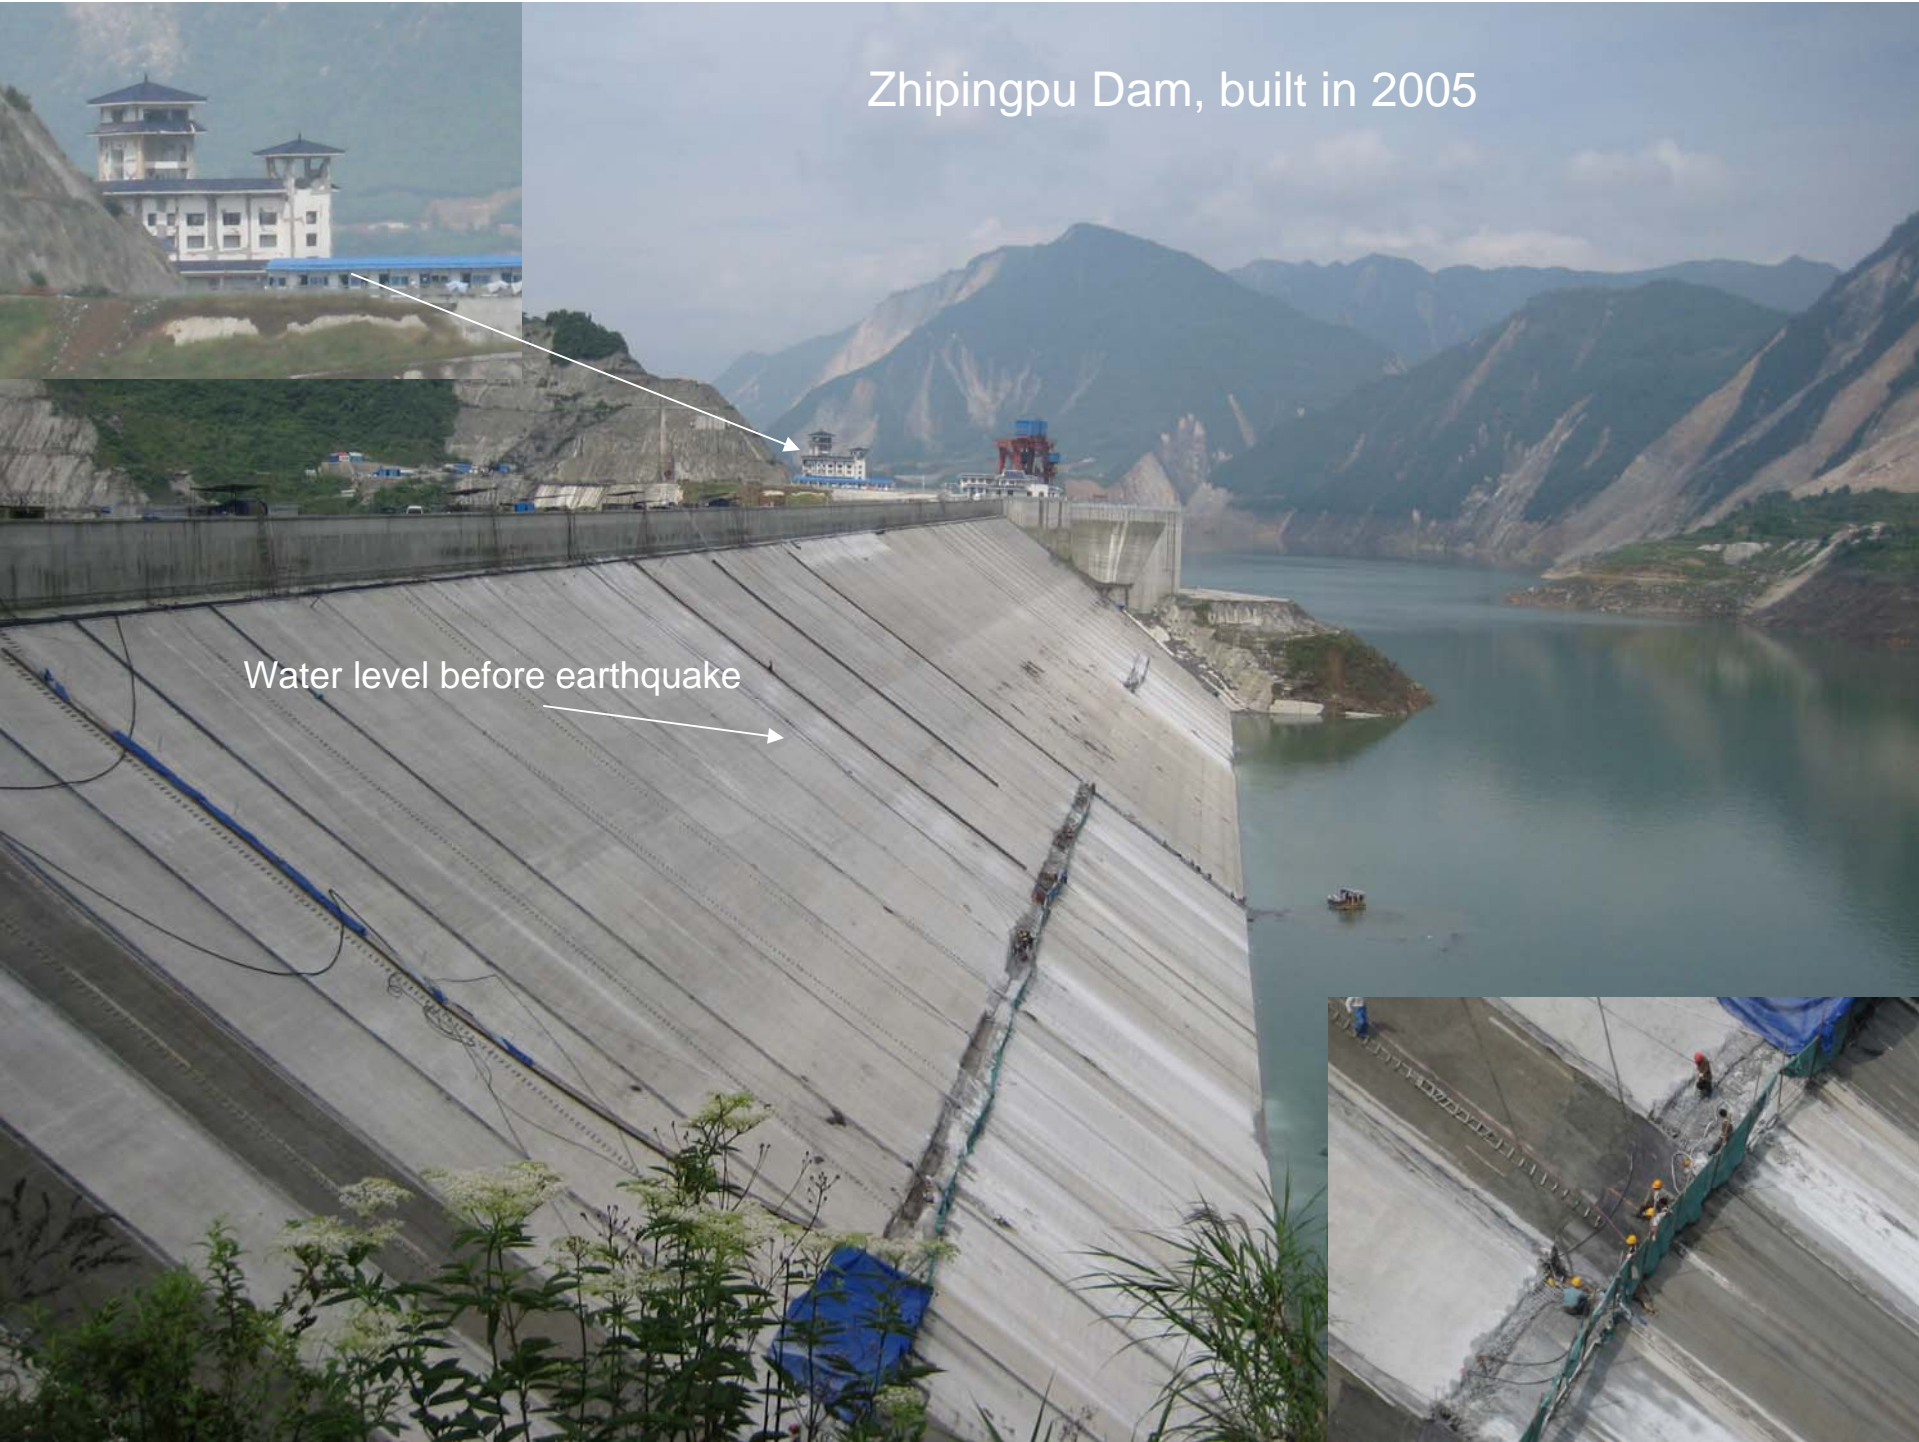
Water level before earthquake

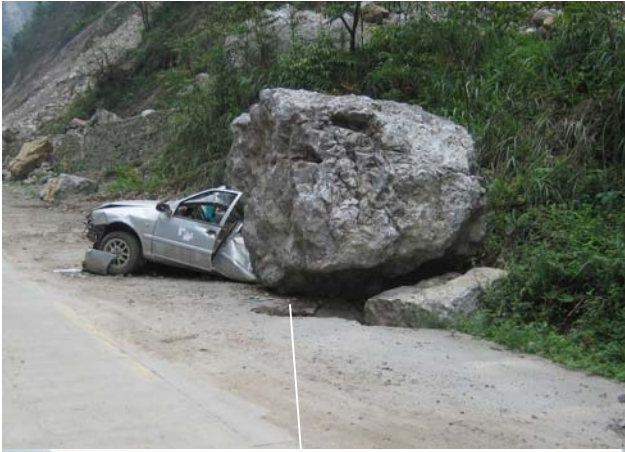
Dangerous road

Damaged bridge

Lateral spreading

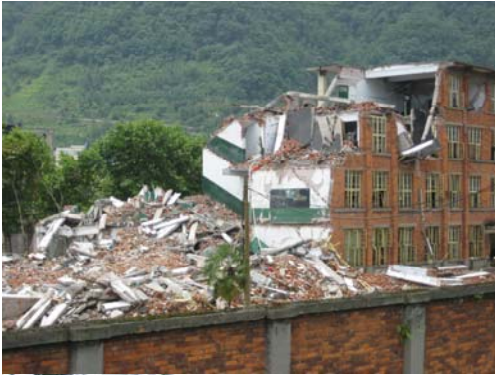
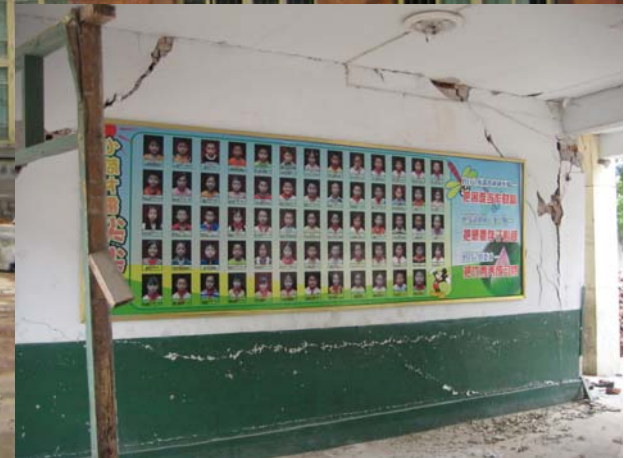
Collapsed school buildings

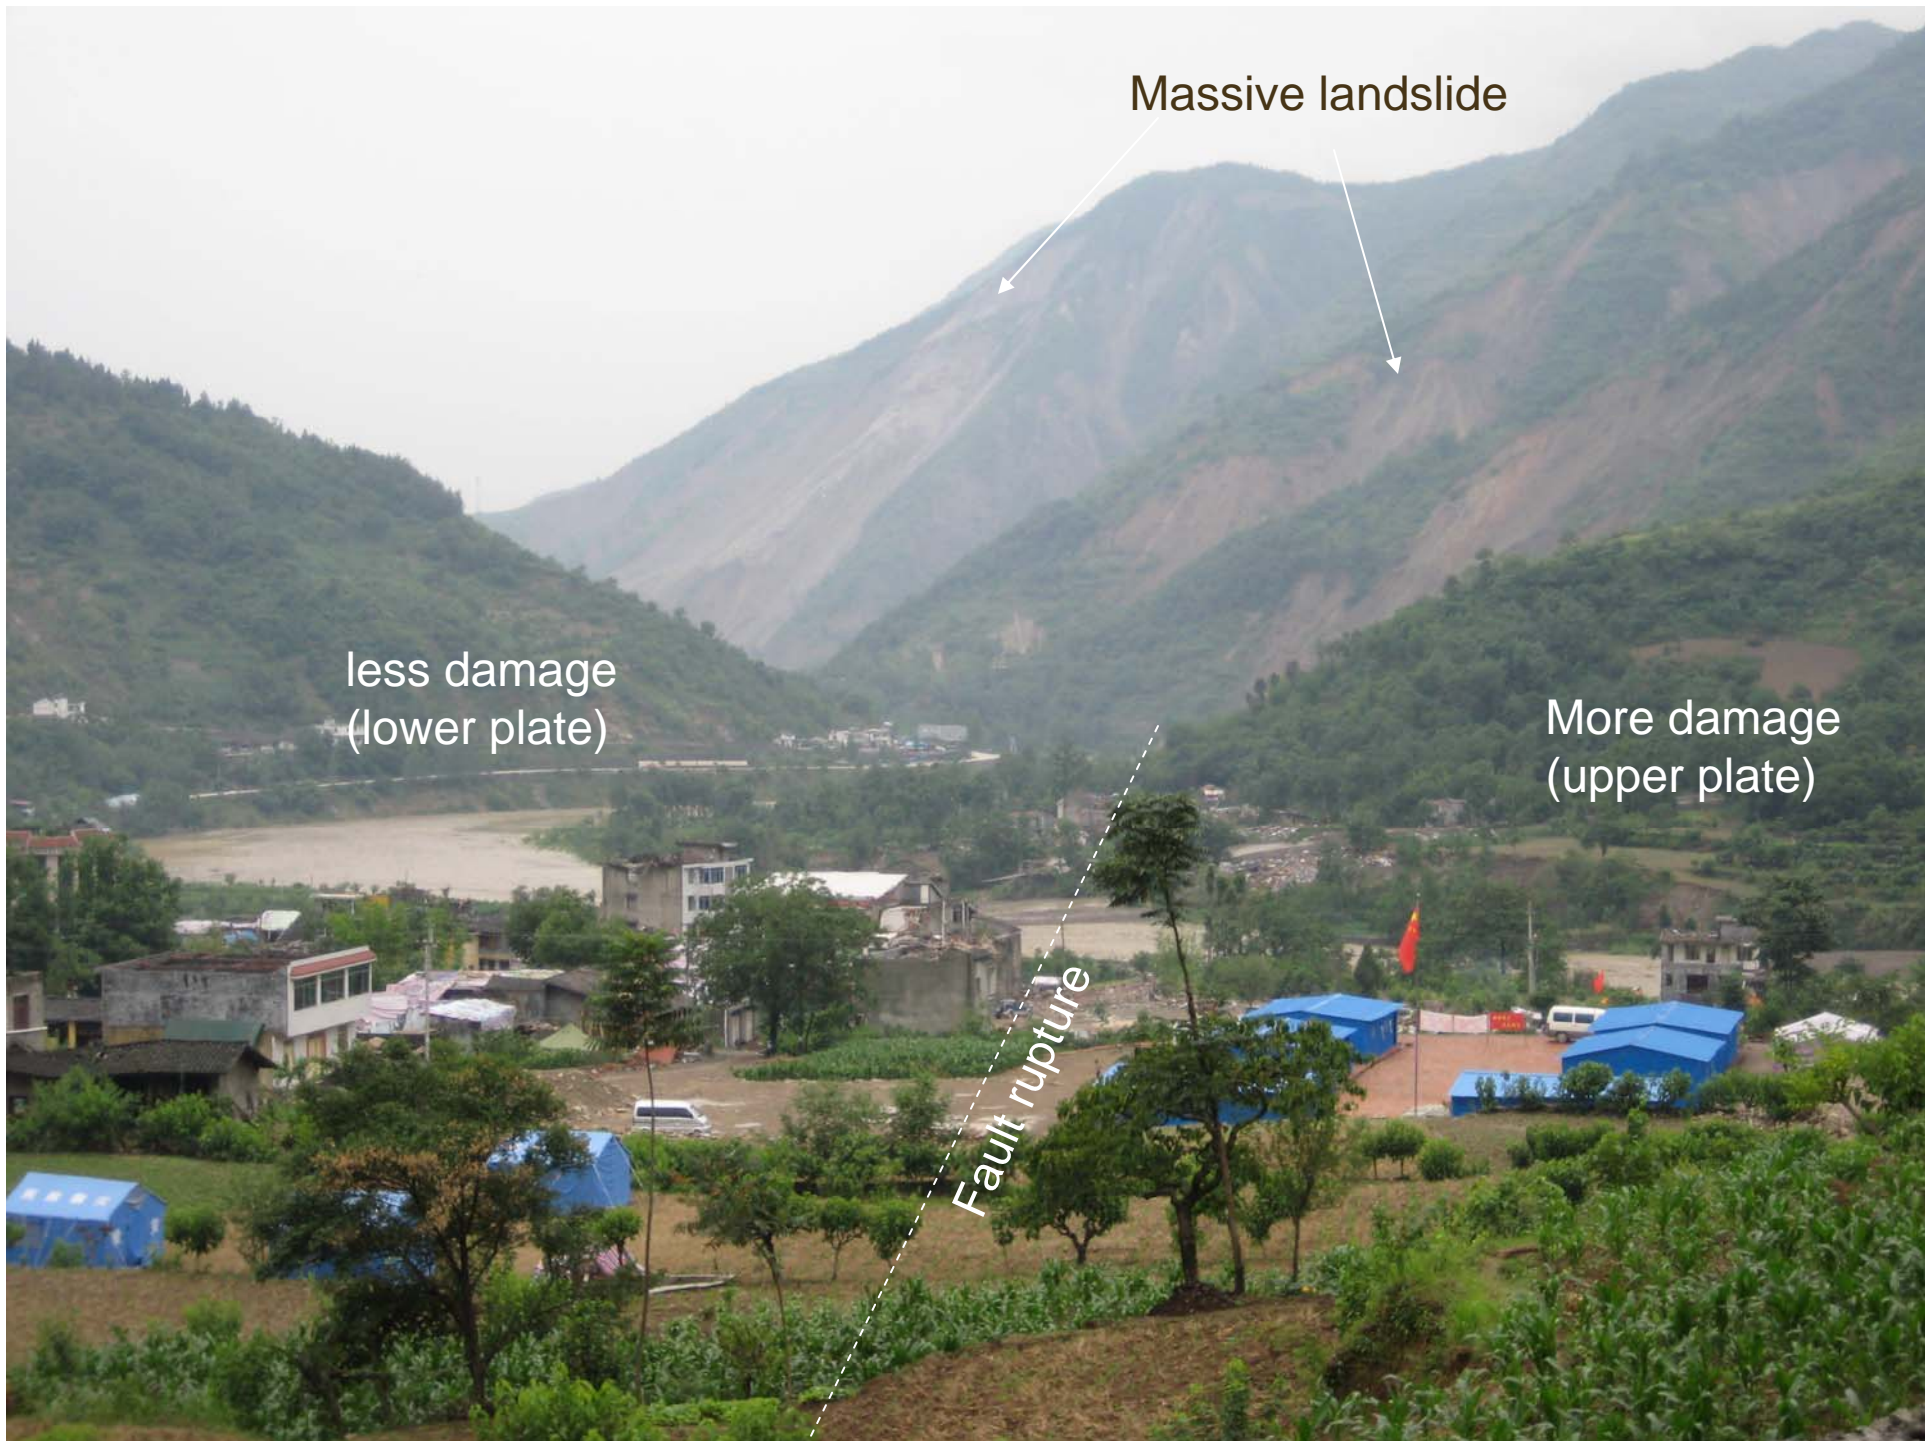
Massive landslide

less damage  
(lower plate)

More damage  
(upper plate)

Fault rupture

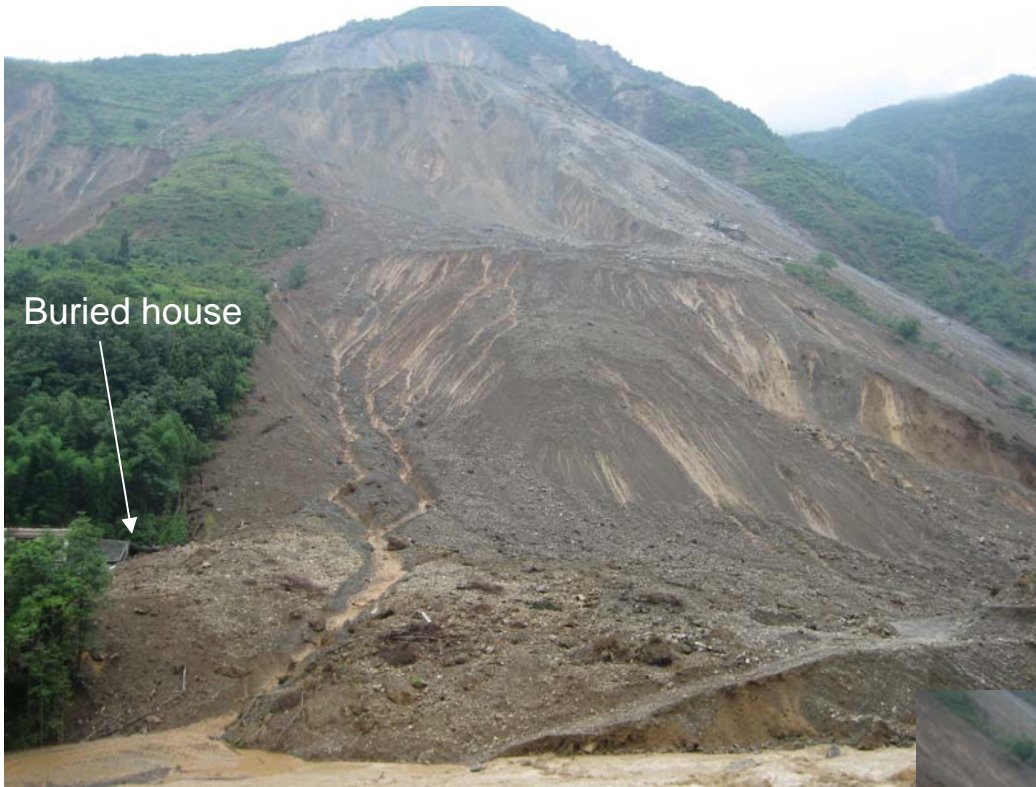
Buried house

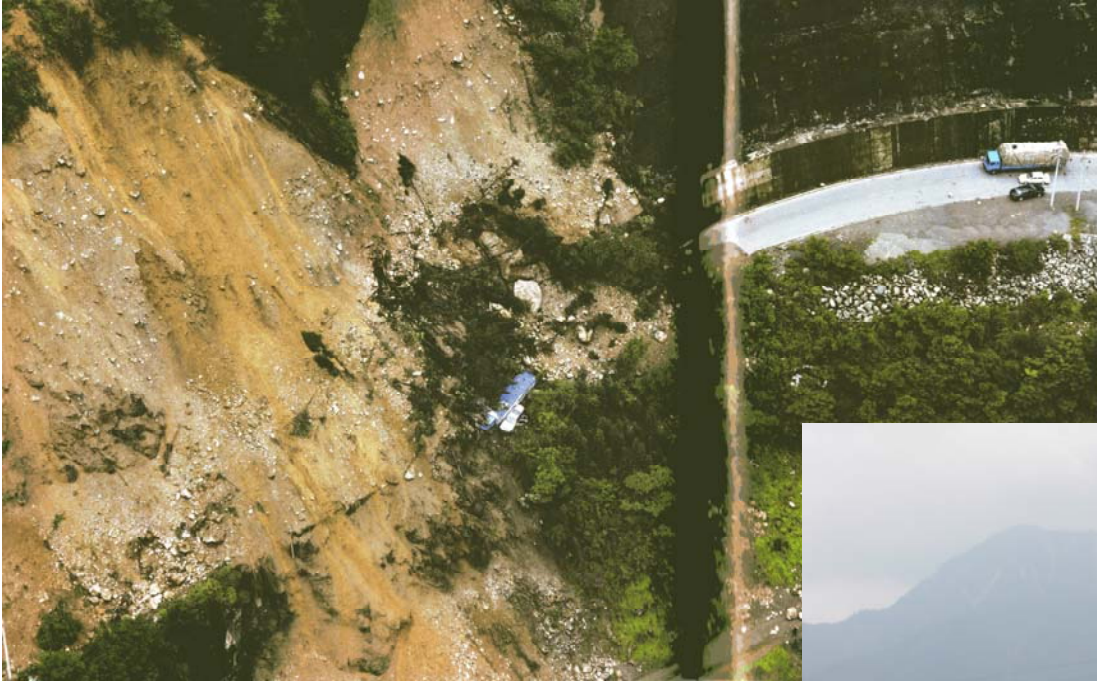
## Secondary Hazard

1. Landslide/Rock fall
2. Ground Motion Amp.
3. Liquefaction (reported)
